**Action Taken Report  
Thorthormi Flood Incident 30 October 2023**

**Hydrology and Water Resources Services division  
National Centre for Hydrology and Meteorology  
Royal Government of Bhutan  
November 2023**

## **Action Taken Report Thorthormi Flood Incident 30 October 2023**

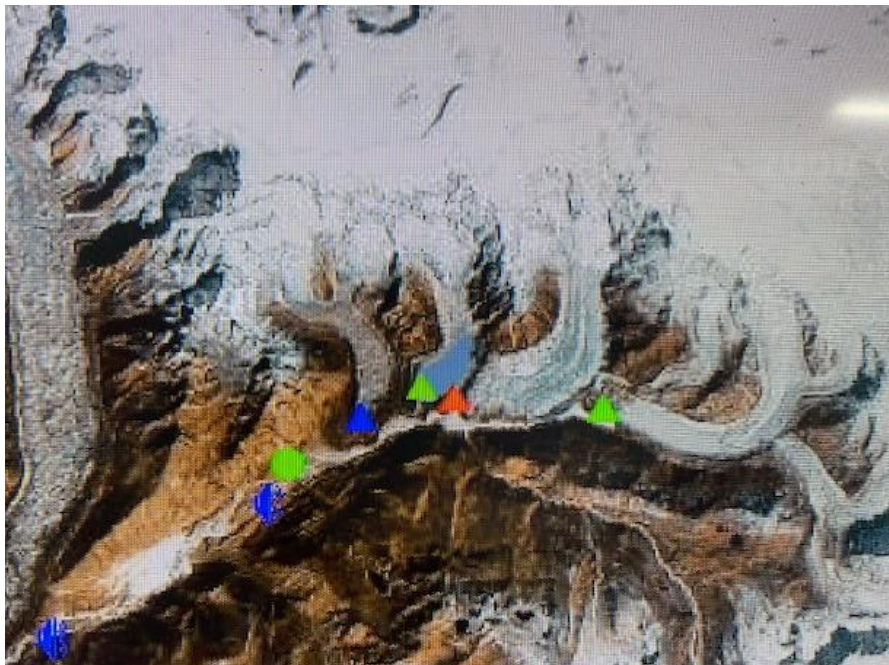
On the evening of 30 October 2023 at around 19:45 p.m, a potential flood was reported from Lunana. The Automatic Water level Station (AWLS) on Thorthormi Lake detected a sudden fall in water level from 5.51 m at 19:15 hrs to 4.72 m at 19:20 hrs indicating breach of lakes. Downstream AWLS at Thanza/Toenchoe village recorded 6.78 m at around 19:45 hrs and the highest level of 6.8 m recorded at 20:00 hrs which is an increase of 0.38 cm from normal water level (6.42 m)

*Figure 1: Detection of GOLF by Thorthormi AWLS Station (Red Triangle)*

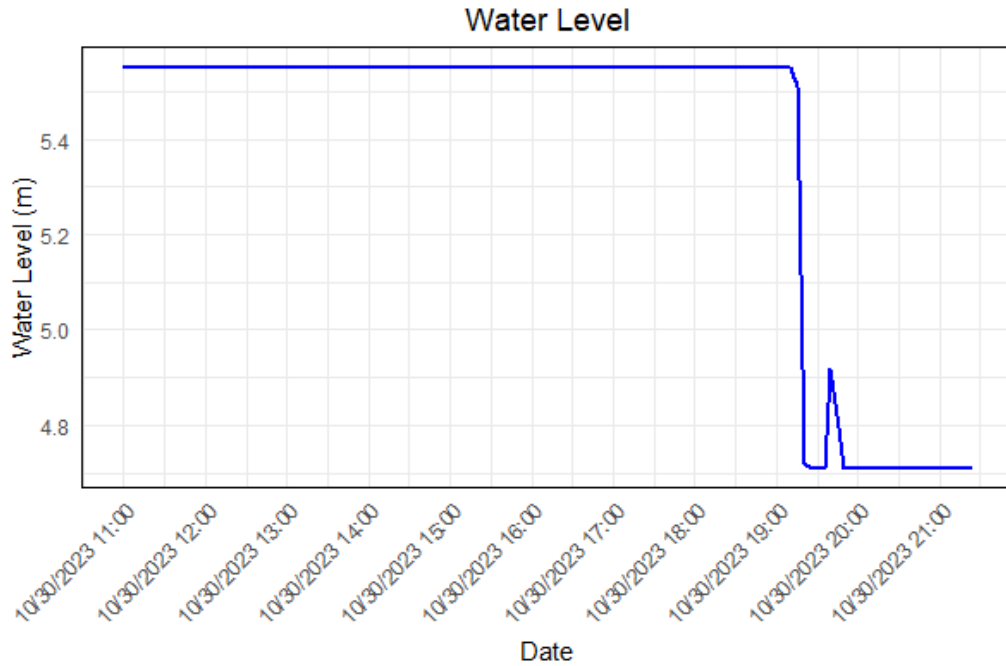
*Figure 2: Detection of fall of water level at Thorthomi AWLS Station*

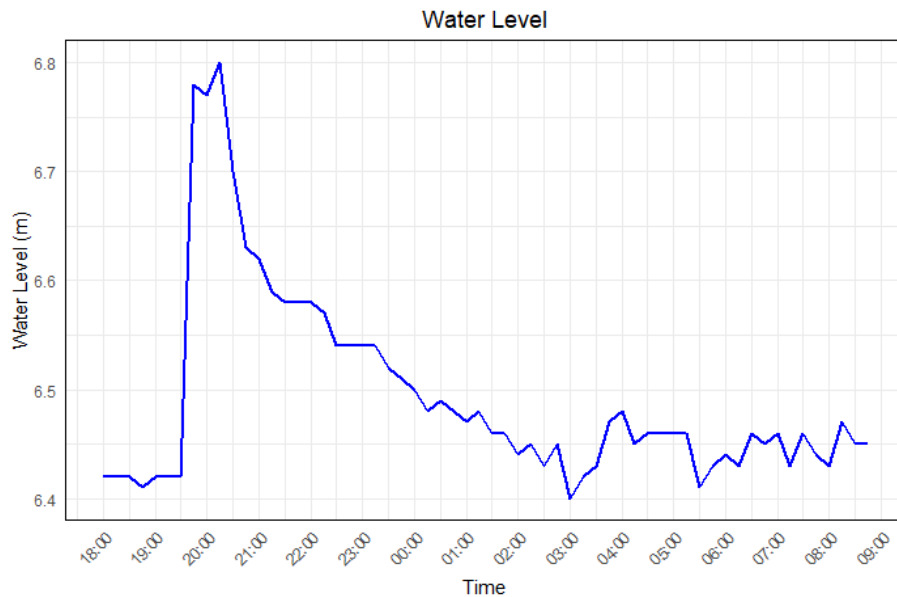
The rise of water level was also detected by GLOF EWS monitoring station at Thanza, which is located approximately 4.60 km along the river channel downstream of Thorthomi lake. An increase in the water level of 6.78m from 6.42m was detected at Thanza station 15 minutes after the incident was reported at Thorthormi Lake outlet.

*Figure 3: Detection of the rise and fall of water level at Thanza Station*

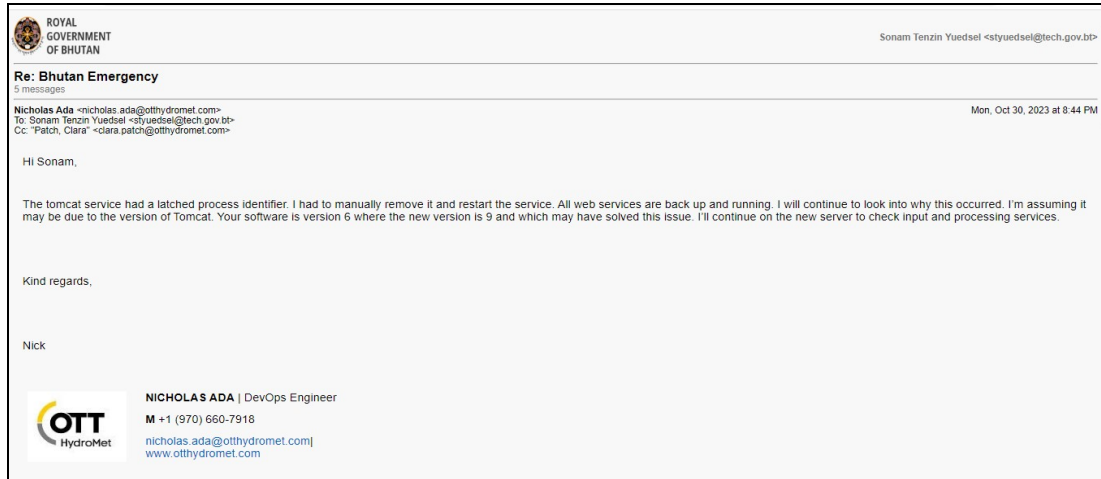
Figure 5: Diagnosis & resolution report

The web services were back online once Mr. Nickolas was able to resolve the issue on the new server. His speculations suggest that the new system with its software versions might have caused a few bugs and compatibility issues which had potentially caused the web based issue. This is to be taken into consideration especially during the migration phase so as to avoid such downtime in the future.

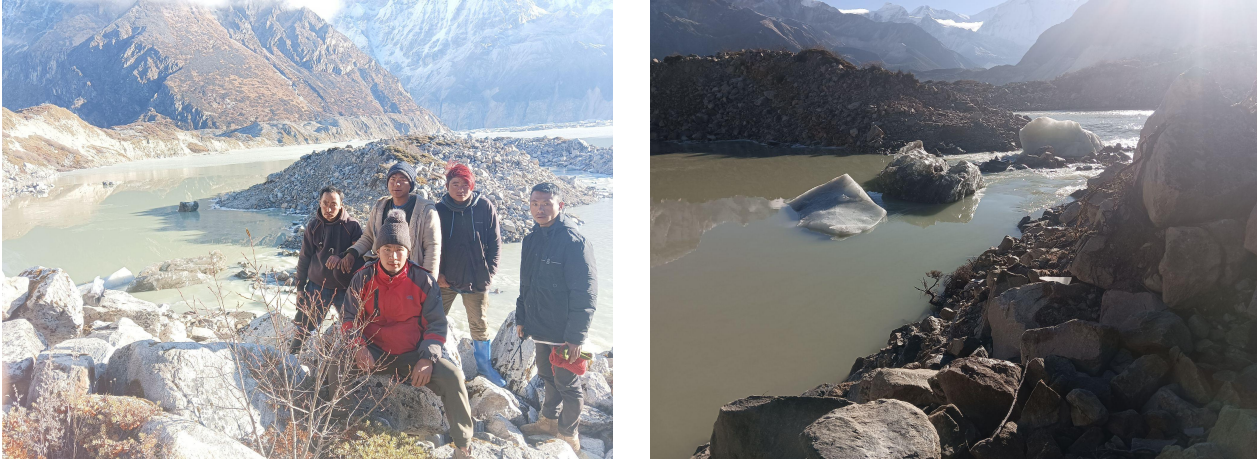
The field staff stationed at Thanza were deputed for field verification soon after detection. Despite harsh weather conditions, the two site staff immediately initiated the action. One stayed at Thanza AWLS reporting the situation while the other continued to monitor the Thorthormi Lake. At 22:17 PM, the field staff after doing the field verification informed FMCR that there are very abrupt changes of the Thorthormi lake. From the visual observation, it was reported that there is a huge displacement of icebergs and new erosion on the Morian walls of subsidiary lakes I and II.

*Figure 10: Site staff at the lake site showing the situation at the site*

Since then, they manually monitored the site at Thorthormi and regularly updated the control room about the situation out there. It was reported by the field staff that the automatic water level sensors were damaged and are not functioning currently so the station was monitored manually. The team from the HQ will assess the AWLS damages and try to repair.

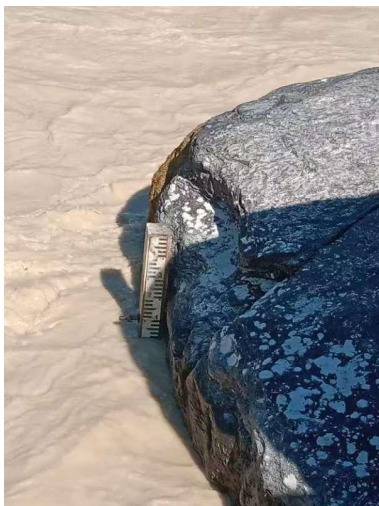
Samadingkha Hydrological Station, Phochhu

At around 8:00 hours, the site staff at Samdingkha started noticing a slight change in the water color and from 09:19 hrs, the water color completely changed its color but did not observe any change in the water level.

*Figure 12: Observation of flood at the downstream*

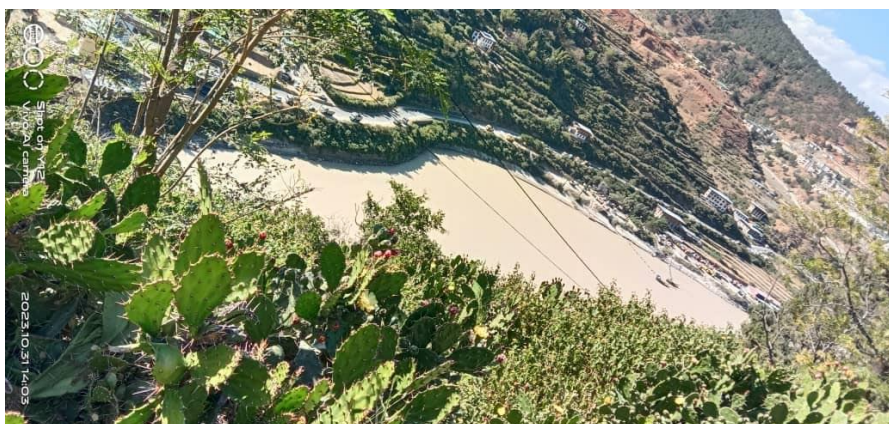
Above Wangdiphodrang Bridge

Similarly, as per the site staff at Wangdue, they noticed the change of water color at 0920 hrs on 31 October 2023 but no apparent increase in water level was recorded. A drastic change in the water color was observed from 14:10 hrs.

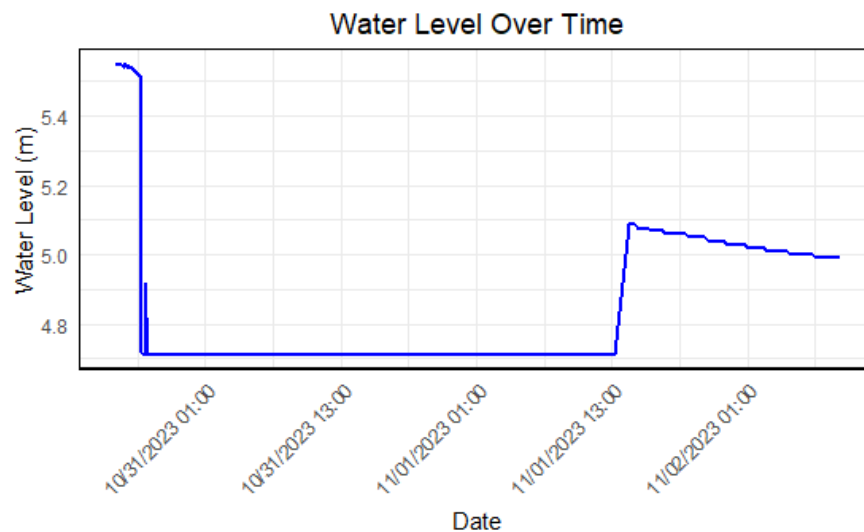
During the incident, the sensor was displaced, causing it to record a constant water level of 4.71m starting from 19:20 on October 30, 2023. However, at 14:30 on November 1, 2023, a sudden rise in the water level was reported. Upon communicating with the field staff, we learned that the sensor had been repositioned, but they indicated the need for maintenance and calibration in the upcoming days.

Figure 13: Thanza water level status

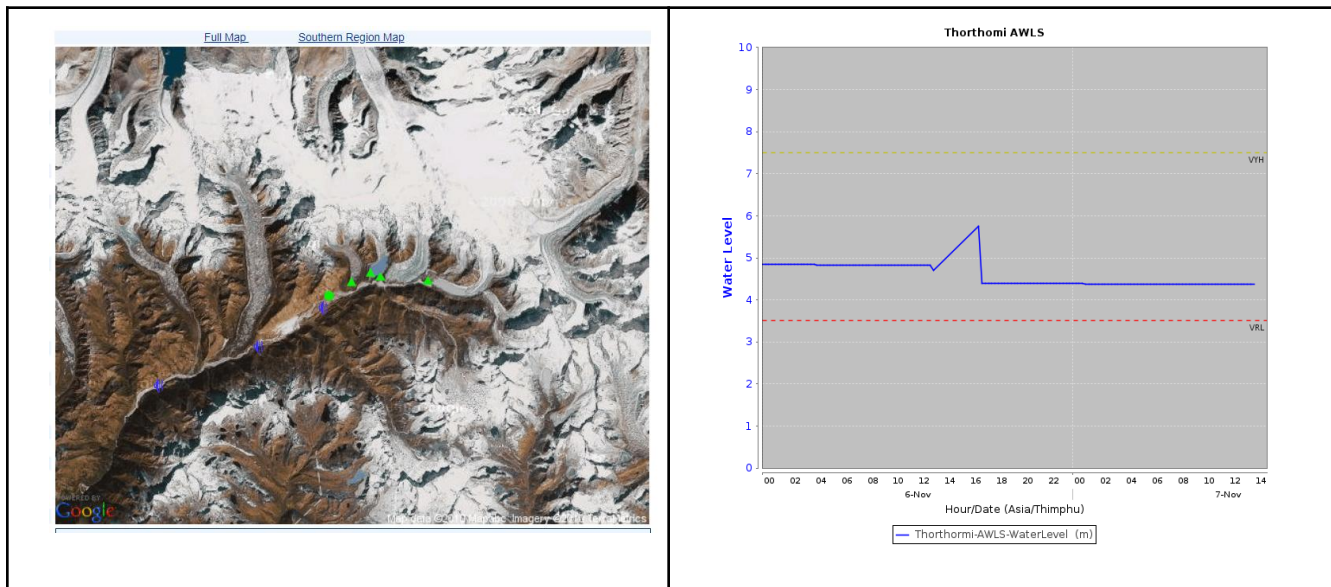
7. The Automated Real Time water level monitoring station on Thorthomi has been damaged by the 29th Oct 2023 event. The bubbler pipe and termination blocks were damaged.

Figure 14: Thorthomi station after restoration

Mr. Sangay Tenzin and Team carried out the emergency maintenance of Thorthomi AWLS station damaged by GLOF. The team temporarily restored the terminal block, changed the bubbler pipe, and refixed the conduit pipe. Besides, the team also conducted basic maintenance on the station. AWLS was made functional after maintenance started transmitting data around 16:50 PM on 6 November 2023. The GLOF EWS Control Room Wangdue was also instructed to change the Alarm Level to 3.5 m.

As a consequence of the recent incident there is a drastic change in the morphological condition of Thorthormi lake and surrounding areas of AWLS, it is recommended to shift the AWLS from subsidiary lake I to the main lake.
