**Site Assessment Report of Dechencholing Flash Flood Incident
10 August 2024, Thimphu**

**Submitted by Technical Team
National Centre for Hydrology and Meteorology (NCHM),
Department of Geology and Mines (DGM),
Ministry of Energy and Natural Resources (MoENR)
14 August 2024**

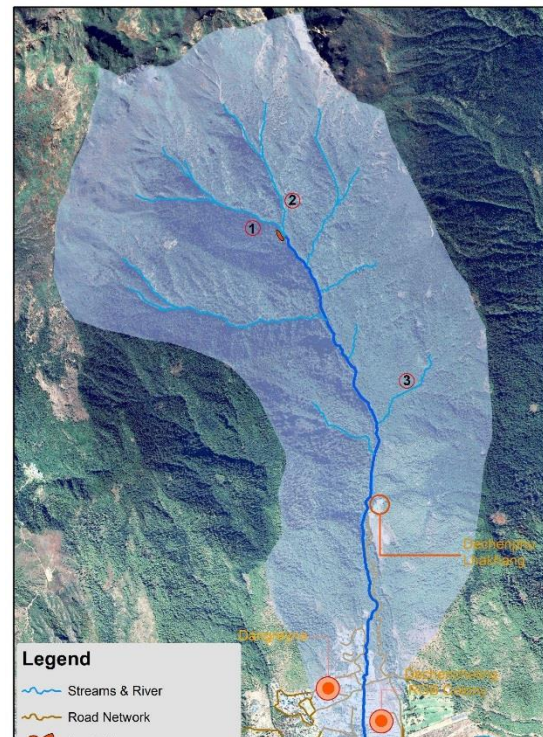
The Dechencholing settlement lies in the north Thimphu region with a catchment area of Dechencholing chhu is approximately 17 sq. km. There are numerous tributaries from both the sides contributing to the flow of mainstream. Two major streams (marked 1 & 2) in the map (Figure 1) are the main source and forms Dechencholing Chhu.

Figure 1: The catchment area of the Dechenphu Chhu, showing major tributaries and streams.

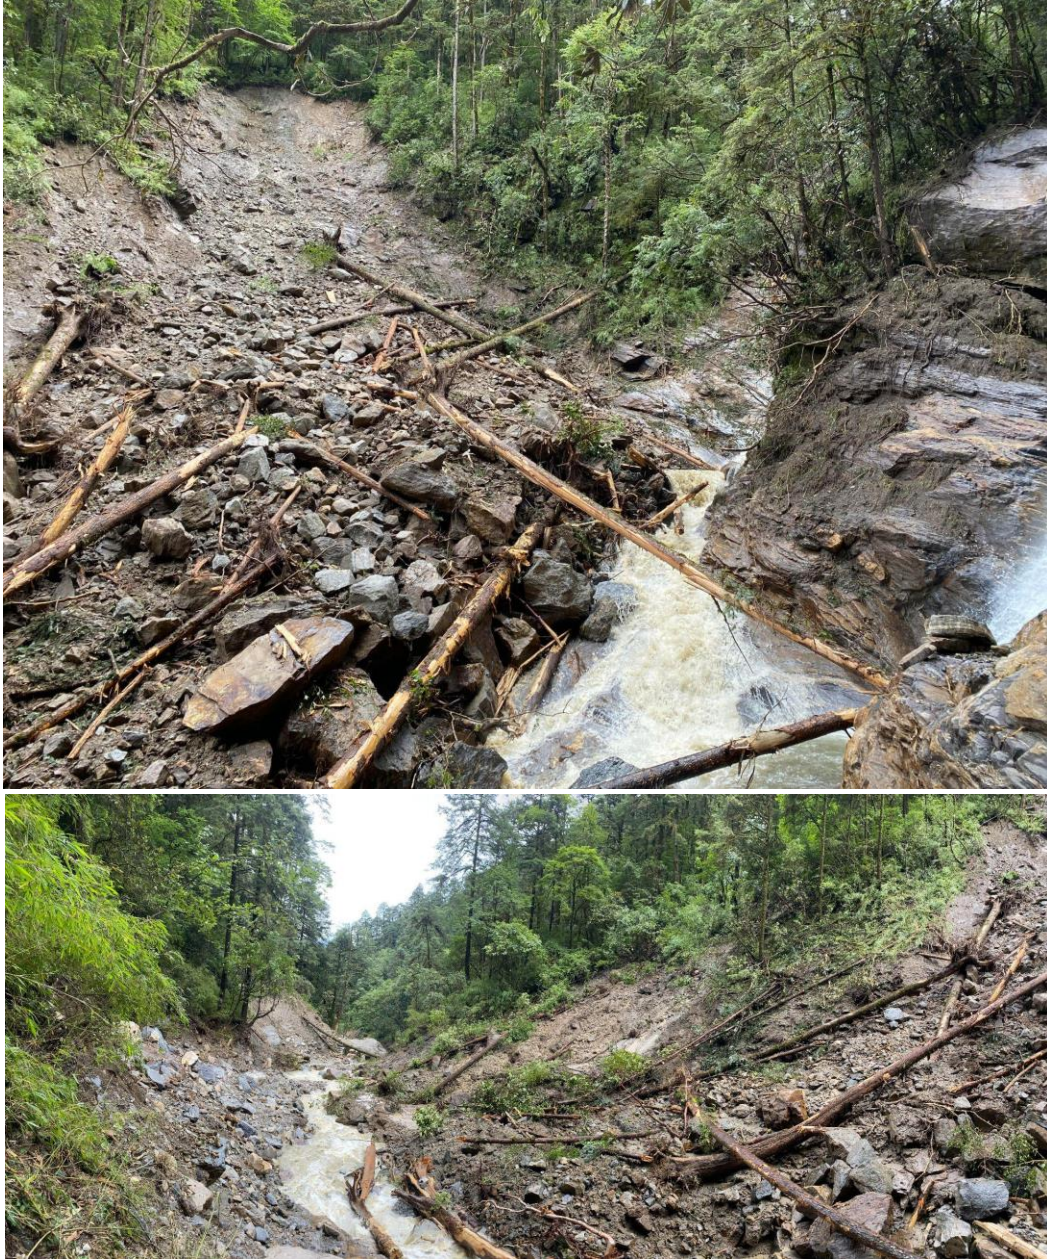
The flash flood triggered several landslides along the stream. These landslides are approximately 5 to 6 meters high, consisting mainly of light brown, sandy soil with a gritty texture and small mica flakes. The soil's sandy nature might have made it highly susceptible to erosion, leading to landslides. Along the river channel, several incidences of slope instabilities due to erosion of slope base were observed leading to increased turbidity and sediment load in the river. A landslide was observed on the right side of the confluence of the two streams (Figure 2) which likely resulted in formation of temporary blockage. However, the formation must have been for a short period given the steep river gradient and high velocity of the river. It should be emphasized, however, that the landslide is still active and in event of heavy precipitation there is likelihood of these loose materials coming down from the slope and creating temporary blockage.

Figure 2: Picture showing confluence point of the two streams (marked 1 & 2 in Figure 1). The crown of the landslide is also visible. The second picture is immediately below the confluence showing high flood mark and constriction of the outlet indicating temporary blockage and formation of landslide dam lake at this point.

1. The loose debris which consists of huge boulders from the active landslide on the right side of the confluence may have created a temporary blockage, resulting in formation of an artificial dam at the stream confluence. Major flooding from tributaries (marked 3, Figure 1) with dislodging of huge debris materials into the mainstream must have created temporary blockage of the river path.

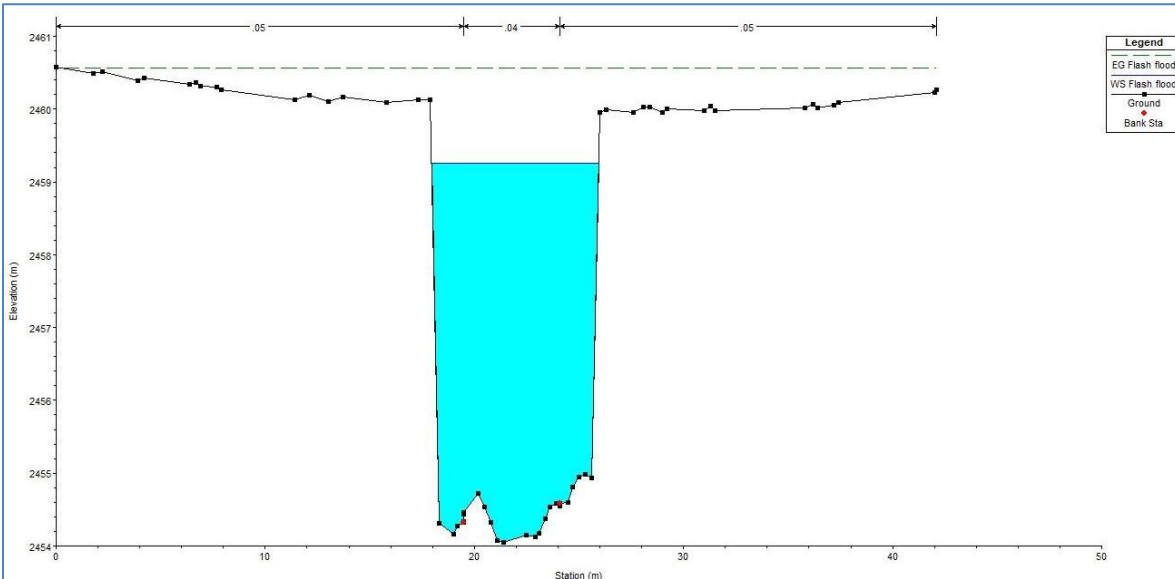
event, including debris, is estimated to be approximately 120 cubic meters per second, a channel cross sectional at Dangrina bridge from the simulated results is shown in Figure 3. The discharge at the upstream is estimated to be higher based on the flood mark and the cross-sectional area. The channel overflow and diversion which occurred below the Dechenphu parking and along the road has substantially reduced the flood volume that reached the Dechencholing area.

Figure 3: A cross-sectional plot of simulated flood at Dangrina bridge. It was observed during the site visit on 11th August that the flood did not reach the bridge deck and the overflow was from the right side of the bridge.

6. Any structures along the stream should have conveyance capacity of the worst flood event, design discharge needs to be incorporated in bridge constructions and Hume pipe installation to accommodate floodwaters.

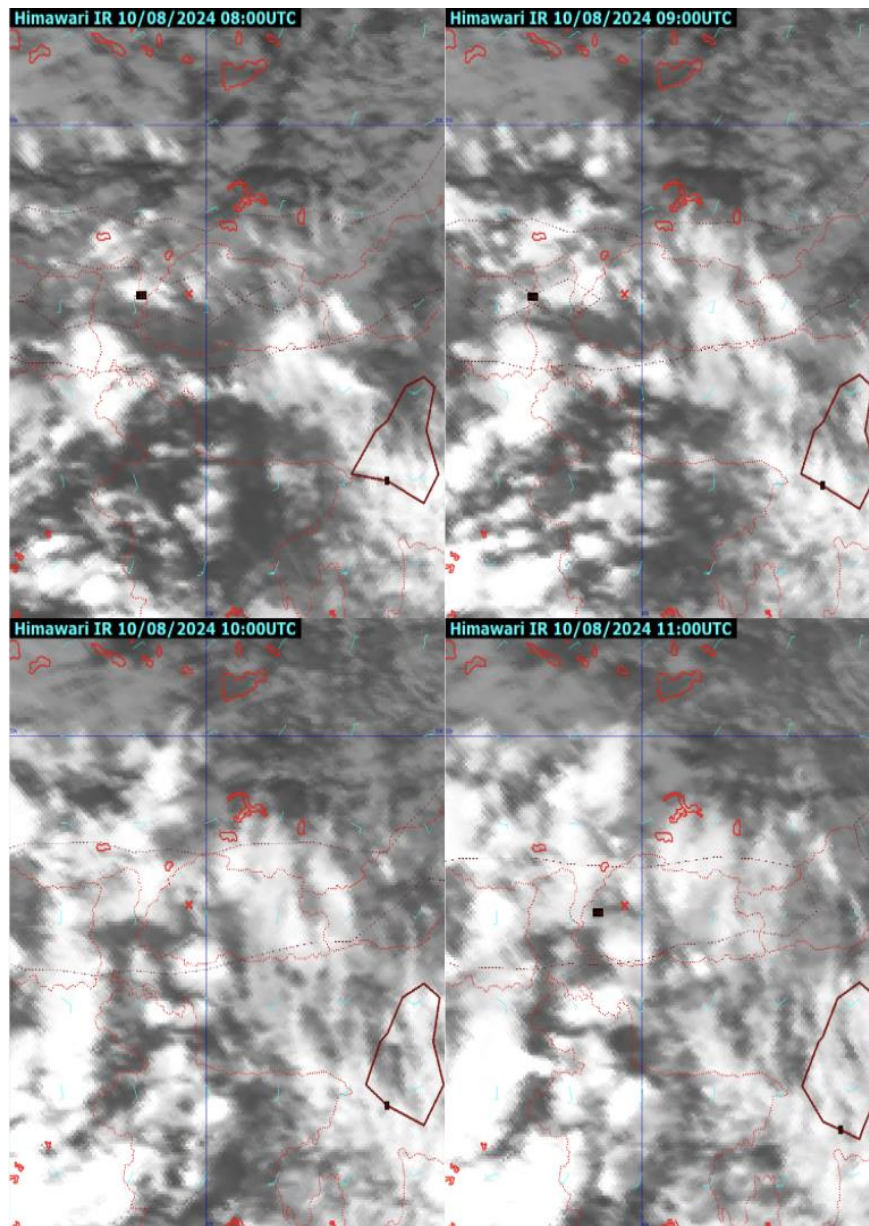
Based on the analysis of weather phenomena and satellite images on 10 August 2024, a sudden heavy rainfall with thunder was caused by the Convective Thunderstorm, which usually occurs during this time of the year (summer and spring). From the high-level water marks observed on all the tributaries, antecedent monsoon rainfall and high intensity heavy rainfall on 10 August 2024 has saturated soils and triggered landslides causing the flash flood. As the flash flood moved downstream, the flood further triggered several landslides, notably at the confluence of the two main streams, forming multiple temporary artificial dams along the stream. Based on the turbidity of the water coming from stream marked 1 (Figure 1), it appears flood originated from this stream; the water from stream 2 is clear without any turbidity. It is evident from the field assessment that the flood initially started from stream 1 and the magnitude of the event was exacerbated

Figure 4: Satellite image analysis (From the Himawari satellite image, a small-scale convective system formed over Thimphu (marked as red cross) can be spotted starting 8 UTC (14:00 BST))

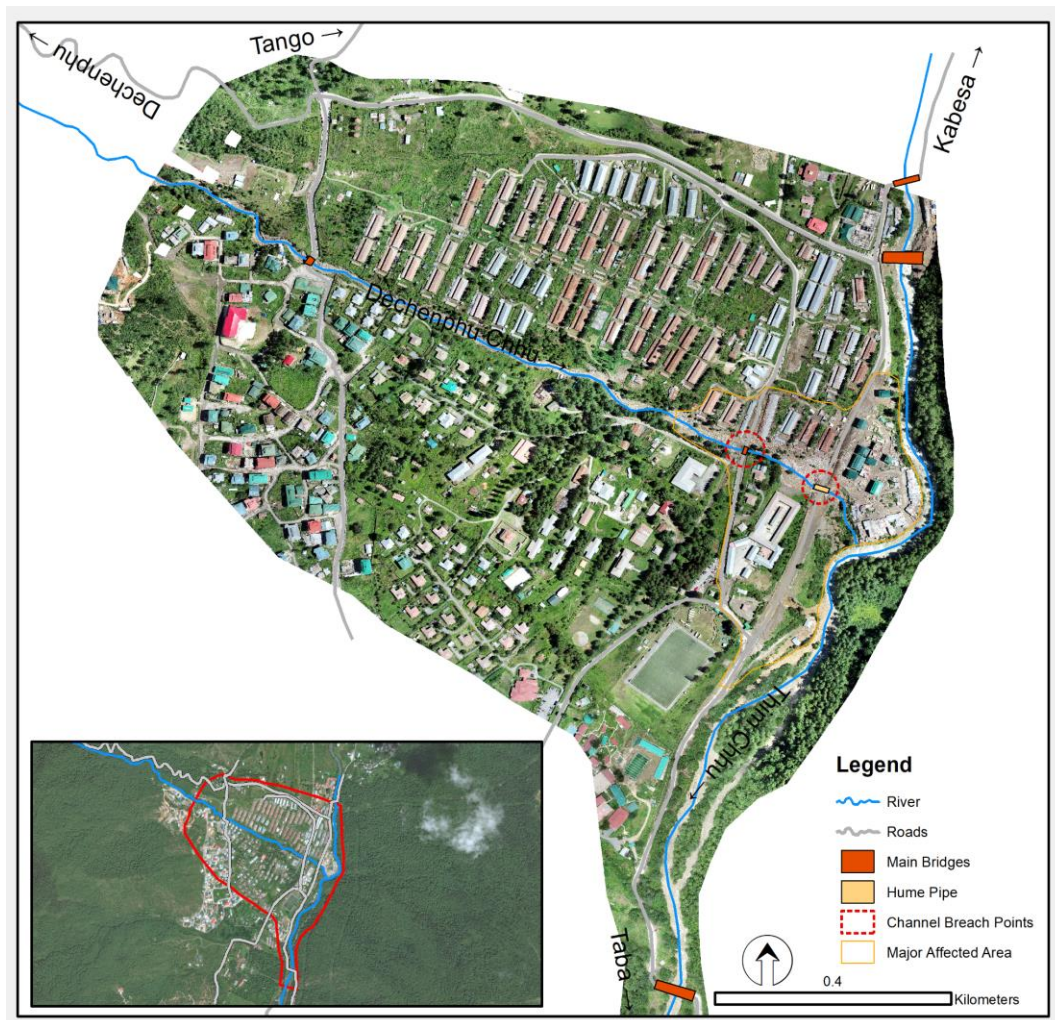
An aerial survey was carried out on 11 August 2024 in the area affected by the flood (Dechencholing area). The aerial image provides bird eye view of the flood affected area which is essential for the post flood damage assessment and to ascertain probable cause of the flood through image analysis especially in settlement areas. The river channel has adequate conveyance capacity for natural flow but during the flash flood, the debris in the flood water caused overflowing resulting in the widespread debris deposits and damages along and near the river channel. The event was exacerbated at the constricted channel locations such as bridges and underground drainage which clogged the channel and drastically reduced channel flow capacity as shown in Figure. 5.

Figure 5: An aerial drone image showing the affected area

5. Stream channel restoration to pre-flood waterways to minimize the flood water overflow and widespread damage in an event of another flood of similar magnitude or higher.
