**Post-Flash Flood Assessment Report:  
Tsaticihu Flash Flood Incident of 19 July 2026 at Lhadrong,  
Lhuntse Dzongkhag**

**Submitted by  
National Centre for Hydrology and Meteorology  
Dorjilung Hydropower Project Authority  
24 July 2026**

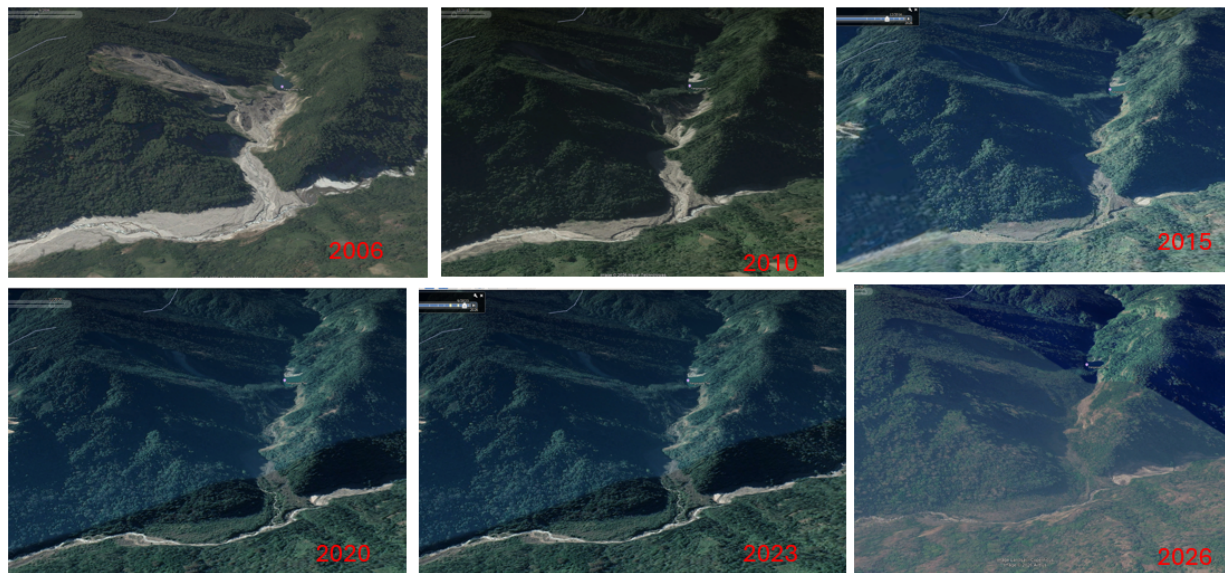
*Figure 1: Time series google map of watershed area*

Multi-temporal Google Earth imagery (2006–2026) of the Tsatichhu site highlights recurring geomorphic instability. A major landslide dam outburst was evident in 2006, followed by a relatively stable phase with vegetation recovery and confined channel conditions up to 2020. However, gradual slope weakening and channel constriction observed over time culminated in the temporary lake breach on 19 July 2026 at approximately 05:45 PM. This recurrence underscores the catchment as a critical landslide dam hotspot.

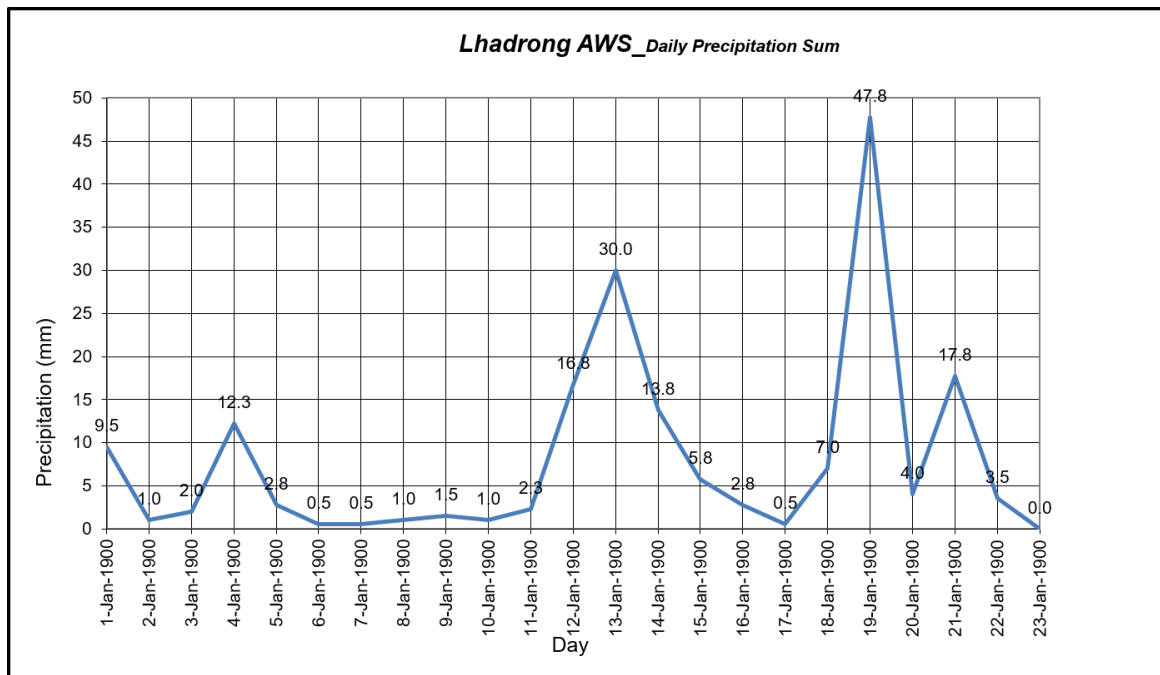
Figure 3. Daily precipitation sum plot for Lhadrong AWS for the month of July 2026

The cumulative antecedent rainfall over the preceding week saturated the steep slope mantles, reducing their shear strength and likely triggering slope failures.

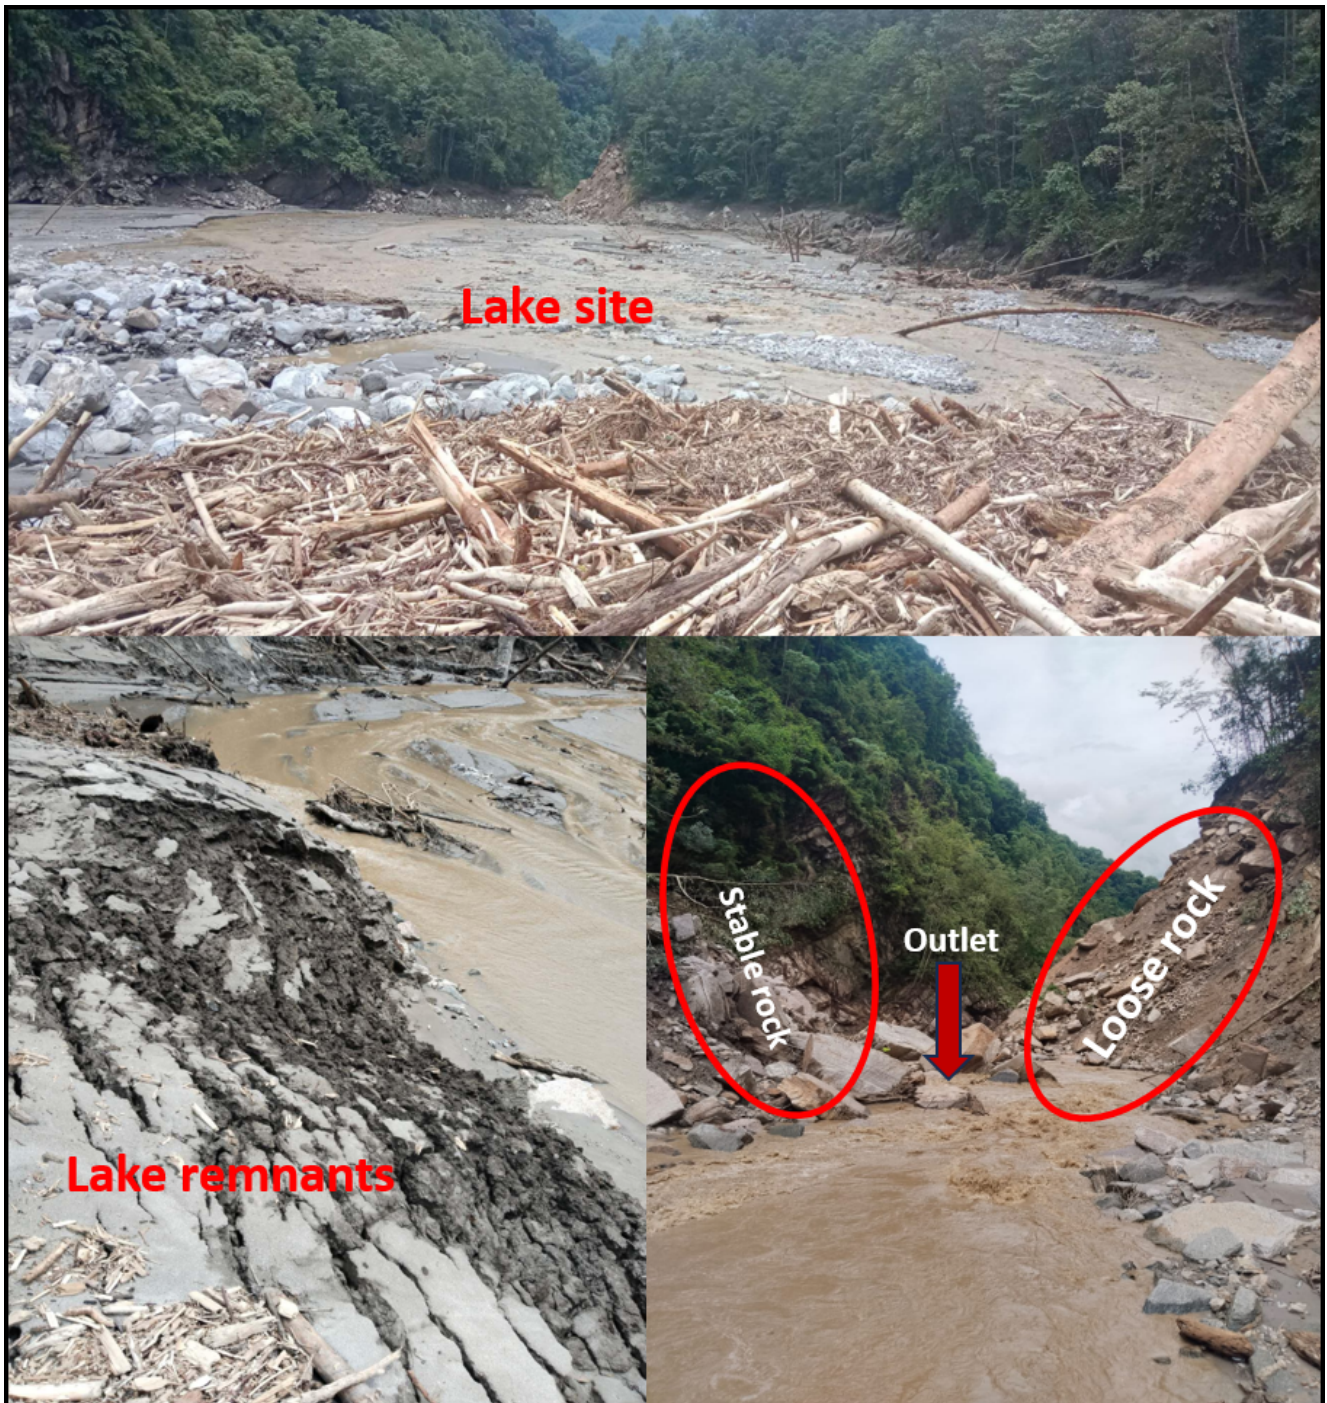
- a. The joint team confirmed that Tsatichhu landslide dam lake had completely breached. No impounded standing water body remains at the original site, except for minor, isolated pools in local depressions.

- b. The outlet section showed extensive physical evidence of severe erosion and scour. Freshly exposed soil, loose rock debris, and uprooted trees were observed along the right bank of the outlet.

- c. The natural embankment collapsed rapidly during the failure event. The breach widened the primary discharge channel substantially, allowing rapid drainage.

- d. Multiple fresh landslide scars were documented immediately upstream of the former lake basin, confirming recent mass movement during the rainfall event.

- e. No structural obstruction currently holds back water, ruling out an immediate risk of a secondary outburst flood. However, unstable debris on the right flank remains susceptible to secondary sliding.

Field evidence indicates that the outburst was not caused by static, gradual overtopping. Rather, it was initiated by a flash flood wave originating upstream, loaded with heavy sediment and woody debris. This debris flow impelled significant shear stress at the toe of the natural landslide barrier, causing toe undermining and rapid structural collapse.

*Figure 5. The lake remnants and outlet after the breached*

- Considering the flashy nature of the catchment and its history of frequent flash flood incidents, it is recommended to maintain continuous monitoring of the Tsatichhu catchment during the monsoon season to detect any renewed slope instability or the formation of temporary landslide dams.
- Conduct a high-resolution UAV (drone) aerial survey and topographic mapping to analyze post-event channel morphology and perform volume calculations of unstable slope debris.
- Sustain close operational coordination between the NCHM Hydrological Site Office, Dorjilung Hydropower Project Authority, the local community, and the Dzongkhag disaster management authorities for early warning dissemination.
- For long-term understanding, conduct in-depth analysis correlating rainfall threshold limits with landslide initiation to establish reliable trigger thresholds for early warnings.

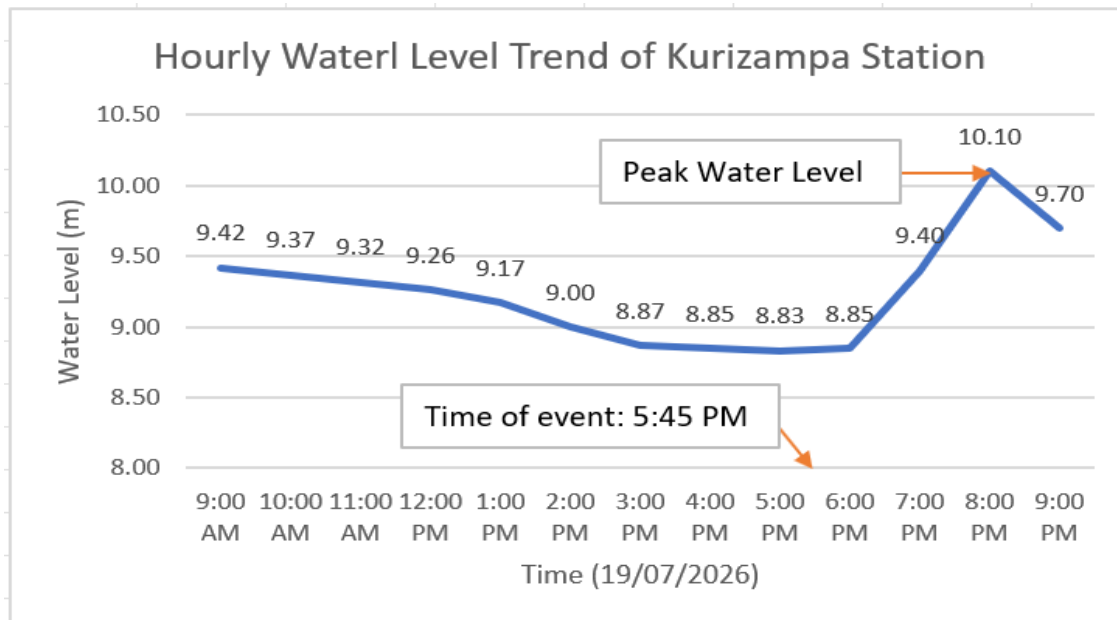
- The flood wave traveled from Tsatichhu to Autsho in approximately 45 minutes, reflecting a steep gradient and high flow velocity. Water levels at Kurizampa peaked at 10.10 m (0.70 m surge).
- The surge receded back to 9.70 m within one hour, confirming a short-duration, high- intensity flood hydrograph typical of lake breaches.
- The lake outlet remains flanked by solid rock on one side and highly unstable loose rock/debris on the other, creating a potential choke point for future damming if new slides occur.

Figure 6. Hourly water level trend observed at Kurizampa
