Report on the Rapid Assessment of Thorthormi Lake and the Restoration of Automatic Water Level Sensors for the GLOF Early Warning System

NATIONAL CENTER FOR HYDROLOGY AND METEOROLOGY ROYAL GOVERNMENT OF BHUTAN

2019

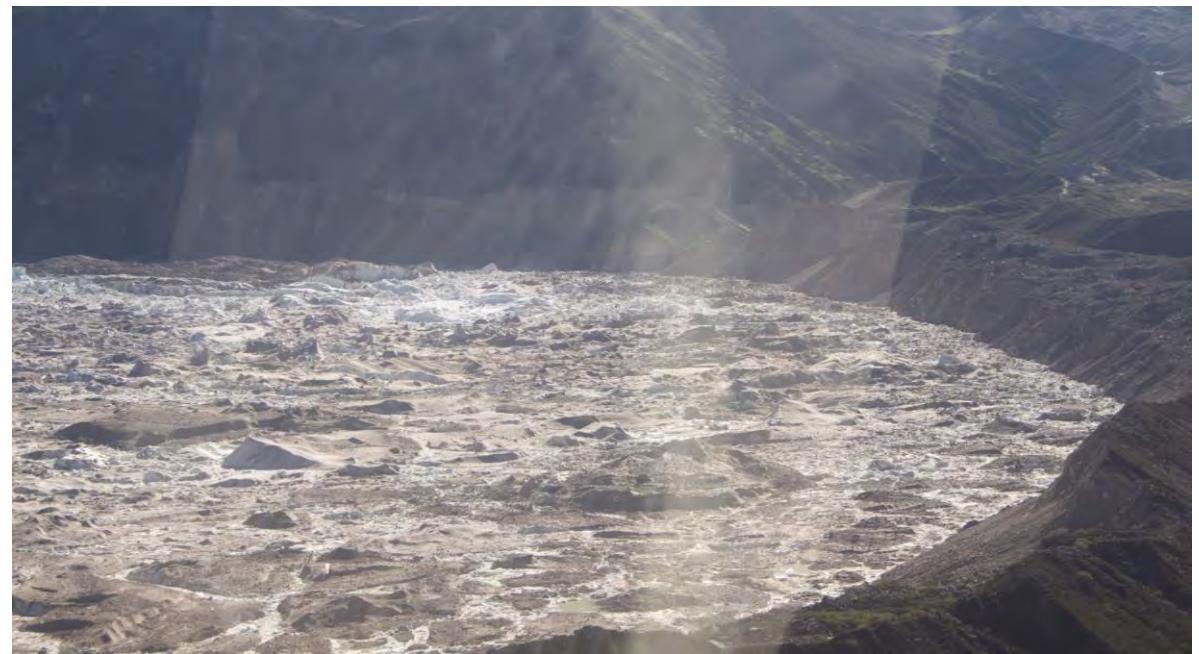
Photo 2: Surface of Thorthormi glacier as observed on 23rd June 2019

On the 23rd June 2019, the team carried out an aerial survey on the Thorthormi lake and the surrounding areas. The whole glacier was observed to have undergone drastic disturbances resulting in breaking down of the mother glacier into pieces which floated on the water bodies as ice bergs (Photo 2).

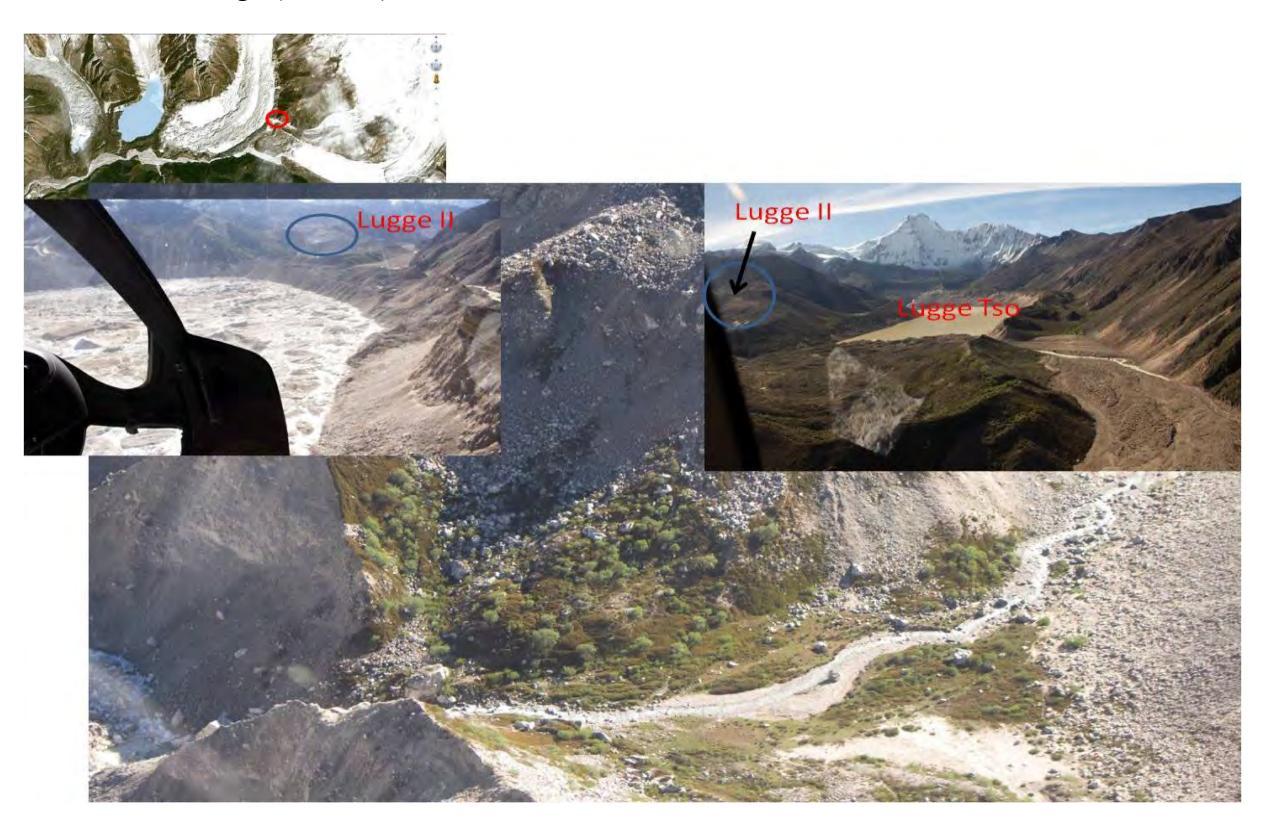
Photo 3: Lugge II glacier with Thorthormi and inlet area into Thorthormi tso

The melt water from Lugge II glacier (photo 3) drains into Thorthormi lake. Therefore, it was important to first check the status of the flow from Lugge II glacier into Thorthomi lake. During the aerial survey, based on the water marks at the inlet area it was found that no unusual flow originated from Lugge II glacier which drains into Thorthomi lake in the recent days (Photo 3).

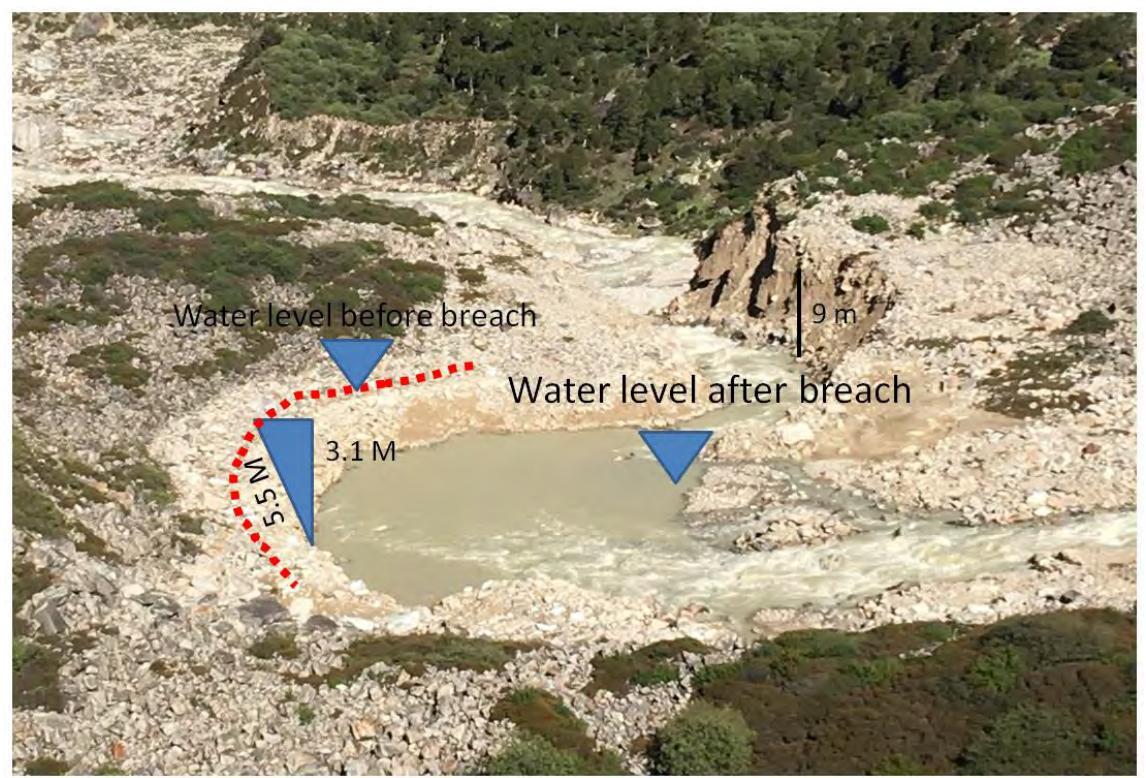
The natural channel at the outlet of subsidiary lake II was found to have undergone huge erosion both at the bed as well as on the side. As a result, the new channel bed lies at approximately 9 m lower than the original channel before the breach. (Photo 4). The vertical height of water level in subsidiary lake II got lowered by 3.1 m (photo 4) due to the breach on the 20th June 2019. The new channel width is about 10 to 12 meters and length more than 100 meters with an average gradient of 13 - 15 degrees. Due to the breach the subsidiary lake II appears to be almost empty now.

Photo 4: Subsidiary lake II after the breach

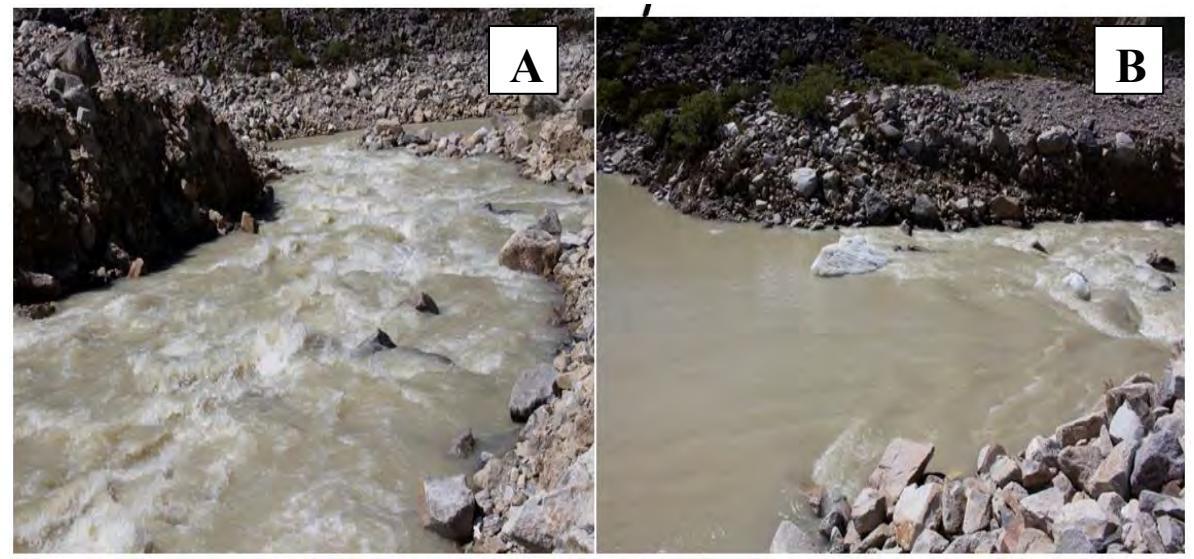
Photo 5 : (A) Lower part of channel between Subsidiary lake I (B) Subsidiary II along with the outlet of subsidiary lake I

The channel between subsidiary lake I and subsidiary lake II has undergone some degree of erosion due to the excess water spilling over from the main lake. However, except for some erosion in the downstream part of this channel the outlet area of subsidiary lake I appeared to be normal. Based on the erosional marks, the lower part of this channel (near subsidiary lake II, Photo 5 (A) was eroded and lowered by 1.2 m on average. The average gradient of this channel length between subsidiary lake I and subsidiary lake II was found to be 11 - 13 degrees.

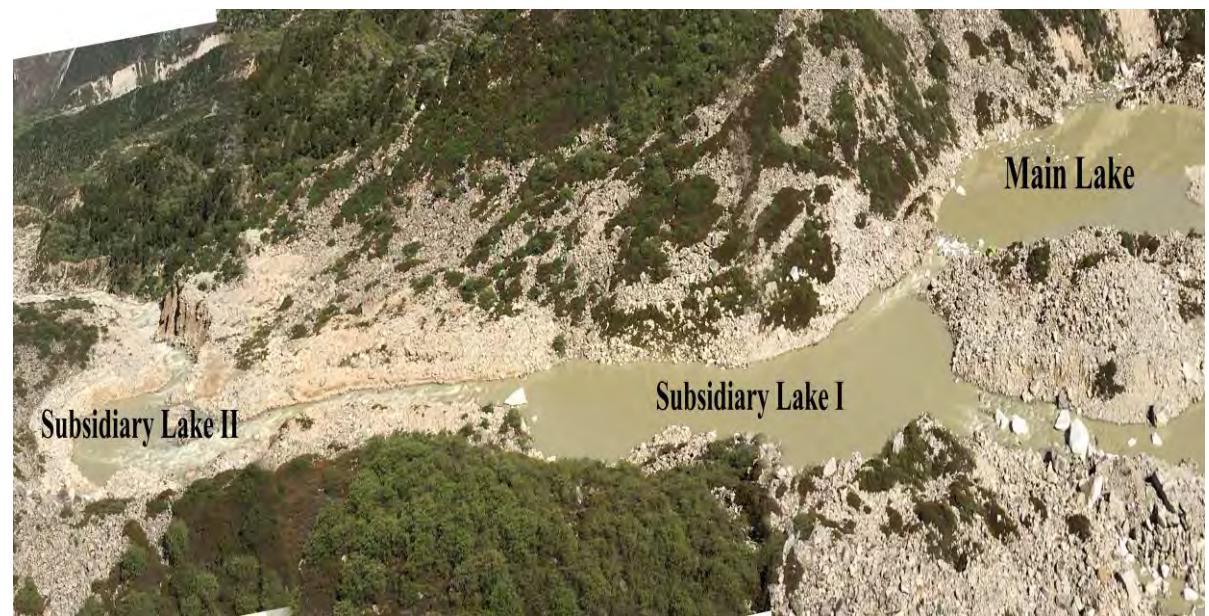
Photo 6 : Condition of subsidiary lake I

Subsidiary lake I on the whole appears to be undisturbed by the incident on 20th June 2019. However, due to large volume of water from the main lake there were remnants of minor mass movement taken place on the side. (Photo 6). There were ice berg displaced at a height of more than a meter was observed on the shoreline of subsidiary lake I (Photo 7).

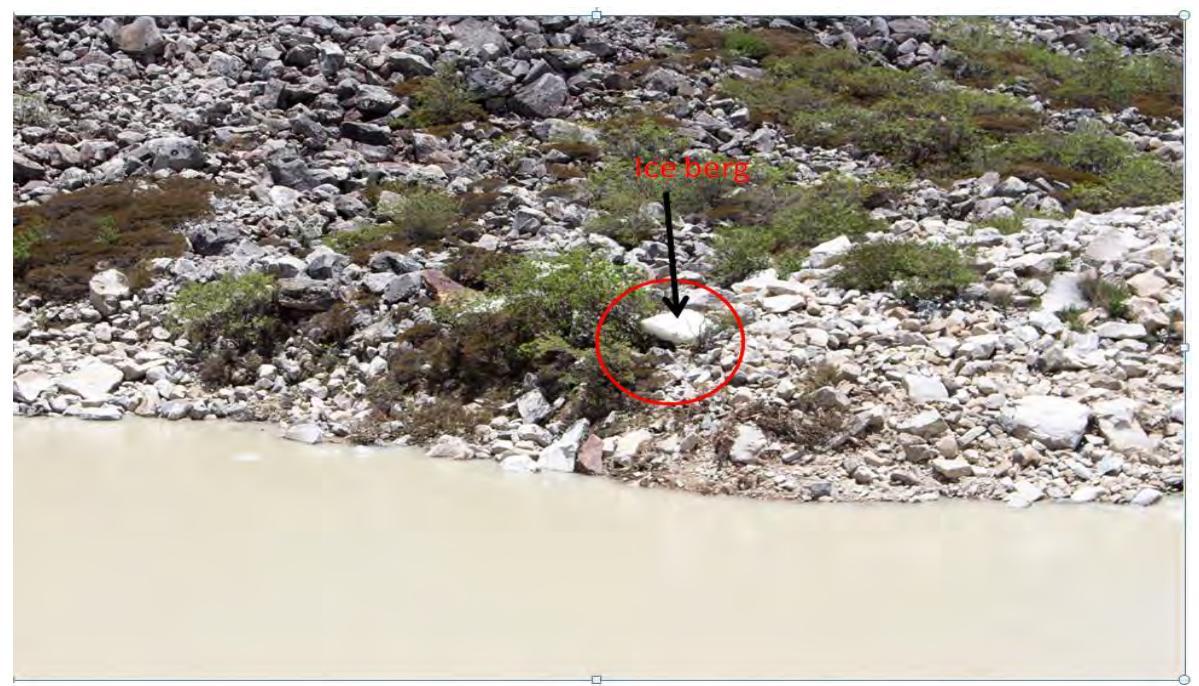
Photo 7 : Displaced ice berg on the shore of subsidiary lake I

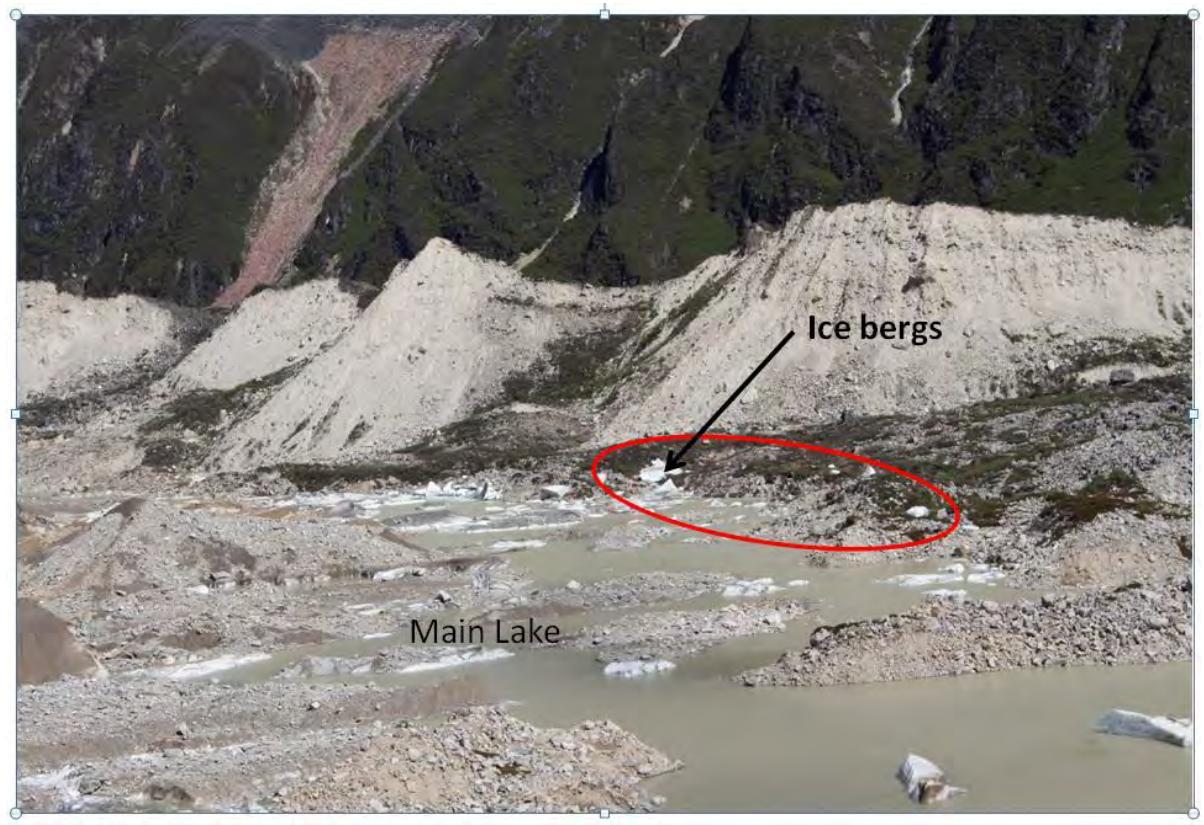
The main glacier (Thorthormi glacier) was observed to have undergone massive changes. The glacier was observed to have disintegrated and broken into smaller pieces of ice (ice berg) which were found to be floating around. Similar to subsidiary lake I, huge ice bergs were observed to have displaced on the shoreline about more than a meter's height from the present water level (Photo 8).

Photo 8 : Displaced ice bergs on the left shoreline of main lake Thorthormi

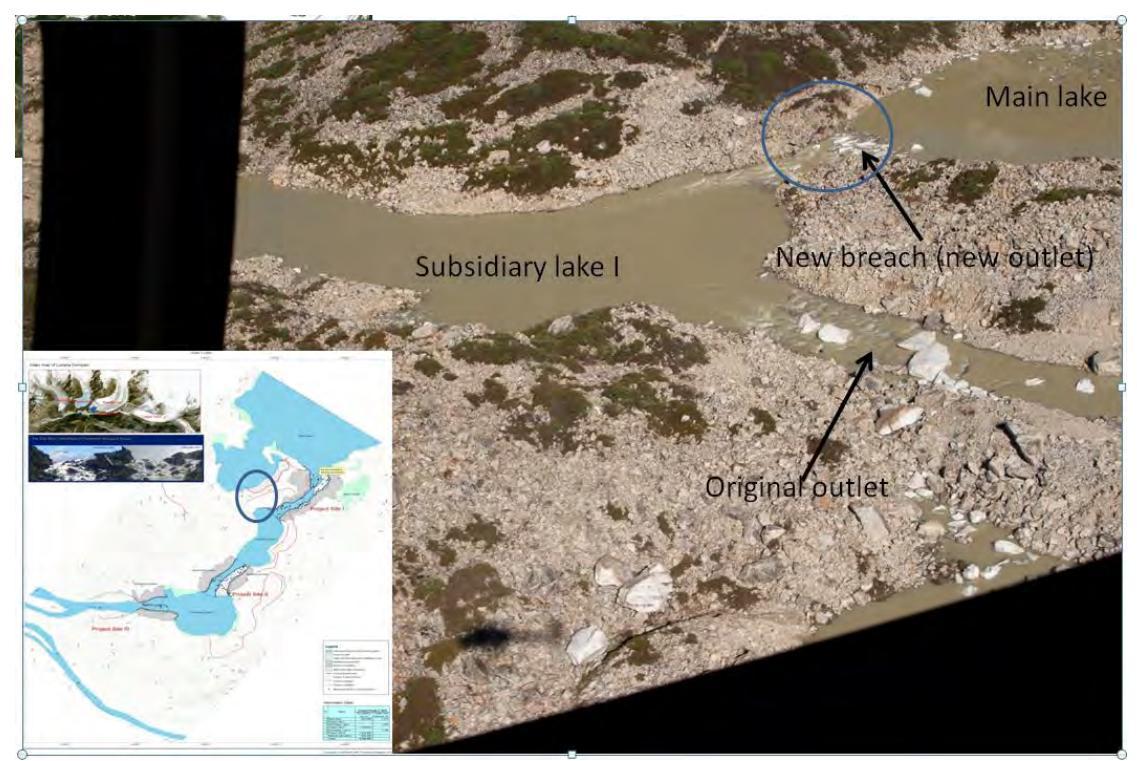
The team also found that a new outlet channel was created during the incident of 20th June 2019 which now lies at the right side of the original outlet channel (Photo 9). The formation of this new outlet channel indicates that a partial breach of the main lake had occurred. The point through which the main lake breached (new outlet channel) was a weaker zone with presence of seepage observed during the mitigation work on Thorthormi lake from 2008 to 2012. The length of the new channel is 25 m long and 12 m wide with an average gradient of 15 -17 degrees. (Photo 9).

Photo 9 : Outlet area of main lake Thorthormi glacier

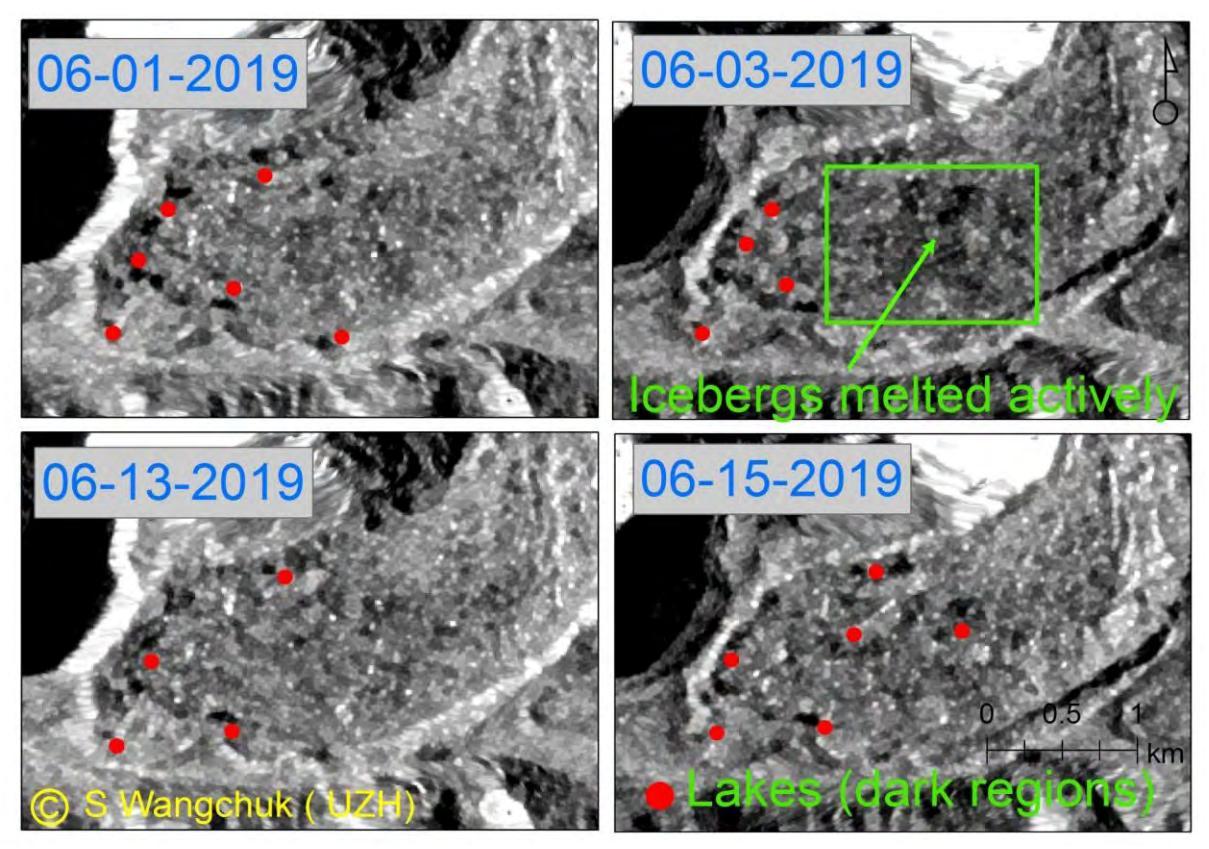
Figure 4 : Sentinial 1 image showing extensive melting taking place on Thorthormi glacier in the month of June 2019.

Figure 4 shows a RADAR image of Sentinel 1 where dark spots denotes water bodies. It is clear from the images that there was extensive melting taking place on Thorthormi glacier in the month of June 2019.

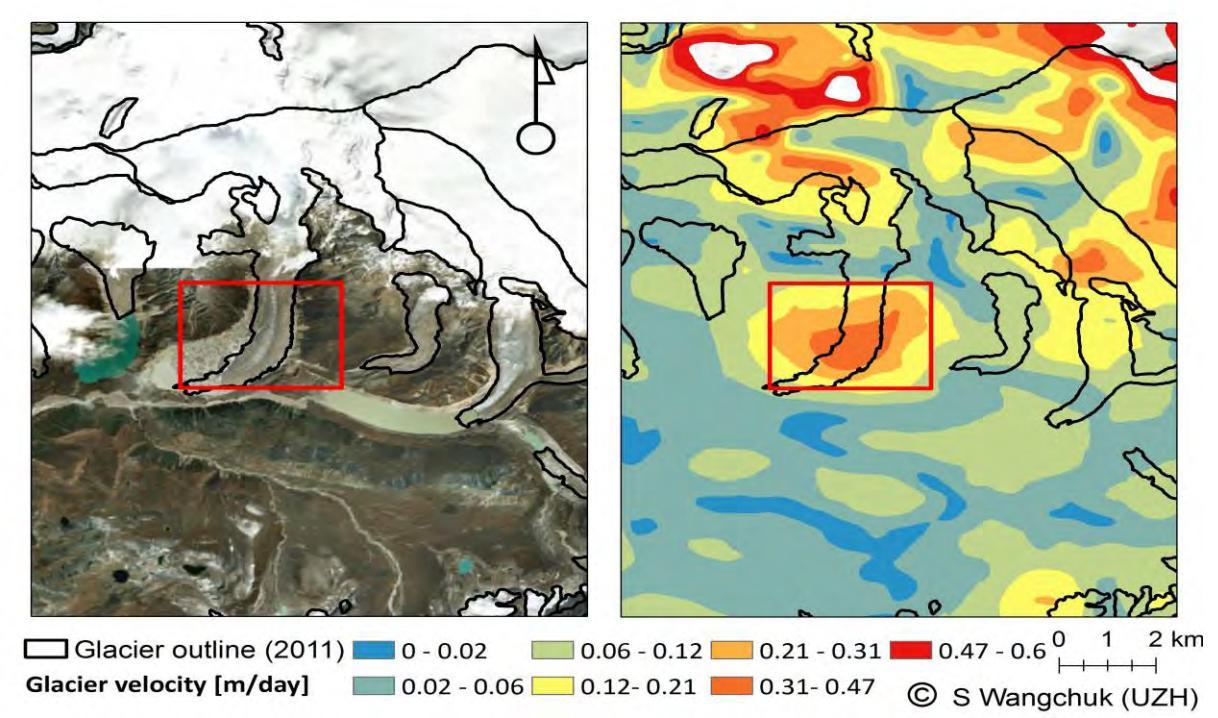
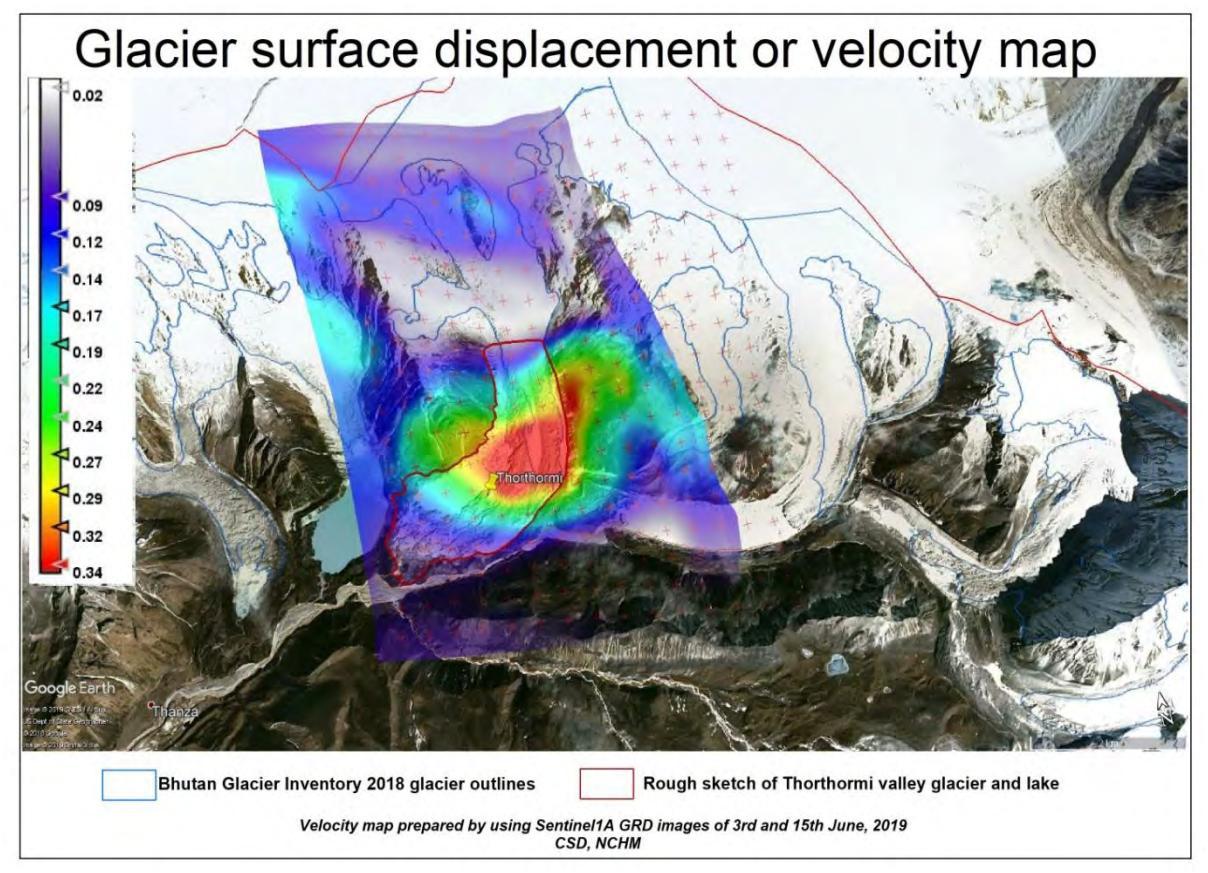
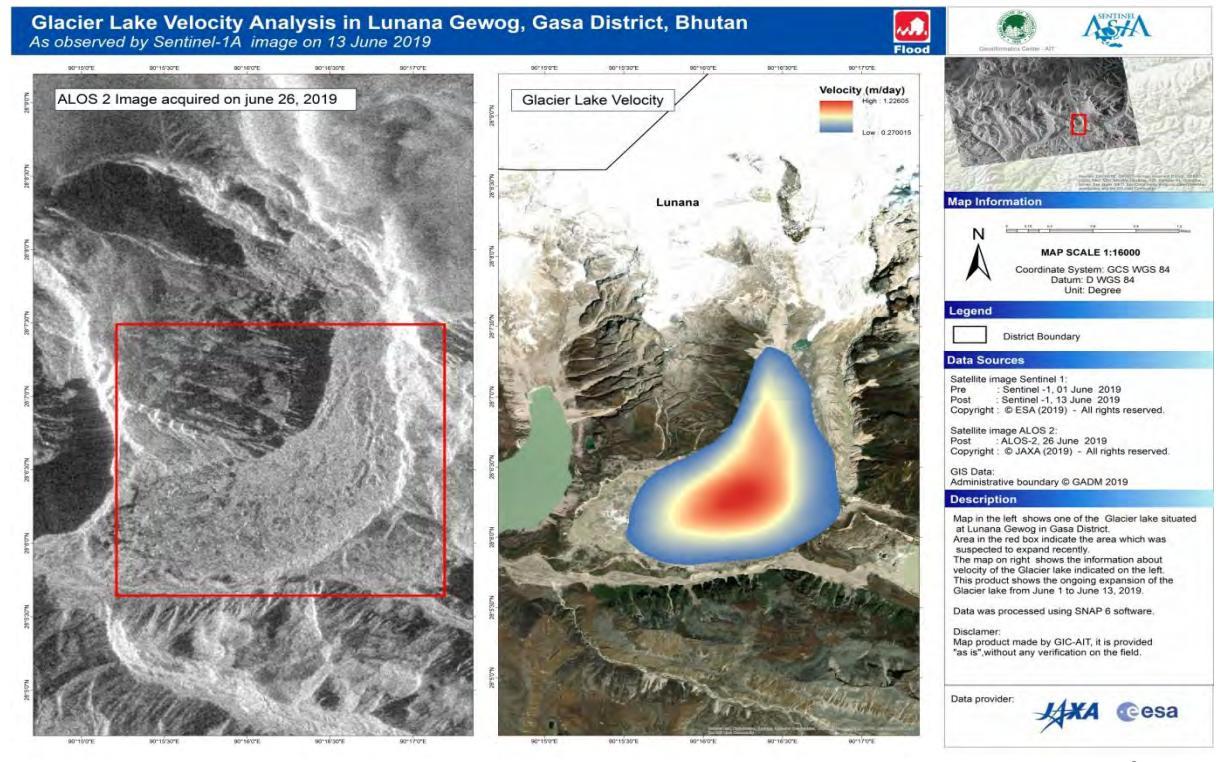
Figure 5, 6 and 7 shows movement on Thorthormi glacier before breaching occurred (before 20th June 2019). It is evident from these images that there was active displacement measuring between as low as 0.34 to as high as 1.2 meters per day on Thorthormi glacier in the early part of June 2019. However, after 20th June 2019, such displacement on Thorthormi glacier subsided (right image of figure 8). The velocity measurement in the late 1990s on Thorthormi glacier showed 90 m per year in the upper region and 40 m in the lower region (Joint Japan – Bhutan research report, 2003) which roughly translates into 0.25 m per day and 0.11 m per day which is lower than the movement observed in the month of June 2019.

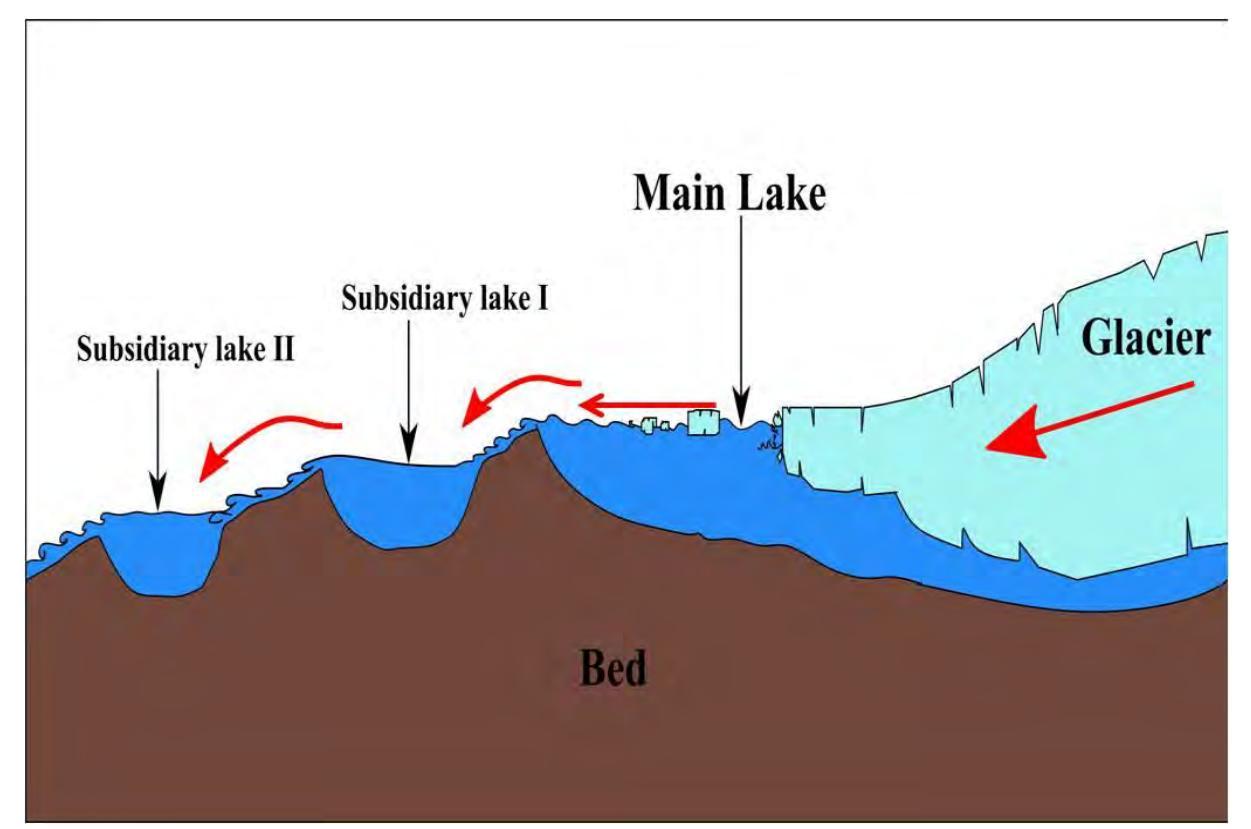
Such sudden forward movement of glacier (surging) might have resulted in the pushing of the water in the lake forward (figure 11) and raising the water level in the lake over 1 m. The displaced iceberg on the shore of Thorthormi lake clearly indicates the possibility of the occurrence of such a process. As the hydrostatic pressure increased in the main lake of Thorthomi, the weakest point on the moraine damming the main lake on Thorthormi glacier failed giving way to a new outlet resulting in a partial breach of the main lake. The excess water which got over spilled into subsidiary lake I further spilling into subsidiary lake II (figure 11). The thickness of moraine wall at the outlet of subsidiary lake II after the mitigation work in 2012 was measured only about 40 m thick at the crest. Therefore, due to increased water volume in subsidiary lake II, the moraine at the outlet fail and resulting in the complete draining of the subsidiary lake II (figure 11 & Photo 4).

Figure 11 : Schematic diagram showing the process of breaching at Thorthormi lake

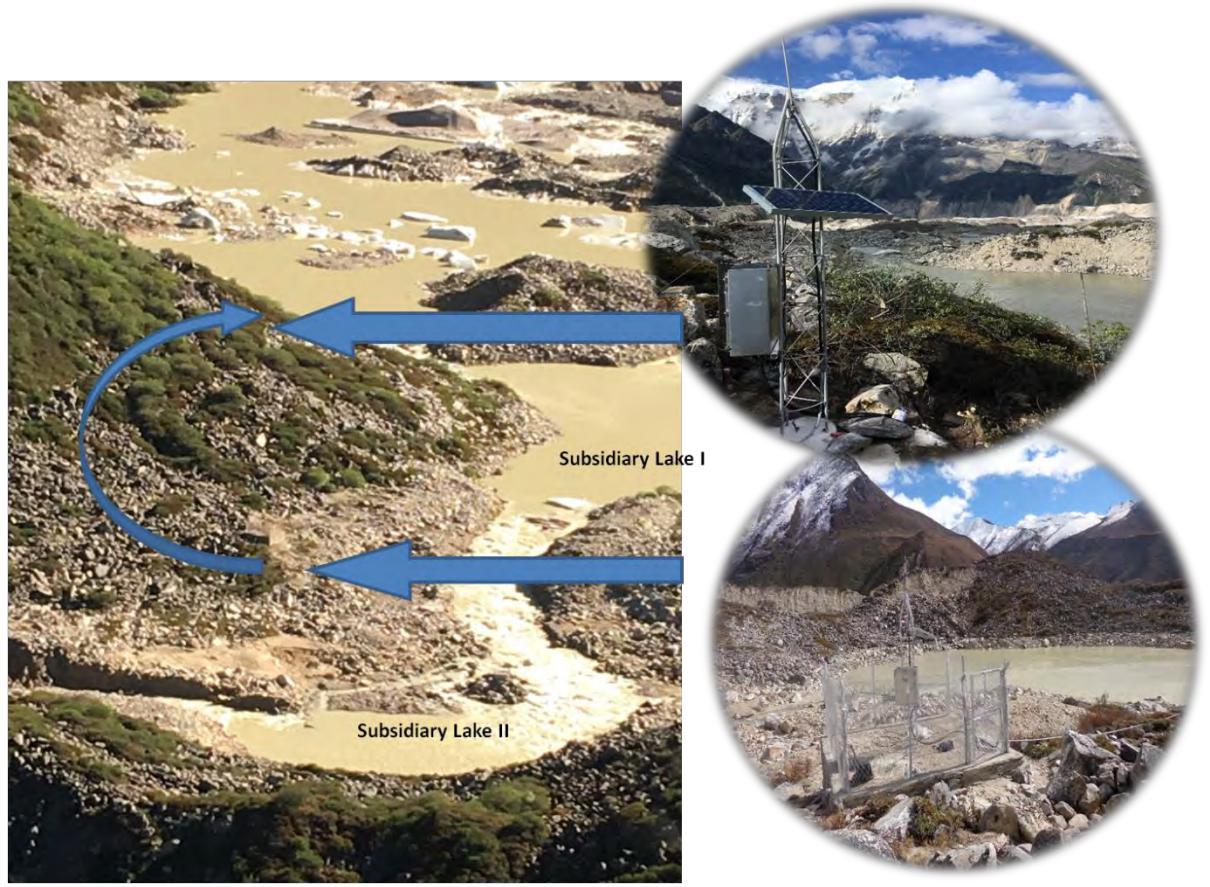
Photo 10 : Relocation of AWLS at Thorthormi Tso

Initial plan was to relocate the AWLS from subsidiary lake II to the main lake. However, after inspecting the site, it was found that a more appropriate site for the relocation was at

subsidiary lake I (photo 10). Thorthormi main lake has two outlets now flowing into subsidiary lake I. By installing the AWLS at subsidiary lake I, the instrument can detect any abnormalities in the flow from both these outlets. The original plan to shift the AWLS to the main lake will not be able to detect any high flow from the original outlet which is located to the left side of new breached outlet channel. The entire work of relocation the AWLS was completed on 24th June 2019 and the station is operational and functioning currently.

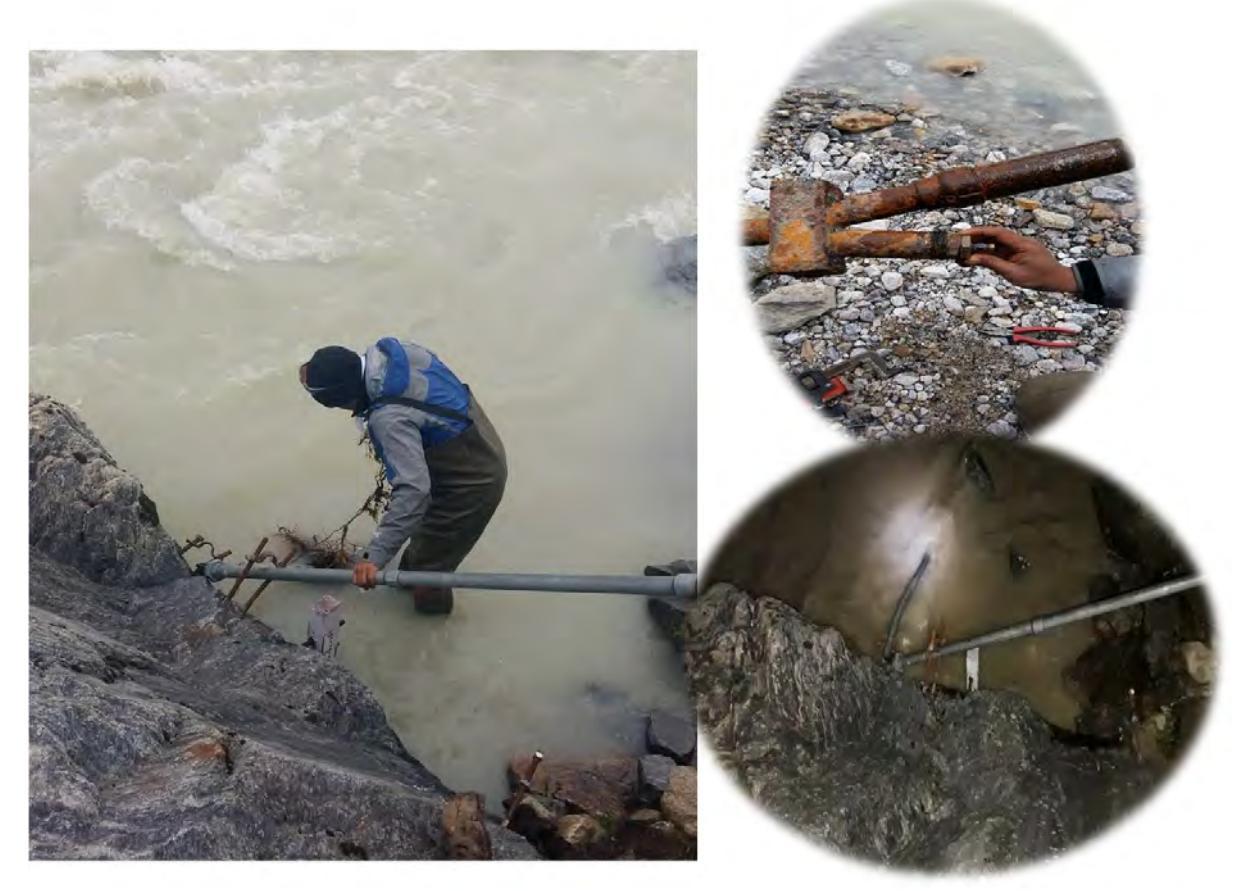
During the high flow on 20th June 2019, the terminal block at Thanza AWLS was damaged completely (Photo 11).

Photo 11: Showing damaged sensors part of Thanza AWLS

The work on the restoration of Thanza AWLS commenced on 25th June 2019. In the next 3 days the team completed the entire work which consisted of repairing the terminal block and changing bubbler pressure pipe. The station is operational and running at present but the communication is not stable. The communication system at Thanza station may take little more time to stabilize.

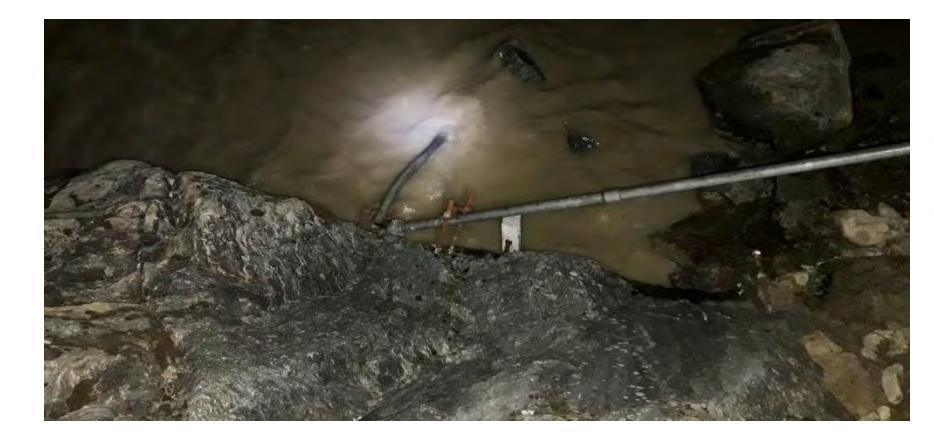
Figure 10: Thanza AWLS rendered non-functional after June 20
