GLOF Early Warning System in the Punakha Wangdue Valley

Project Implementation Procedures followed and Lessons Learnt

Reducing Climate Change-induced Risks and Vulnerabilities from Glacier Lake Outburst Floods in the Punakha-Wangdue and Chamkhar Valleys

Department of Hydro-met Services
Ministry of Economic Affairs
Thimphu: Bhutan

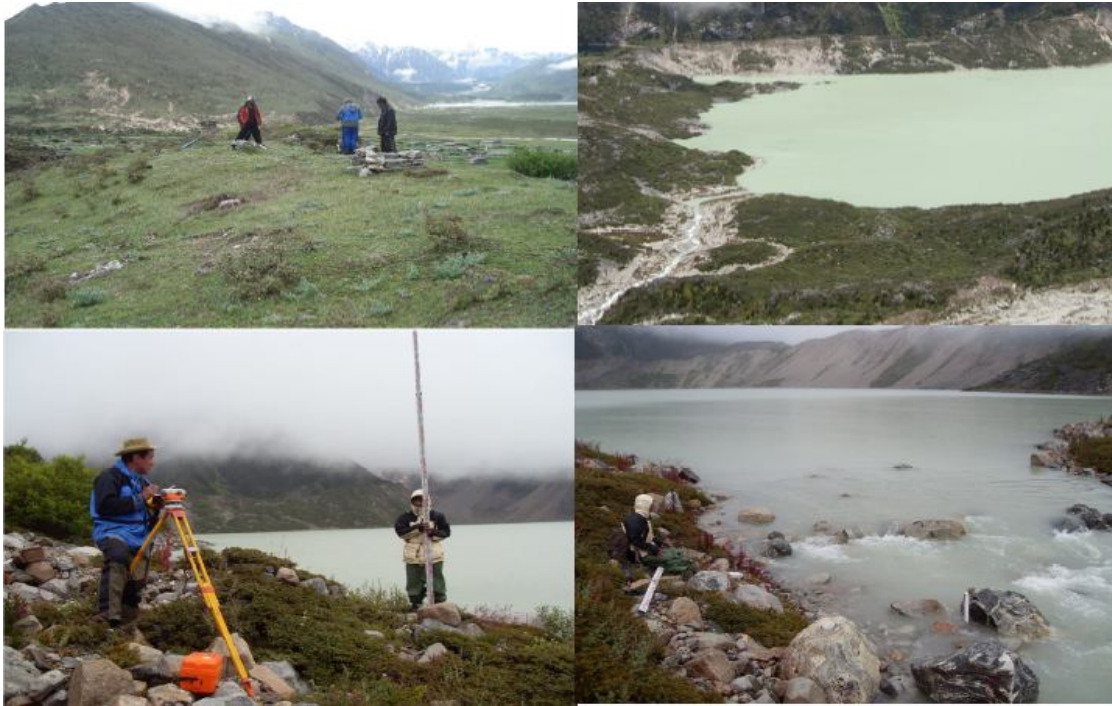
Photo 3: Location of Sensors and Sirens in Lunana Areas

Lunana project sites have very limited access. Places are accessible only during summer months. DoE deputed a team of engineers to carry out the site assessment study to identify location of sensors, sirens and communication system in Lunana from 6 July to 7 August 2009. Team identified location of sensors sites, siren towers and communication system for GLOF EWS.

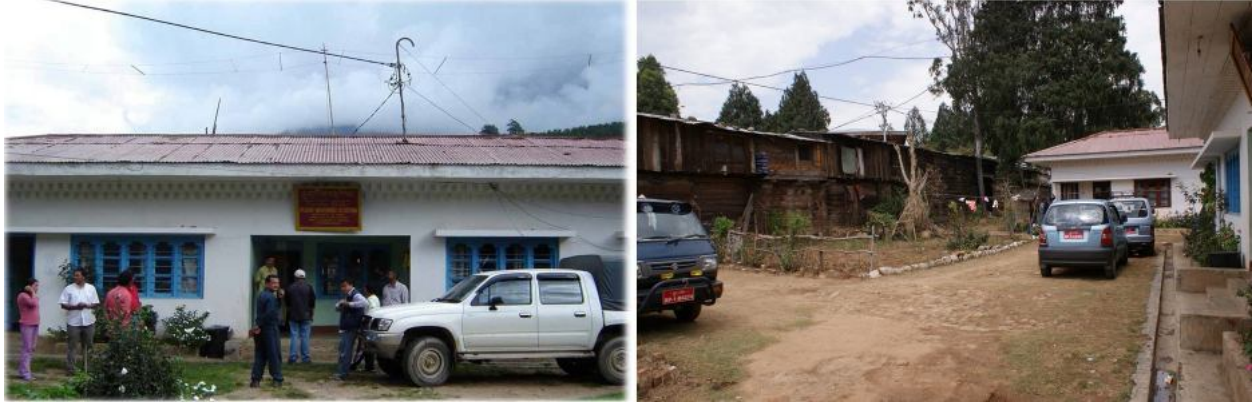
Photo 4: Wangdue Flood Warning Office

The Department of Geology and Mines (DGM) in their earlier preliminary site assessment report proposed to set up GLOF EWS control room at Khuruthang, Punakha. However, the Department of Energy proposed and decided to set up GLOF EWS Control Room at Wangdue Flood Warning Office due to existent of acquired land and infrastructures. The Flood Warning Office, Wangdue was also the control room for the Manual GLOF early warning system operated by the erstwhile Hydro-met Services Division (HMSD), DoE. Water level status from Thanza, Lunana are transmitted (as per the schedule 8 times daily) by staff stationed through wireless directly to Wangdue Flood Warning Office with Dobani flood Warning Station at Sankosh as back up. These offices are equipped with HF wireless set, telephone line and access to electricity. Location of Wangdue Office very near to the Bhutan Telecom Transmission/Receiver tower and availability of residential quarters for staff within office compound were other reasons for selection of Control Room location at Wangdue.

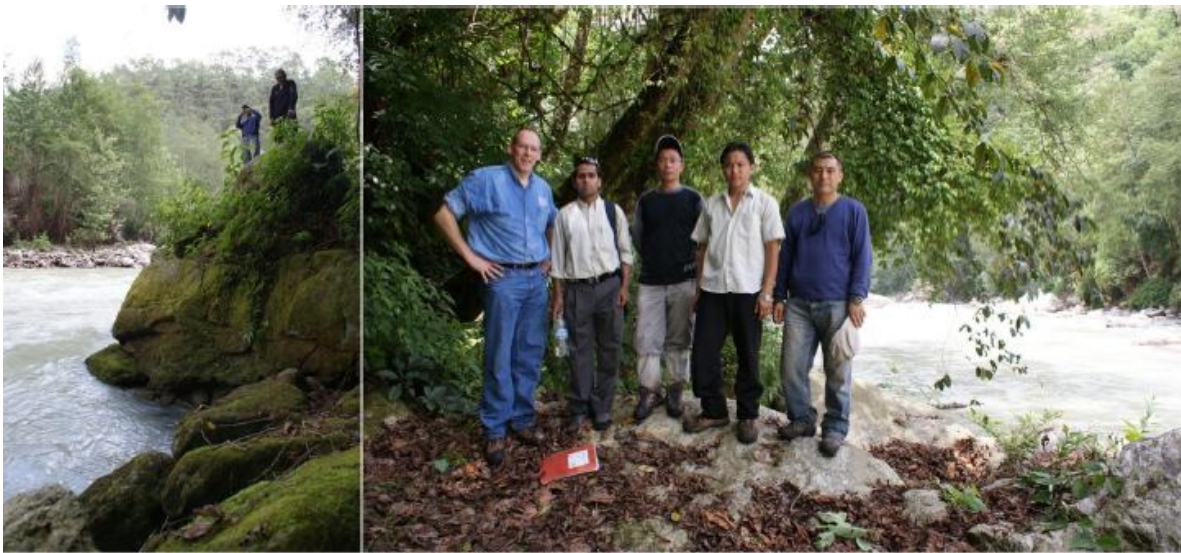
Photo 6: Dangsa Automatic Water Level Monitoring Station Site, upstream of Tame Damchhu Village under the Punakha-Dzongkha (May 2010)

Project sites (Sensor site at Dangsa, Control Station and Siren stations) along the Punakha-Wangdue valley were handed over to the Contractor between 25-26 May 2010. Due to nature of the project sites, Lunana area sites were handed over to the Contractor only in between 6 July to 7 August 2010.

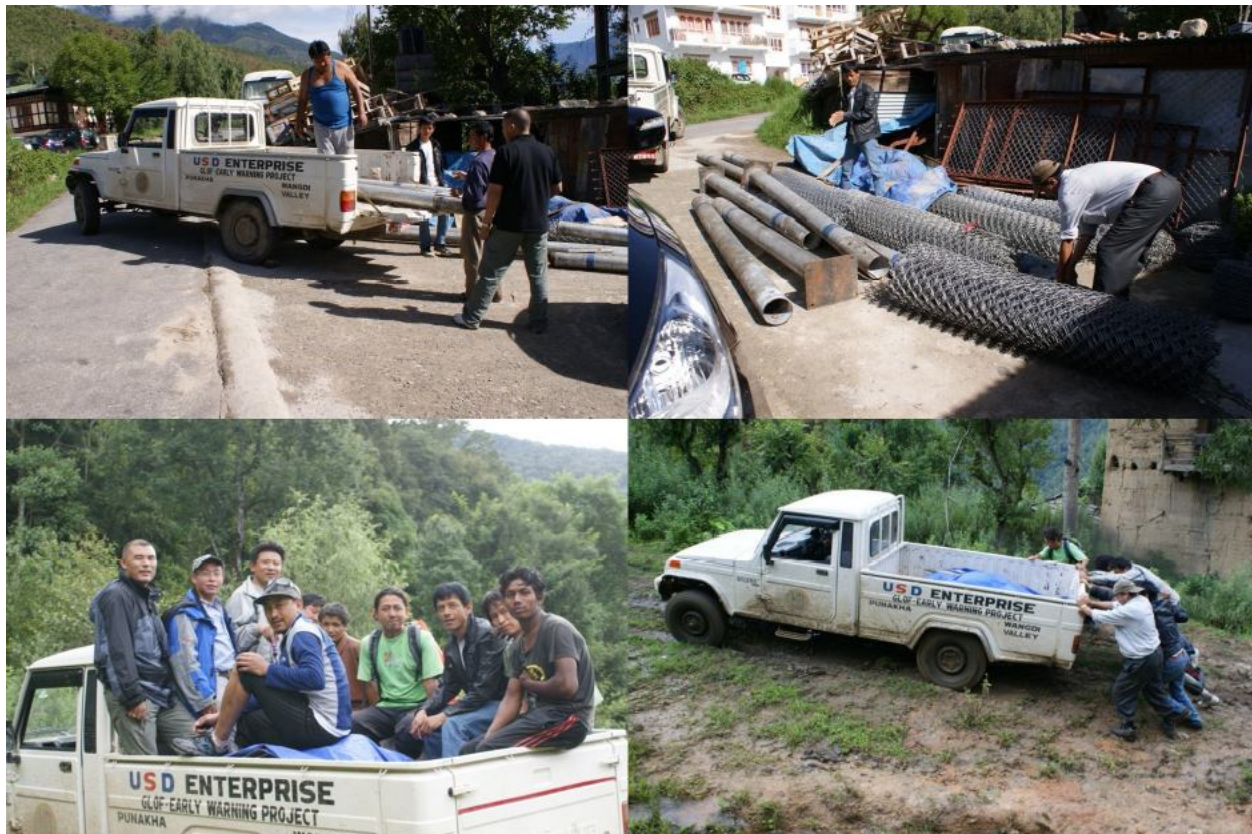
Photo 10: Transportation of materials to sites during the monsoon by pick-up Van (August 2010)

Civil work in the Punakha-Wangdu valley started soon after the award of work by the Contractor from June 2010. Materials for the civil construction were transported by dedicated pick up vehicle procured for the project by local contractor that was suitable for narrow and unpaved farm roads.

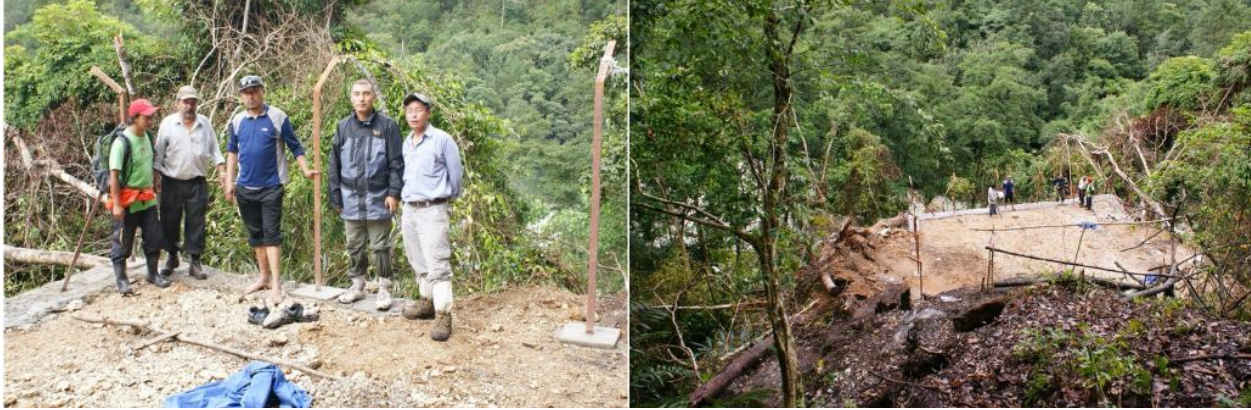
Photo 11: Progress of civil work at Dangsa for Automatic Water Level Site above Tamedamchhu, Punakha (August 2010)

By end of September 2010, almost all the civil work in the lower region of Punakha-Wangdue were completed except for those siren sites in the Punatsangchhu-I and Punatsangchhu-II Hydropower Project sites, where we had to relocated to new sites identified by the projects. Civil works were supervised by dedicated site engineer deployed by the project management office.

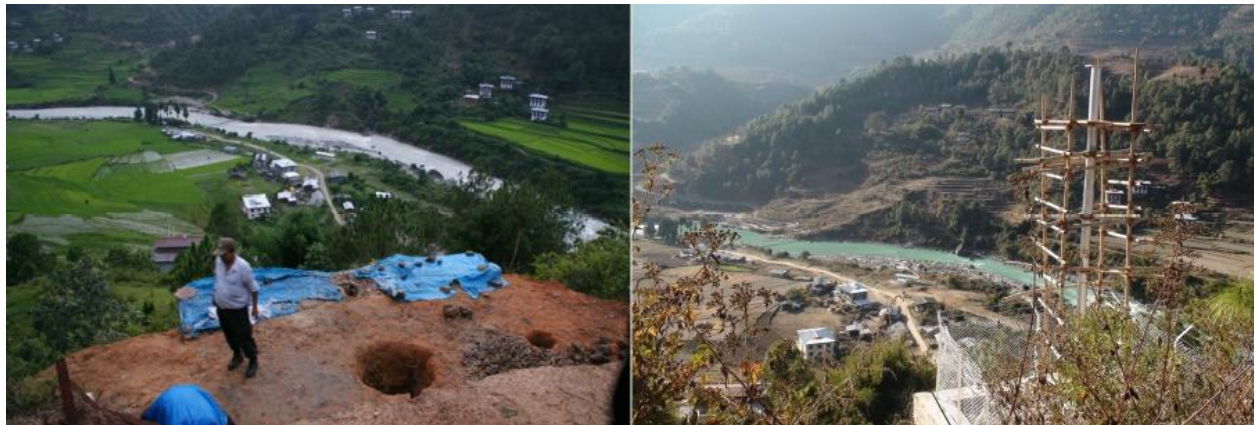
Photo 12: Progress of civil work at Samdingkha Siren Station (August 2010)

The contractor completed all the civil works and erections of 14 sirens towers in the lower valley by the end of December 2010.

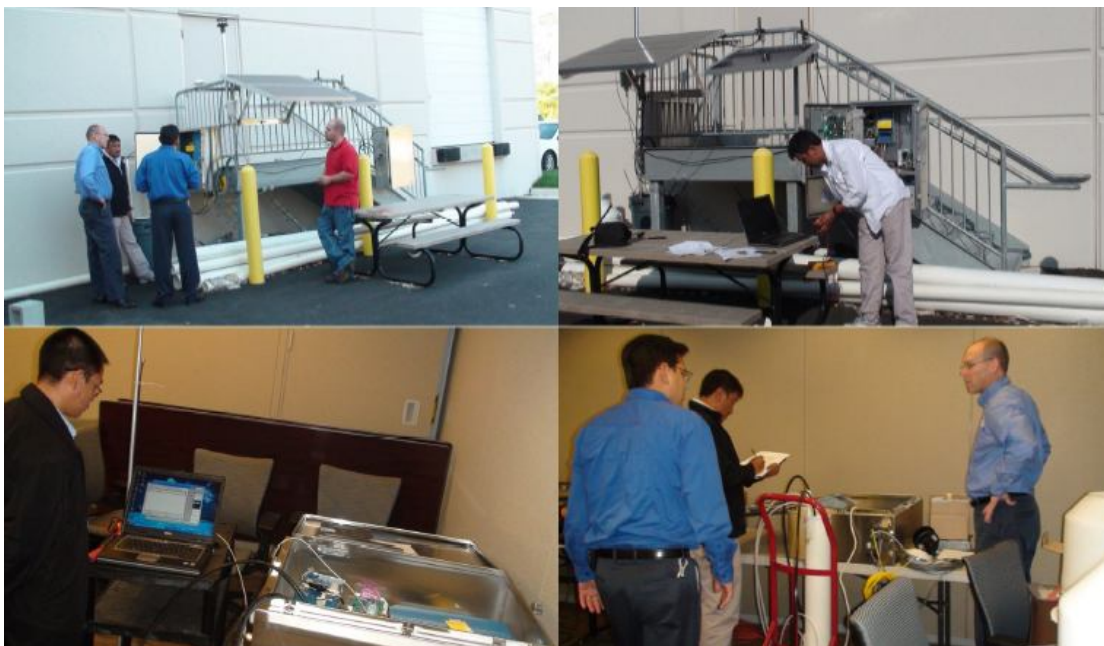
Photo 13: Testing and inspection of AWS/AWLS setup at Sutron, USA (September 2010)

During the FAT, Employer representatives together with Sutron professionals reviewed, checked and verified technical specifications of all equipment for the various components of the system. Team also verified and checked electrical circuits/wiring of stations/equipments as per the wiring diagram and voltage of electrical circuit of all the assembled equipment. The tests were performed for all the components of GLOF Early Warning System as given below.

- a. 6 Automatic Water Level Station (AWLS) – 4 in the lakes, one at confluence, Thanza, Lunana and one at Dangsa, Punakha;
- b. 2 Automatic Weather Stations (AWS) - one at Thanza, Lunana and another at Dangsa, Punakha.
- c. 17 Siren Stations- 3 in Lunana area and 14 in Punakha-Wangdue Valley and
- d. Control station hardware and software.

The procedures and test results of all the stations were recorded in the FAT Forms, which were duly signed by the representatives of DoE and Sutron after completion of each test.

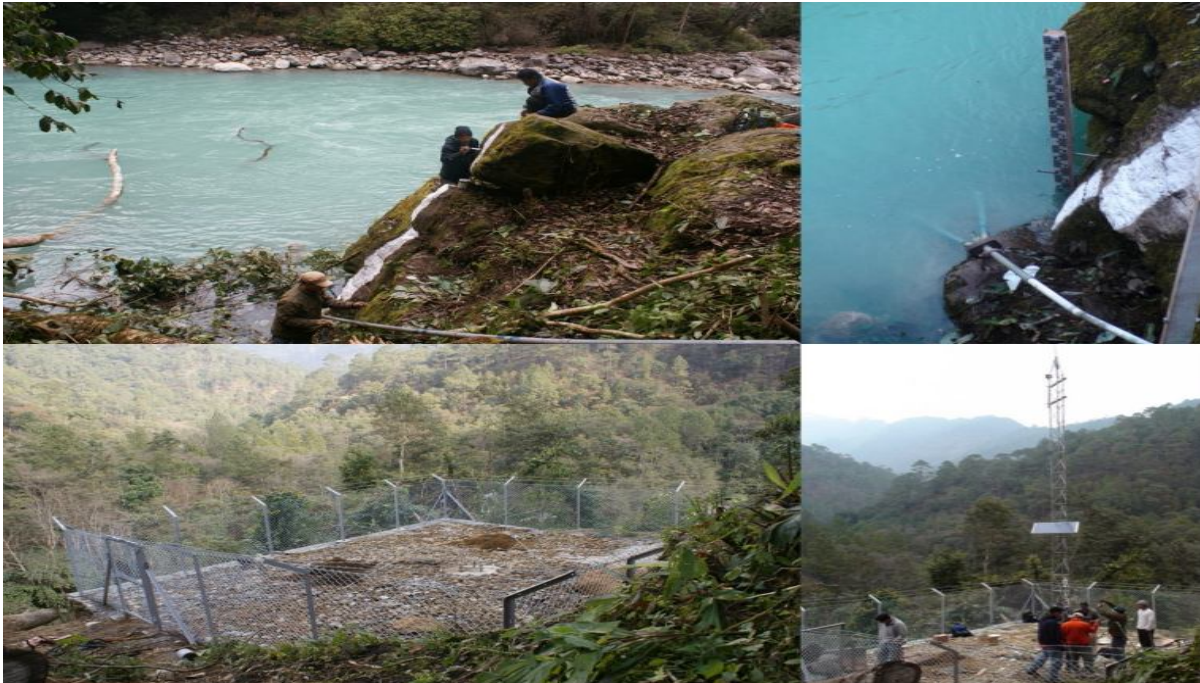
Photo 17: Installation of AWLS at Dangsa, Tame Damchhu (January 2011)

Installation of automatic water level station at Dangsa, 14 Sirens and setting up of Control Room at Wangdue in the Punakha-Wangdue were carried out from January 17-27, 2011 and completed within 11 days as equipment for each site was assembled and packed into difference boxes prior to shipment from USA to Bhutan. Installation was made it simple and easy, it was just a matter of basic fitting various components of equipment and its accessories at each site.

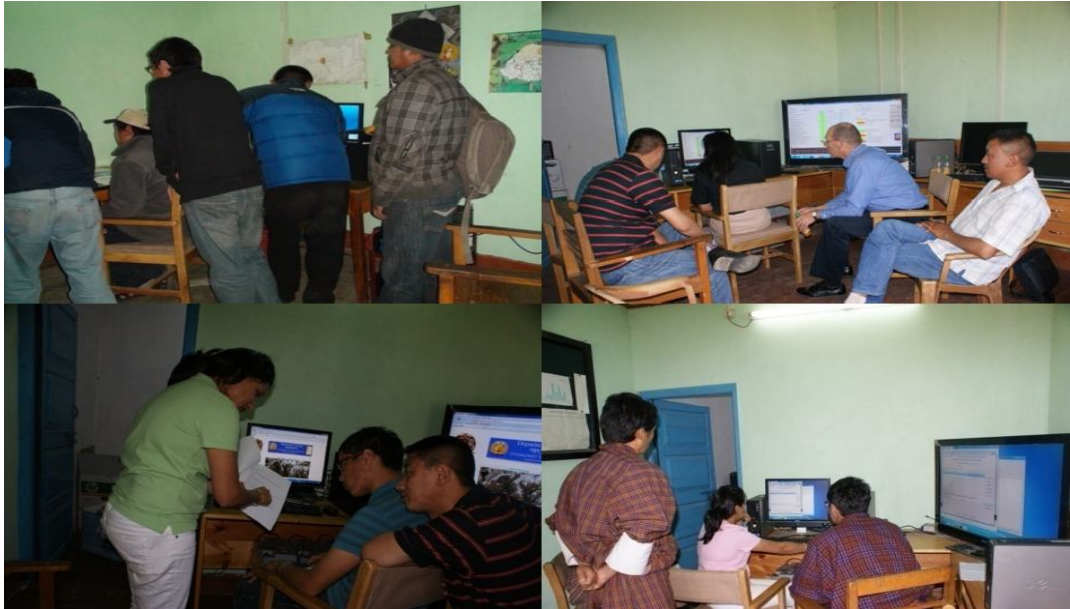
Photo 19: Installation and Training at Control Centre, Wangdue (January 2011)

Upon completion of installation, Site Acceptance Testing (SAT) for all the sites and control room was conducted. Site Acceptance Testing (SAT) for GLOF EWS on lower region was signed between Sutron and DHMS project management on 27th January 2011 taking ownership of above stations and Control Room. The GLOF EWS on lower region was operational thereafter.

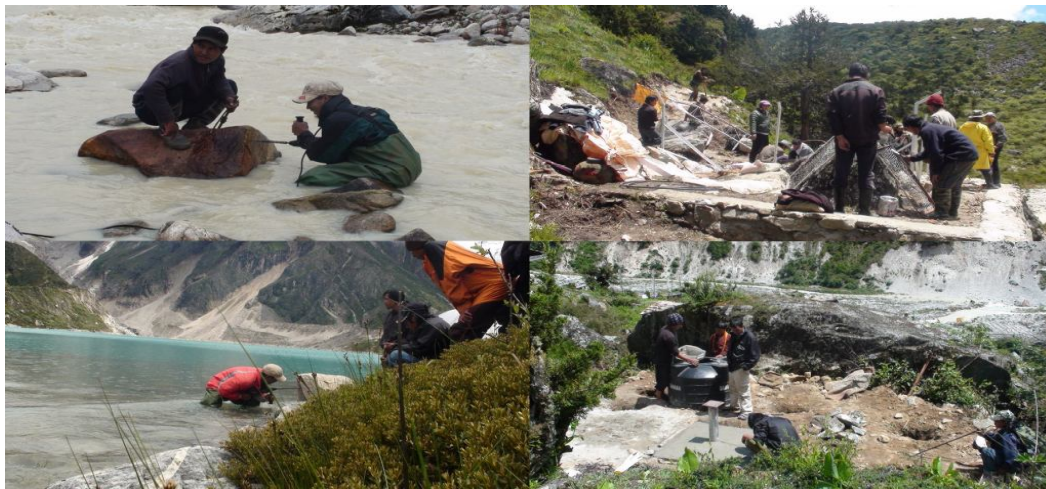
Photo 20: Progress of civil works in Lunana (August 2011)

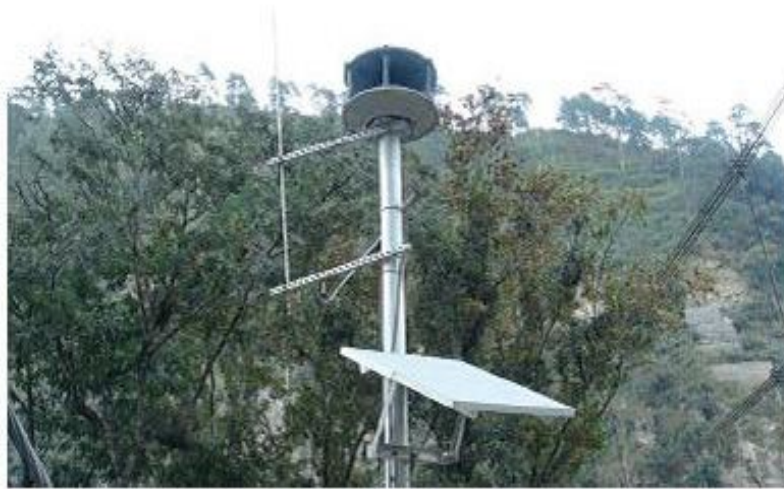
The early warning flood siren at Kamichhu, Wangdue

At 7:15 AM on 22nd January 2013, all the 14 sirens along the Punakha-Wangdue Valley got automatically activated due false rise in water level at Thanza, Automatic Water Level Monitoring (AWLS) creating false alarms in the valley. Like the earlier occasion this was also caused by the icing that blocked the dual orifice terminal submerged under the water when the water level decreases during the winter. Activation of Sirens in the lower region could have prevented from the Control Room as the system is designed in such a way that it will wait 30 minutes before automatically activation of sirens by the system. Thus, the false alarm occurred due to lapses from the Control Room, Wangdue. DHMS will rectify station equipment problem in the coming summer 2013. The false alarm in the Punakha-Wangdue valley was covered by media. An article that came out in Kuensel dated 23 January 2013 is given Figure 2.

Ice caused a rise in water level, which activated a sensor and caused the alert to go off

partment of Hydro-met Services, said because of ice there was a rise in water level, which crossed the alert and alarm set for early warning system at Thangza stream, the main confluence of potentially dangerous lakes - Lugtsho, Thorthorimi, Rapstreng and Baytsho.
