Near-Surface Ground Temperature Monitoring for Permafrost Detection in Laya, Bhutan

Technical Report (Version 1)

10 October - 27 October 2025

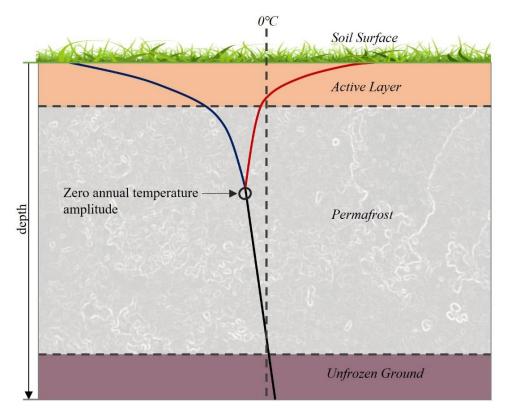
Figure 1: A typical permafrost ground structure and temperature profiles.

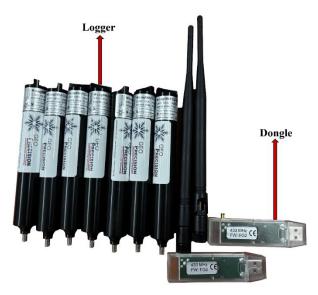
Figure 3: GeoPrecision miniature data loggers (20 numbers) procured by the National Centre for Hydrology and Meteorology (NCHM), Bhutan.

Measuring near-surface ground temperature (NSGT), often with networks of miniature data loggers (Figure 3), can helps us understand how permafrost, rock glaciers, and seasonally frozen soils are responding to warming conditions and affecting lives and livelihoods of mountain communities. The NSGT records can also reveal the timing and depth of ground freezing and thawing, processes which directly influence regional water availability, slope

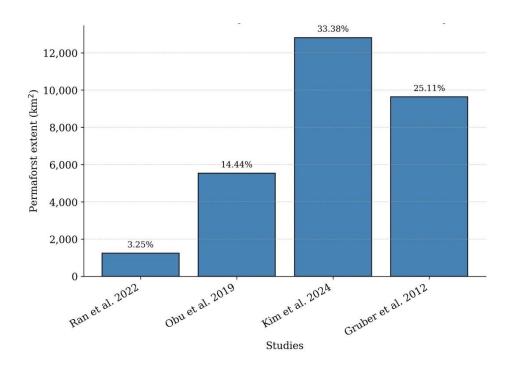
Figure 4. Permafrost extent in the Bhutan Himalaya by different studies.

stability, and the health of mountain ecosystems. Although direct, in-situ observations in the remote and rugged mountains are rare and challenging, NSGT measurements can provide vital local evidence to validate and complement broader-scale satellite observations of permafrost extents (Figure 4 & 5) [3], [4], [5], [6].

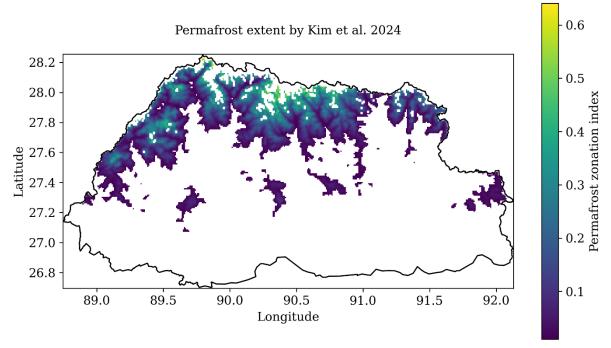
Figure 5. Permafrost extent map in Bhutan by Kim et al (2024).

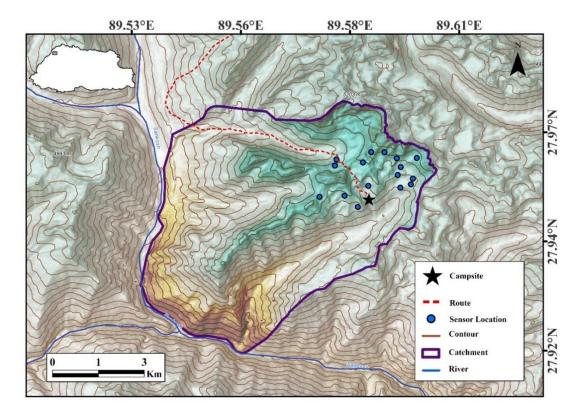
Figure 6. Site where 19 miniature data loggers were deployed, Redrukzhi, Laya, Bhutan

The site is located in the high-altitude alpine catchment of Redrukzhi, approximately three days walk from Laya in the northern Himalayas of Bhutan. Situated within the Mo Chu sub-basin of the Punatshangchu Basin, the catchment lies north of Thimphu, between latitudes 27°55'30"N and 27°59'30"N, and longitudes 89°32'E and 89°36'E. The Redrukzhi catchment has steep, rugged and highly dissected topography. Elevation ranges from approximately 3,400 meters on the lower valley floor to 5,203 meters at its highest point, with the northern ridgeline reaching around 5,100 meters above sea level.

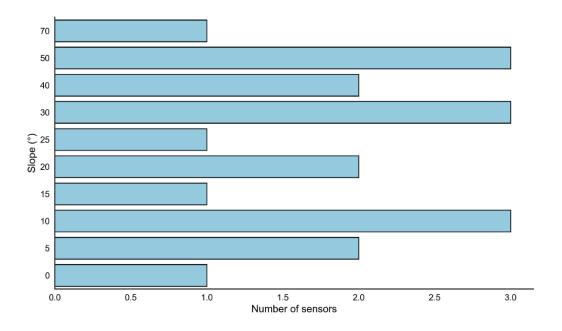
Figure 7. Distribution of sensors with respect to slope.

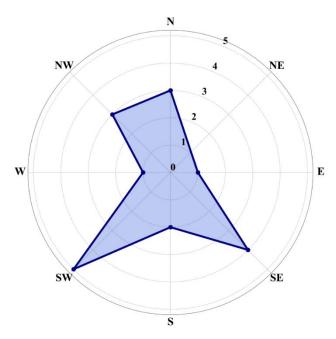
Figure 8. Distribution of sensors with respect to aspect.

Figure 9. Distribution of sensors with respect to elevation.

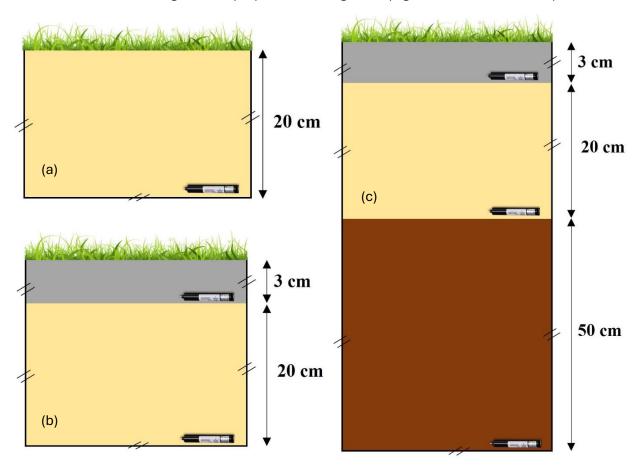
Figure 10. Sensors at different soil depths.

Fourteen sensors were installed at a depth of 20 cm below the ground surface to reduce potential disturbances caused by livestock and human interference (Figure 10 a). Two sensors were installed at a depth of 3 cm and 20 cm in the same location (Figure 10 b, Annex Form 1). Three sensors were installed at a depth of 3 cm, 20 cm, and 50 cm, close to the 2021 landslide area to facilitate modelling thermal properties of the ground (Figure 10 c, Annex Form 6).

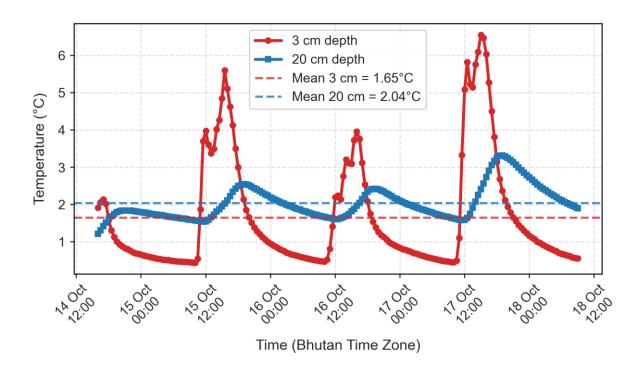
Figure 11. Ground temperature measurements at two depths (3 cm and 20 cm).

The data collected over four days (14–18 October 2025) at two depths, 3 cm and 20 cm, indicated that the near-surface (3 cm) temperature was slightly lower on average than the temperature at 20 cm depth, with mean values of 1.65 °C and 2.04 °C, respectively.

During daytime, the 3 cm temperature rose significantly above the 20 cm temperature due to direct solar heating of the surface layer. In contrast, during nighttime, the shallow layer cooled rapidly and becomes much colder than the 20 cm depth, which retains heat longer.

The diurnal temperature amplitude at 3 cm was much larger compared to 20 cm. The 20 cm temperature signal was noticeably damped, reflecting the insulating effect of the overlying material and the slower rate of heat transfer with depth. The damping at 20 cm was a result of heat diffusion in soils. The near-surface temperatures responded quickly to diurnal forcing, while deeper layers (20cm) respond more slowly appearing the signal attenuated (reduced amplitude) and phase-shifted (delayed).

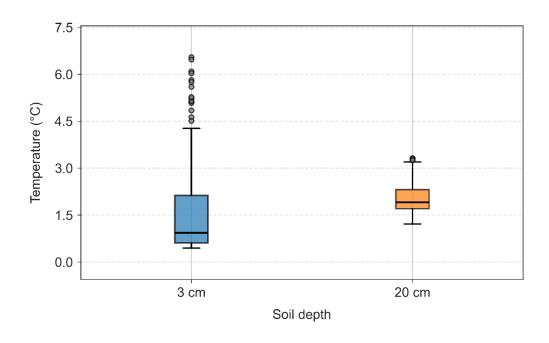
Figure 12. Ground temperature distributions at 3 cm and 20 cm depths.

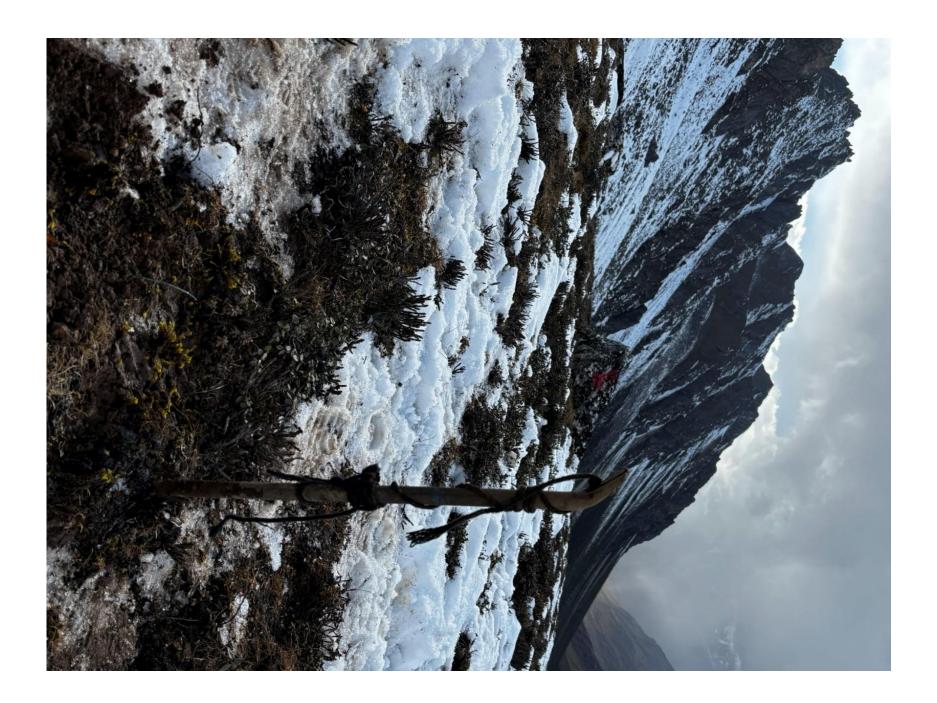
Form No: 1

Sl.No	Parameter Name	Descriptions	Unit
1	Sensor name	BT-RD-HPP1-25-10-14 BT-RD-HPP2-25-10-14	
2	Sensor type	GeoPrecision M-Log5W-FG2	
3	Serial number	A551EF (20 cm) A551EB (3 cm)	
4	Access code	FF1D 3C1C	
5	Latitude	27.96529	DD
6	Longitude	89.57987	DD
7	Elevation	4793	m
8	Launch date & time	Date: 14/10 /2025 Time: 16:07 Time: 16:09	Local
9	Data recording date & time	Date: 14/10 /2025 Time: 09:07 Time: 09:09	UTC
10	Aspect	North	
11	Slope	10	degrees
12	Sensor depth	20 3	cm
13	Photographs	Yes [x] No [] Name & Affiliation: Dr. Sonam Wangchuck, ICIMOD	
14	Site description and remark (if any)	 At the time of installation, there are snow patches, and shrubs. The soil is moist, and mineral type. Sensor is towards the east with at a distance of 9.1m from the marker. Photo taken towards the marker facing in west direction. During configuration, the time deviation was 0 sec for both the sensor.

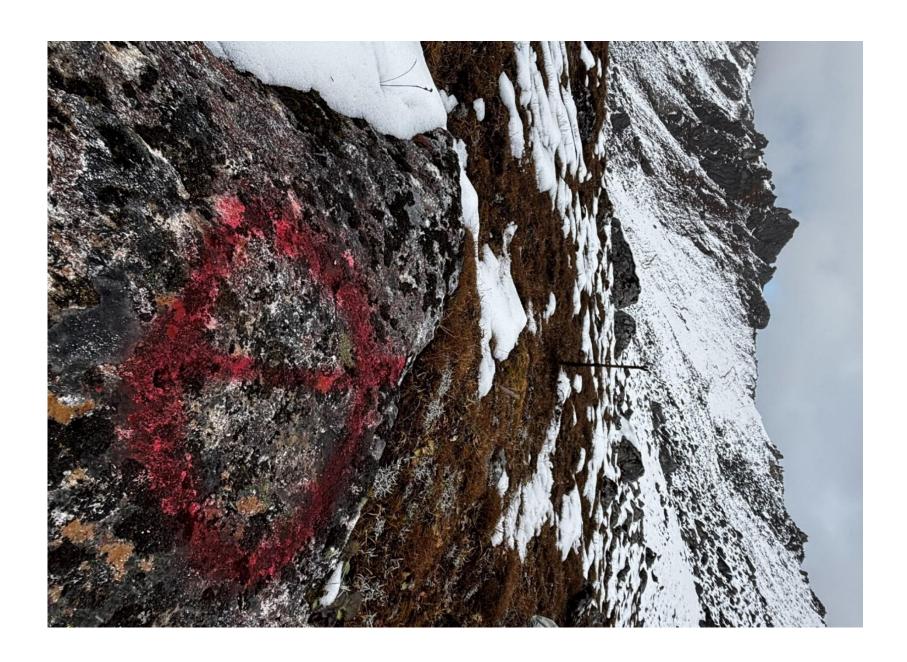
Form No: 2

Sl.No	Parameter Name	Descriptions	Unit
1	Sensor name	BT-RD-HPP3-25-10-14	
2	Sensor type	GeoPrecision M-Log5W-FG2	
3	Serial number	A551F9	
4	Access code	319C	
5	Latitude	27.96373	DD
6	Longitude	89.57948	DD
7	Elevation	4825	m
8	Launch date & time	Date:14/10 /2025 Time: 16:41	Local
9	Data recording date & time	Date: 14/10 /2025 Time: 10:40	UTC
10	Aspect	North	
11	Slope	0	degrees
12	Sensor depth	20	cm
13	Photographs	Yes [x] No [] Name & Affiliation: Dr. Sonam Wangchuck, ICIMOD	
14	Site description and remark (if any)	 At the time of installation, there are snow patches, shrubs, surrounded by boulders. The soil is moist, and mineral type. In terms of microtopography it is almost south. Sensor is towards the east with at a distance of 2.74m from the marker. During configuration, the time deviation was -1sec. Photo is taken, towards North direction.

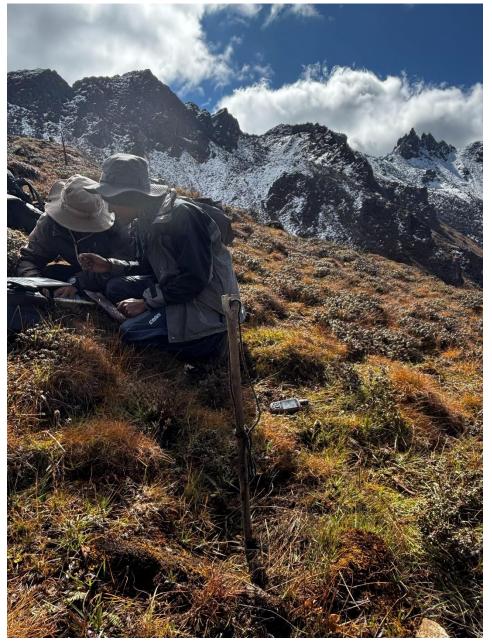
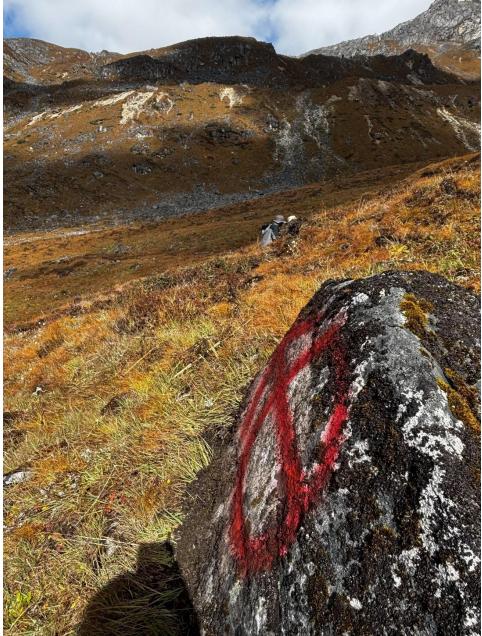
Form No: 3

Sl.No	Parameter Name	Descriptions	Unit
1	Sensor name	BT-RD-MPP1-25-10-15	
2	Sensor type	GeoPrecision M-Log5W-FG2	
3	Serial number	A551F6	
4	Access code	35DC	
5	Latitude	27.95813	DD
6	Longitude	89.59613	DD
7	Elevation	4628	m
8	Launch date & time	Date: 15/10 /2025 Time: 09:39	Local
9	Data recording date & time	Date: 15/10 /2025 Time: 03:39	UTC
10	Aspect	North-West	
11	Slope	15	degrees
12	Sensor depth	20	cm
13	Photographs	Yes [x] No [] Name & Affiliation: Dr. Sonam Wangchuck, ICIMOD	
14	Site description and remark (if any)	 At the time of installation, there are no snow patches, but the sensor is surrounded by shrubs. The soil is moist, and mineral type. Sensor is towards the North-West at a distance of 10m from the marker. During configuration, the time deviation was -2sec. Photo was taken, towards south-west direction.

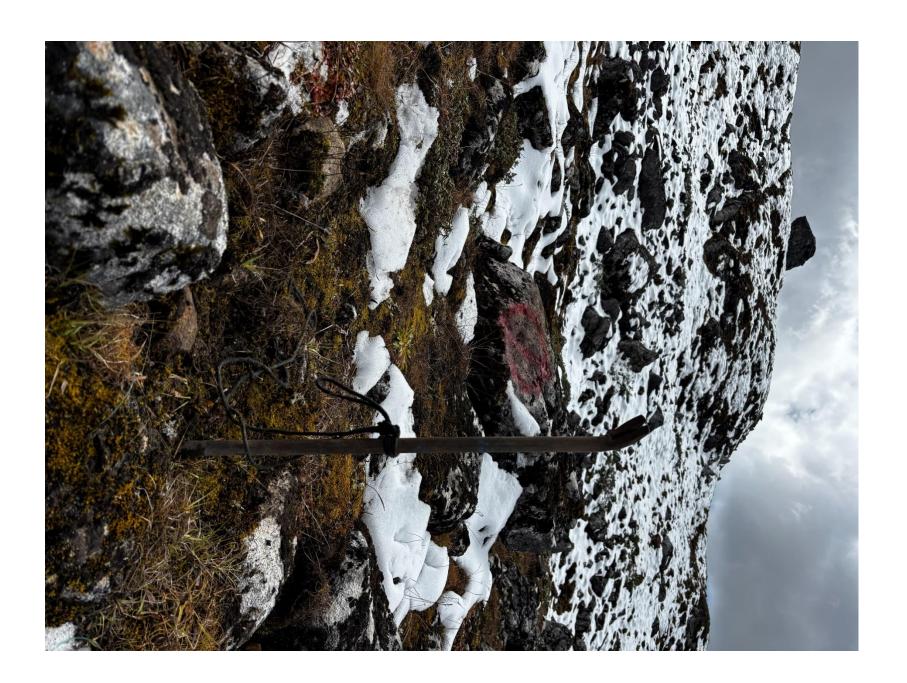
Form No: 4

Sl.No	Parameter Name	Descriptions	Unit
1	Sensor name	BT-RD-HPP4-25-10-15	
2	Sensor type	GeoPrecision M-Log5W-FG2	
3	Serial number	A551E8	
4	Access code	3D5C	
5	Latitude	27.95896	DD
6	Longitude	89.59880	DD
7	Elevation	4687	m
8	Launch date & time	Date: 15/10 /2025 Time: 10:42	Local
9	Data recording date & time	Date: 15/10 /2025 Time: 04:42	UTC
10	Aspect	North-West	
11	Slope	5	degrees
12	Sensor depth	20	cm
13	Photographs	Yes [x] No [] Name & Affiliation: Dr. Sonam Wangchuck, ICIMOD	
14	Site description and remark (if any)	 At the time of installation, there are little snow patches, but the sensor is surrounded by scattered boulders and it is placed at rock–soil interface. The soil is moderately dry. Sensor is towards North at a distance of 2.1m from the marker. During configuration, the time deviation was -1sec. Photo was taken, towards North direction.

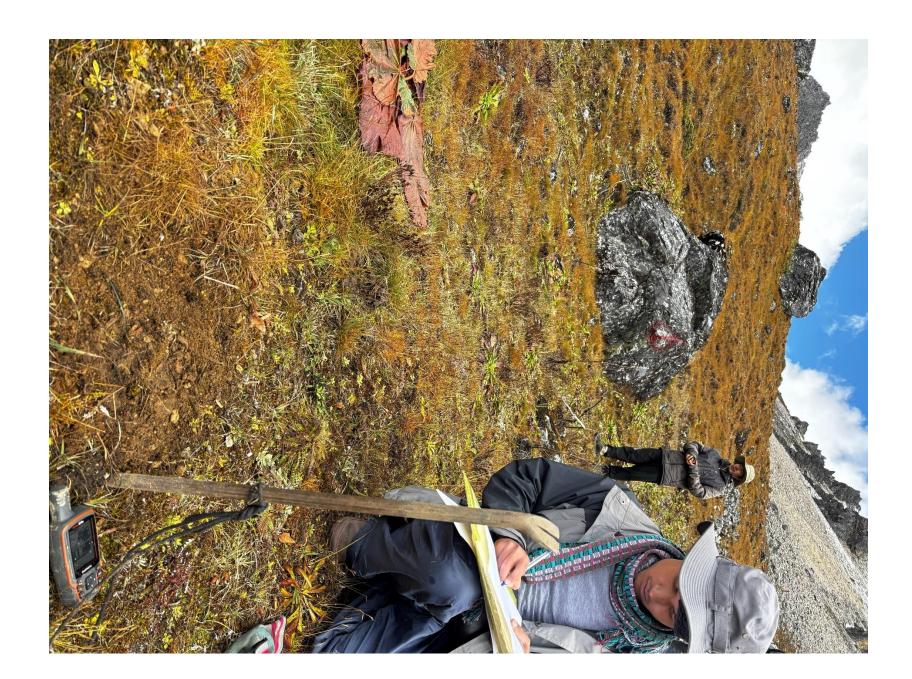
Form No: 5

Sl.No	Parameter Name	Descriptions	Unit
1	Sensor name	BT-RD-MPP2-25-10-15	
2	Sensor type	GeoPrecision M-Log5W-FG2	
3	Serial number	A551EC	
4	Access code	FE5D	
5	Latitude	27.96043	DD
6	Longitude	89.59933	DD
7	Elevation	4692	m
8	Launch date & time	Date: 15/10 /2025 Time: 11:15	Local
9	Data recording date & time	Date: 15/10 /2025 Time: 05:15	UTC
10	Aspect	South	
11	Slope	10	degrees
12	Sensor depth	20	cm
13	Photographs	Yes [x] No [] Name & Affiliation: Dr. Sonam Wangchuck, ICIMOD	
14	Site description and remark (if any)	 At the time of installation, there are no snow patches, but the sensor is placed at well-drained, coarse-textured soil combined with coarse aggregates and surrounded by scattered surface boulders. Sensor is towards south at a distance of 7.1m from the marker. During configuration, the time deviation was -1sec. Photo was taken, towards North direction of the sensor.

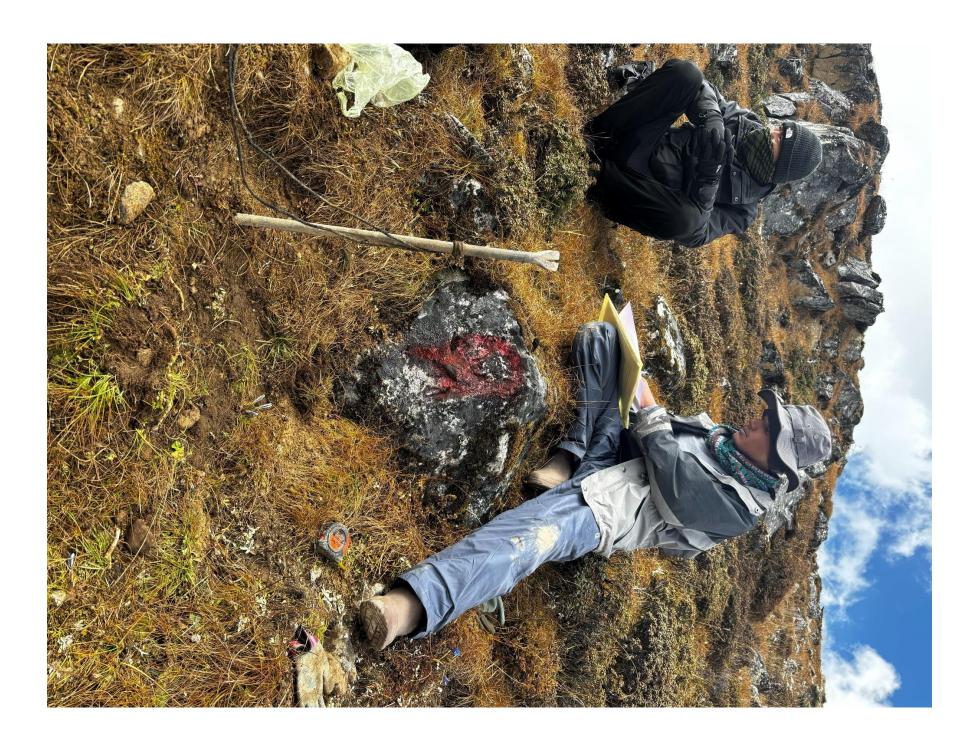
Form No: 6

Sl.No	Parameter Name	Descriptions	Unit
1	Sensor name	BT-RD-LPP1-25-10-15 BT-RD-LPP2-25-10-15 BT-RD-LPP3-25-10-15	
2	Sensor type	GeoPrecision M-Log5W-FG2	
3	Serial number	A551F0 (50 cm) A551F8 (20 cm) A551ED (3 cm)	
4	Access code	375C F15D 3E9C	
5	Latitude	27.96136	DD
6	Longitude	89.59544	DD
7	Elevation	4700	m
8	Launch date & time	Date: 15/10 /2025 Time: 12:40 Time: 12:45 Time: 12:48	Local
9	Data recording date & time	Date: 15/10 /2025 Time: 06:15 Time: 06:45 Time: 06:48	UTC
10	Aspect	South-West	
11	Slope	50	degrees
12	Sensor depth	50 20 3	cm
13	Photographs	Yes [x] No [] Name & Affiliation: Dr. Sonam Wangchuck, ICIMOD	
14	Site description and remark (if any)	 At the time of installation, sensor is placed at well-drained, coarse-textured mineral soil and surrounded by shrubs. Sensor is towards south-west from the marker. The sensor was installed approximately 40 m to the left of the 2021 landslide scarp, when viewed from the downslope direction. During configuration, the time deviation was -1sec for all the three sensors. Photo was taken, towards South-west direction of the sensor.

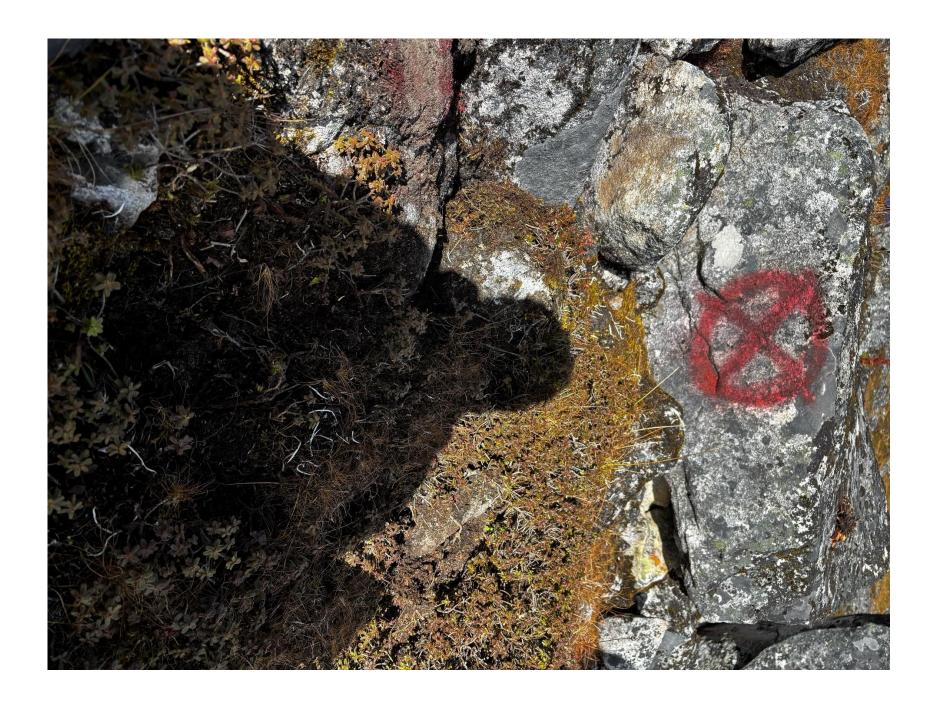
Form No: 7

Sl.No	Parameter Name	Descriptions	Unit
1	Sensor name	BT-RD-LPP4-25-10-15	
2	Sensor type	GeoPrecision M-Log5W-FG2	
3	Serial number	A551F5	
4	Access code	349C	
5	Latitude	27.96334	DD
6	Longitude	89.59619	DD
7	Elevation	4752	m
8	Launch date & time	Date: 15/10 /2025 Time: 13:34	Local
9	Data recording date & time	Date: 15/10 /2025 Time: 07:34	UTC
10	Aspect	East	
11	Slope	30	degrees
12	Sensor depth	20	cm
13	Photographs	Yes [x] No [] Name & Affiliation: Dr. Sonam Wangchuck, ICIMOD	
14	Site description and remark (if any)	 The sensor is sited in shrub-boulder terrain at the boundary between a boulder field and a soil-dominated surface. Boulders are prominent and occur as compacted clusters on one side; the opposite side is mineral soil supporting low shrubs and mosses. Sensor is placed towards south-west at a distance of 1.37m from the marker. During configuration, the time deviation was -2sec. Photo was taken, towards South-west direction of the sensor.

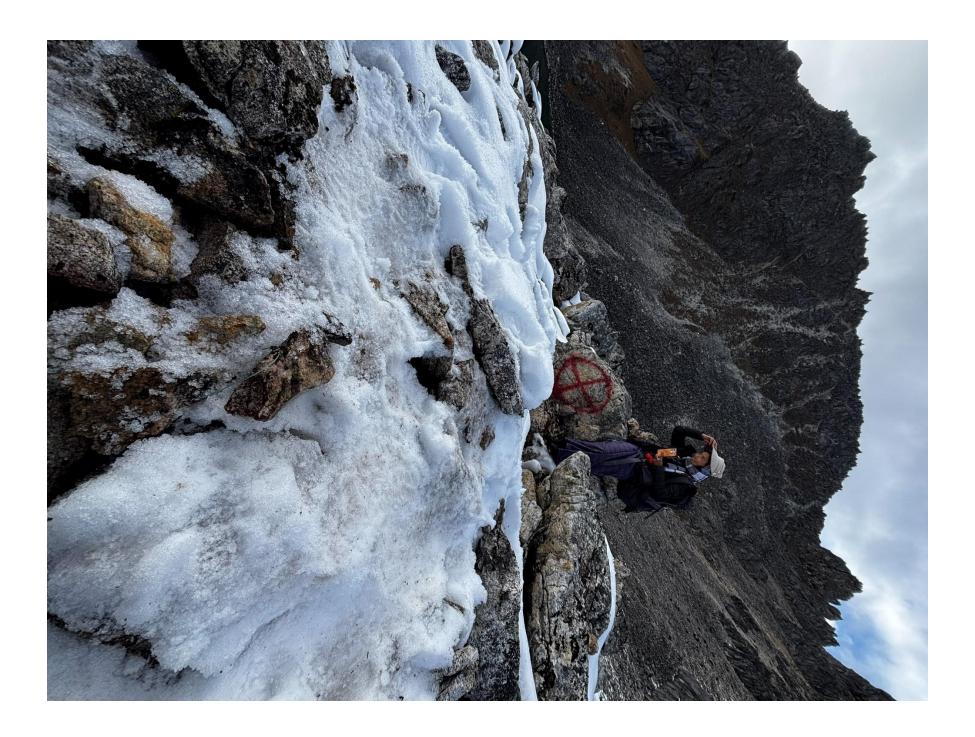
Form No: 8

Sl.No	Parameter Name	Descriptions	Unit
1	Sensor name	BT-RD-HPP5-25-10-15	
2	Sensor type	GeoPrecision M-Log5W-FG2	
3	Serial number	A551F4	
4	Access code	F45D	
5	Latitude	27.96567	DD
6	Longitude	89.60030	DD
7	Elevation	4863	m
8	Launch date & time	Date: 15/10 /2025 Time: 14:34	Local
9	Data recording date & time	Date: 15/10 /2025 Time: 08:34	UTC
10	Aspect	North-West	
11	Slope	25	degrees
12	Sensor depth	20	cm
13	Photographs	Yes [x] No [] Name & Affiliation: Dr. Sonam Wangchuck, ICIMOD	
14	Site description and remark (if any)	 The sensor was installed within a rock- and boulder-dominated surface under seasonal snow cover. At installation, the housing was backfilled with coarse gravel and partially covered by snow. No fine-earth (soil) matrix is present. Sensor is placed towards south-west at a distance of 3.49m from the marker. During configuration, the time deviation was -1sec. Photo was taken, towards South-west direction of the sensor.

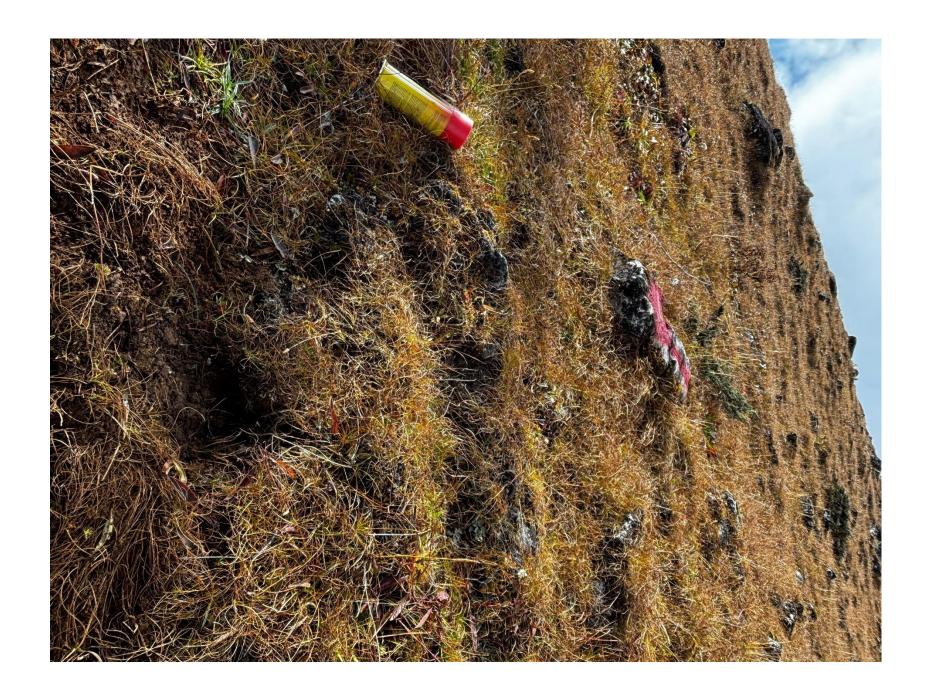
Form No: 9

Sl.No	Parameter Name	Descriptions	Unit
1	Sensor name	BT-RD-LPP5-25-10-15	
2	Sensor type	GeoPrecision M-Log5W-FG2	
3	Serial number	A551E9	
4	Access code	FD9D	
5	Latitude	27.96562	DD
6	Longitude	89.59522	DD
7	Elevation	4845	m
8	Launch date & time	Date: 15/10 /2025 Time: 15:34	Local
9	Data recording date & time	Date: 15/10 /2025 Time: 09:34	UTC
10	Aspect	South	
11	Slope	70	degrees
12	Sensor depth	20	cm
13	Photographs	Yes [x] No [] Name & Affiliation: Dr. Sonam Wangchuck, ICIMOD	
14	Site description and remark (if any)	 At the time of installation, there are no snow patches, but the sensor is surrounded by shrubs and it is soil dominated. The soil is moist, and mineral type. Sensor is placed towards south at a distance of 1.34m from the marker. During configuration, the time deviation was -1sec. Photo was taken, towards north-west direction from the sensor.

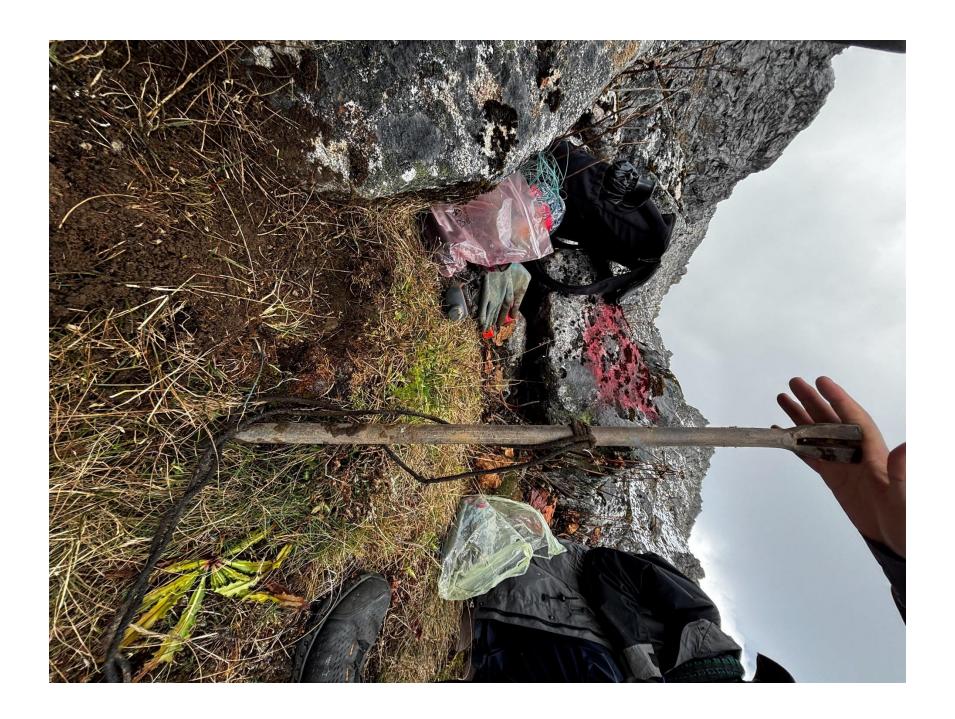
Form No: 10

Sl.No	Parameter Name	Descriptions	Unit
1	Sensor name	BT-RD-LPP6-25-10-15	
2	Sensor type	GeoPrecision M-Log5W-FG2	
3	Serial number	A551EA	
4	Access code	FCDD	
5	Latitude	27.96715	DD
6	Longitude	89.59207	DD
7	Elevation	4925	m
8	Launch date & time	Date: 15/10 /2025 Time: 16:14	Local
9	Data recording date & time	Date: 15/10 /2025 Time: 10:14	UTC
10	Aspect	South-West	
11	Slope	30	degrees
12	Sensor depth	20	cm
13	Photographs	Yes [x] No [] Name & Affiliation: Dr. Sonam Wangchuck, ICIMOD	
14	Site description and remark (if any)	 The sensor is installed on a mixed substrate co-dominated by boulders and moist mineral soil, positioned at the soil–boulder boundary near the site marker. Sensor is placed towards south at a distance of 56cm from the marker. During configuration, the time deviation was -1sec. Photo was taken, towards west direction at a distance of 56 cm from the sensor.

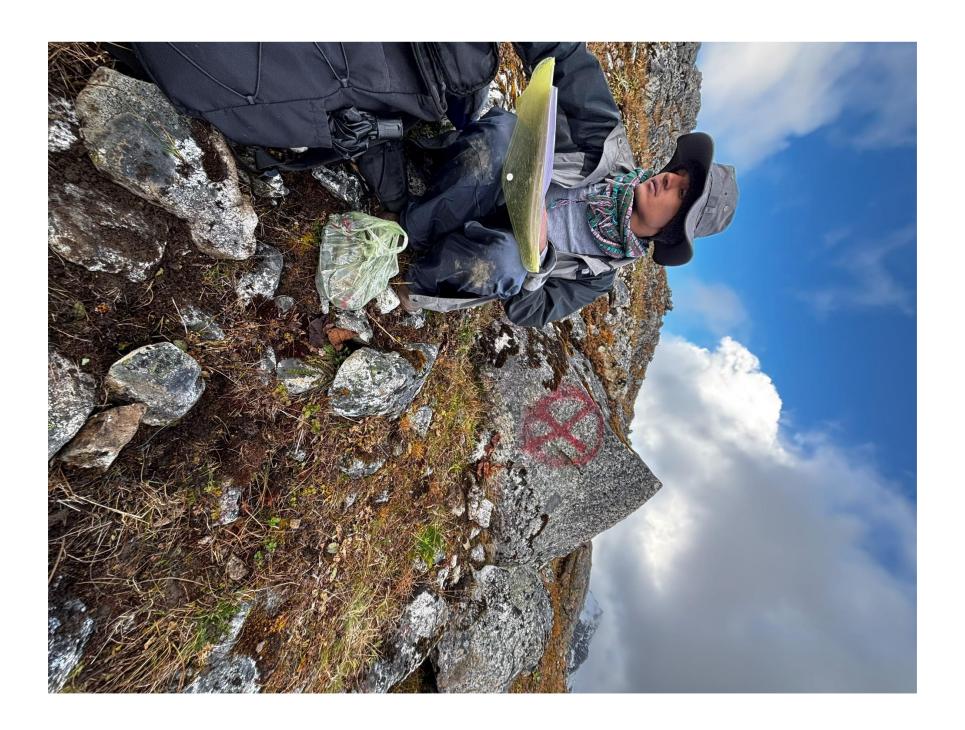
Form No: 11

Sl.No	Parameter Name	Descriptions	Unit
1	Sensor name	BT-RD-LPP7-25-10-15	
2	Sensor type	GeoPrecision M-Log5W-FG2	
3	Serial number	A551F3	
4	Access code	361C	
5	Latitude	27.96720	DD
6	Longitude	89.58867	DD
7	Elevation	4932	m
8	Launch date & time	Date: 15/10 /2025 Time: 16:50	Local
9	Data recording date & time	Date: 15/10 /2025 Time: 10:50	UTC
10	Aspect	West	
11	Slope	20	degrees
12	Sensor depth	20	cm
13	Photographs	Yes [x] No [] Name & Affiliation: Dr. Sonam Wangchuck, ICIMOD	
14	Site description and remark (if any)	 The sensor is installed on a mixed substrate co-dominated by boulders, moist mineral soil, and gravel. Sensor is placed towards west at a distance of 1.35m from the marker. During configuration, the time deviation was -1 sec. Photo was taken, towards west direction from the sensor.

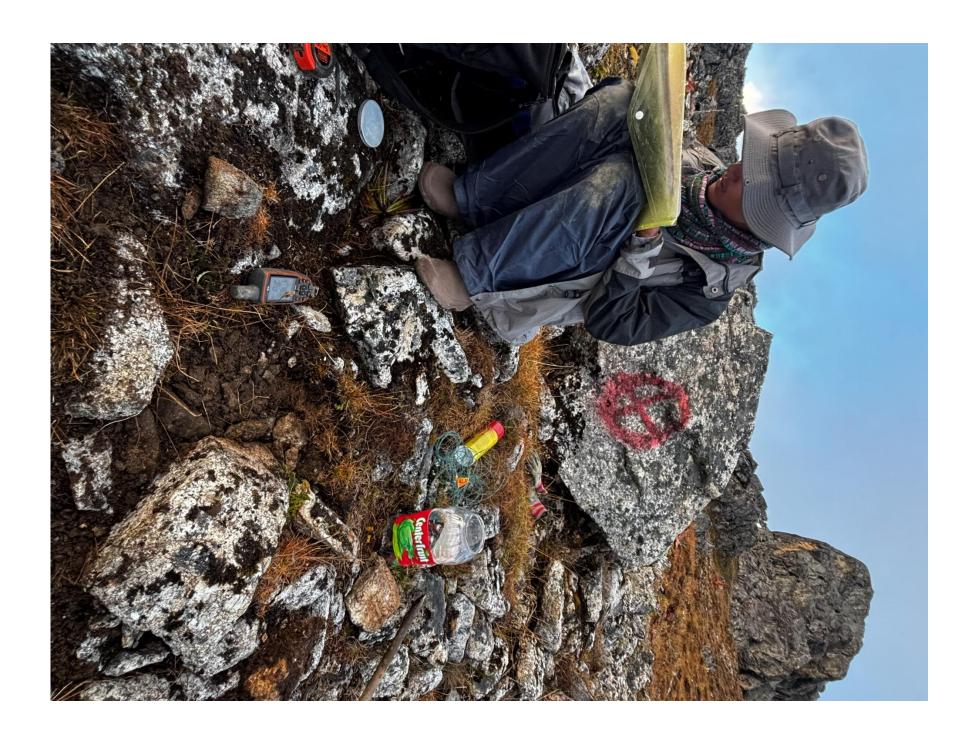
Form No: 12

Sl.No	Parameter Name	Descriptions	Unit
1	Sensor name	BT-RD-LPP8-25-10-15	
2	Sensor type	GeoPrecision M-Log5W-FG2	
3	Serial number	A551F7	
4	Access code	F51D	
5	Latitude	27.96452	DD
6	Longitude	89.58661	DD
7	Elevation	4911	m
8	Launch date & time	Date: 15/10 /2025 Time: 17:21	Local
9	Data recording date & time	Date: 15/10 /2025 Time: 11:21	UTC
10	Aspect	South-West	
11	Slope	20	degrees
12	Sensor depth	20	cm
13	Photographs	Yes [x] No [] Name & Affiliation: Dr. Sonam Wangchuck, ICIMOD	
14	Site description and remark (if any)	 The sensor was installed within a boulder-dominated area; it is seated in moist mineral soil and buried beneath coarse rock/gravel. Sensor is placed towards south-west at a distance of 1.5m from the marker. During configuration, the time deviation was 0 sec. Photo was taken, towards north-east direction of the marker.

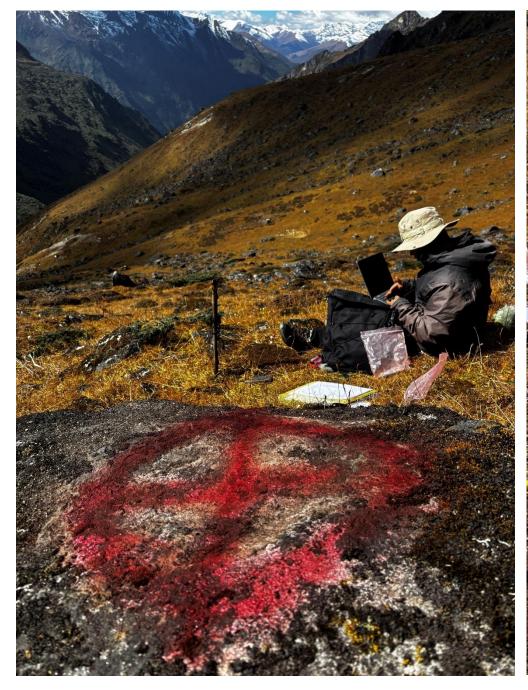
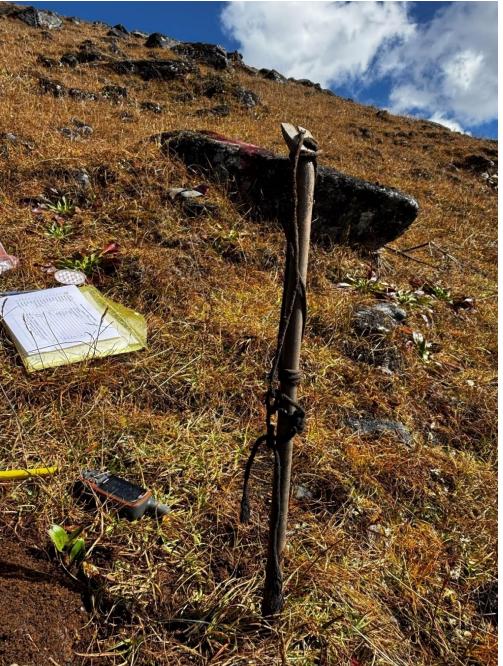
Form No: 13

Sl.No	Parameter Name	Descriptions	Unit
1	Sensor name	BT-RD-LPP9-25-10-16	
2	Sensor type	GeoPrecision M-Log5W-FG2	
3	Serial number	A551FA	
4	Access code	30DC	
5	Latitude	27.95321	DD
6	Longitude	89.58531	DD
7	Elevation	4665	m
8	Launch date & time	Date: 16/10 /2025 Time: 09:49	Local
9	Data recording date & time	Date: 16/10 /2025 Time: 03:49	UTC
10	Aspect	South-West	
11	Slope	40	degrees
12	Sensor depth	20	cm
13	Photographs	Yes [x] No [] Name & Affiliation: Dr. Sonam Wangchuck, ICIMOD	
14	Site description and remark (if any)	 The sensor is sited in mixed rock–soil terrain with grasses only and no snow. It is positioned at the soil–boulder boundary but embedded in moist mineral soil free of rock or gravel inclusions. Sensor is installed towards south-west at a distance of 1.65m from the marker. During configuration, the time deviation was -2 sec. Photo was taken, towards north-east direction of the marker.

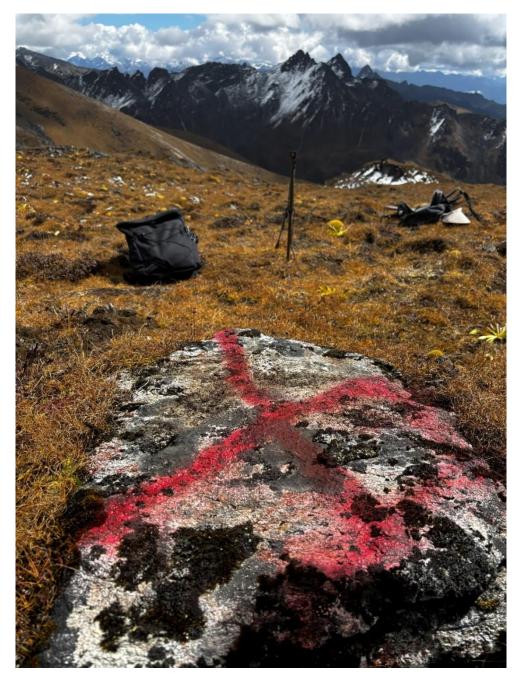
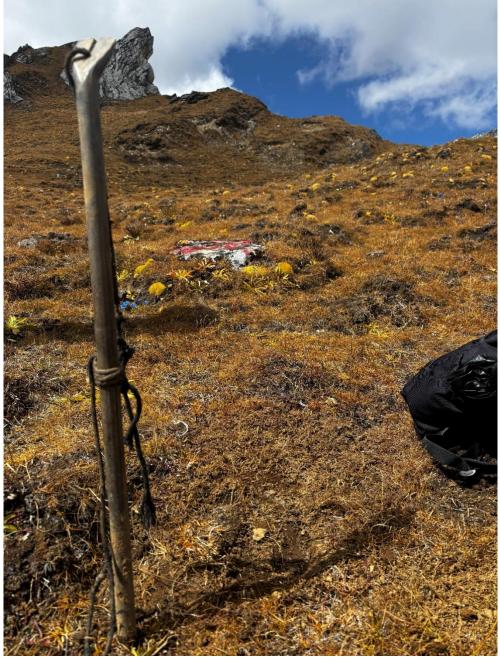
Form No: 14

Sl.No	Parameter Name	Descriptions	Unit
1	Sensor name	BT-RD-MPP3-25-10-16	
2	Sensor type	GeoPrecision M-Log5W-FG2	
3	Serial number	A551F1	
4	Access code	F79D	
5	Latitude	27.95581	DD
6	Longitude	89.57556	DD
7	Elevation	4855	m
8	Launch date & time	Date: 16/10 /2025 Time: 11:06	Local
9	Data recording date & time	Date: 16/10 /2025 Time: 05:06	UTC
10	Aspect	South-East	
11	Slope	5	degrees
12	Sensor depth	20	cm
13	Photographs	Yes [x] No [] Name & Affiliation: Dr. Sonam Wangchuck, ICIMOD	
14	Site description and remark (if any)	 The sensor is sited in a soil-dominated microsite with low shrub and moss cover, with no snow present at the time of installation. The substrate is moist mineral soil lacking coarse rock or gravel inclusions, providing good probe contact and minimal thermal shading from vegetation. Sensor is installed towards south-west at a distance of 1.71m from the marker. During configuration, the time deviation was -1 sec. Photo was taken, towards south-west direction from the marker.

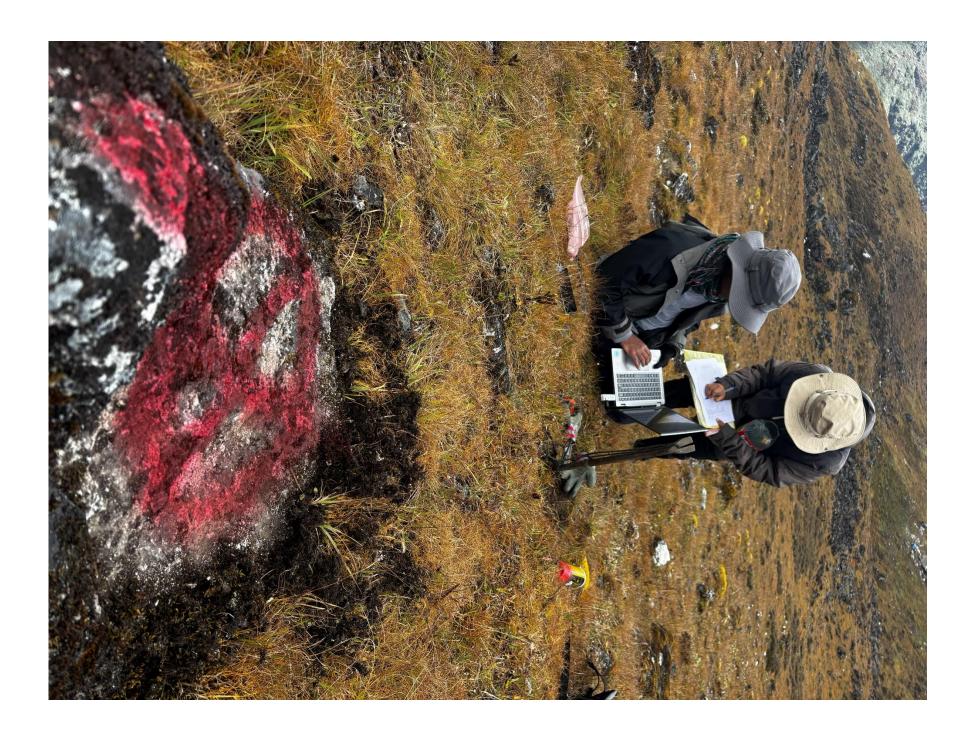
Form No: 15

Sl.No	Parameter Name	Descriptions	Unit
1	Sensor name	BT-RD-LPP10-25-10-16	
2	Sensor type	GeoPrecision M-Log5W-FG2	
3	Serial number	A551F2	
4	Access code	F6DD	
5	Latitude	27.95609	DD
6	Longitude	89.58194	DD
7	Elevation	4776	m
8	Launch date & time	Date: 16/10 /2025 Time: 12:12	Local
9	Data recording date & time	Date: 16/10 /2025 Time: 06:12	UTC
10	Aspect	South-West	
11	Slope	40	degrees
12	Sensor depth	20	cm
13	Photographs	Yes [x] No [] Name & Affiliation: Dr. Sonam Wangchuck, ICIMOD	
14	Site description and remark (if any)	 The sensor is sited in a shrub- and moss-covered area with scattered surrounding boulders. The substrate is moist mineral soil containing coarse aggregates (gravel), ensuring firm seating. Sensor is installed towards south-west at a distance of 1.2m from the marker. During configuration, the time deviation was -2 sec. .

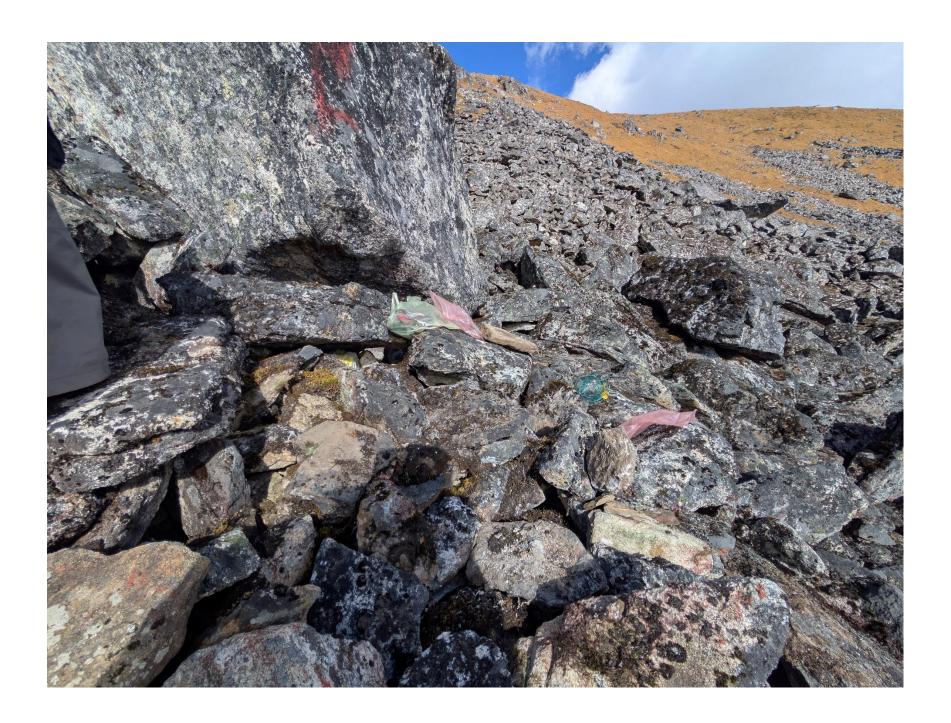
Form No: 16

Sl.No	Parameter Name	Descriptions	Unit
1	Sensor name	BT-RD-LPP11-25-10-16	
2	Sensor type	GeoPrecision M-Log5W-FG2	
3	Serial number	A551EE	
4	Access code	3FDC	
5	Latitude	27.95858	DD
6	Longitude	89.58798	DD
7	Elevation	4726	m
8	Launch date & time	Date: 16/10 /2025 Time: 14:25	Local
9	Data recording date & time	Date: 16/10 /2025 Time: 08:25	UTC
10	Aspect	South-West	-
11	Slope	30	degrees
12	Sensor depth	20	cm
13	Photographs	Yes [x] No [] Name & Affiliation: Tshewang Jamtsho, NCHM	
14	Site description and remark (if any)	 The sensor is installed within a boulder-only substrate, with no soil or snow present at the site. It is buried 20 cm deep among small gravel and boulder fragments. Sensor is installed towards south-west at a distance of 1m from the marker. The photograph was taken in north-west towards the marker. During configuration, the time deviation was -2 sec.
