**Report on  
Establishment of Interim Manual Flood Monitoring  
Gauges at Dechencholing-Taba Bridge on Thimchhu**

**National Center for Hydrology and Meteorology  
Royal Government of Bhutan  
Thimphu: Bhutan  
June 2021**

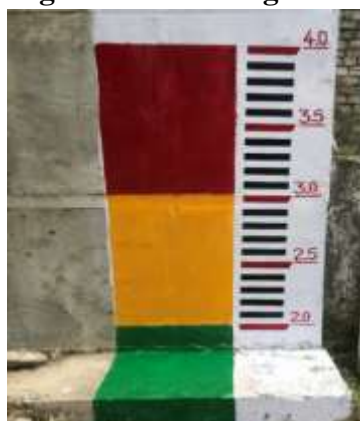
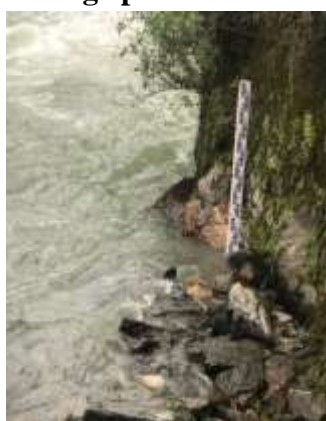
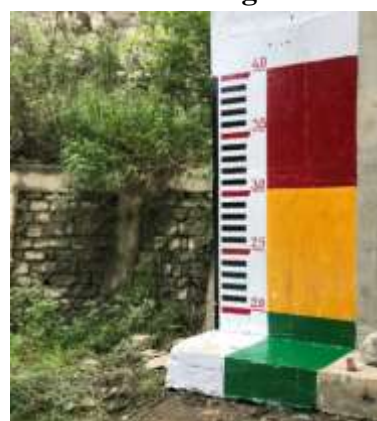
Figure 3: Water level marking at Dechencholing-Taba Bridge with Normal (Green), Alert (Yellow) and Alarm (red) water level

Based on the threshold defined for Alert and Alarm water level from the flood modelling and historical records, the new flood gauge was installed at the abutments of Dechencholing bridge at an altitude 2334.10 meter above sea level, Latitude 27° 31'25.73" N and Longitude 89° 38'43.88" E. The gauge height graduation and marking were done on the bridge foundation wall and threshold levelling was marked with different colour viz: **GREEN** for Normal, **YELLOW** for Alert and **RED** for Alarm are done in both the side of the bridge abutments.

**Right bank of bridge**

**Gauge post**

**Left bank of bridge**

The flood gauge threshold set at Dechencholing bridge are as follows;

Station	Normal level	Alert level	Alarm level
<b>Dchencholing Bridge</b>	<b>&lt; 2.0 m</b>	<b>2.0m = &lt;3.0m</b>	<b>=&gt; 3.0 m</b>
