## Executive Summary

On 9 August 2026, a flood/GLOF (Glacial Lake Outburst Flood) event was reported in the Pachhu sub-basin, Paro. Residents observed the onset of the flood at the source at approximately 11:06 AM, and an associated rise in water level and discharge was recorded at the Bondey principal gauging station (approximately 61 km downstream) at around 11:00 PM the same day, indicating a flood travel time of approximately 12 hours.

Findings indicate that the event did not originate from a breach of Jechu Drake Lake (the main proglacial lake) itself. Rather, it originated from the partial breach of a small, unnamed glacial lake (upper lake) located approximately 2 km upstream of Jechu Drake Lake, beyond the glacier's left lateral moraine. Water released from the upper lake traveled roughly 200 m as visible surface flow before entering the glacier's englacial drainage system, re-emerging approximately 500 m above the main lake, and then flowing into Jechu Drake Lake. This additional inflow raised the main lake's water level by an estimated 25–30 cm and produced a sharp, temporary increase in the lake's outflow discharge, which propagated downstream as the reported flood. Th

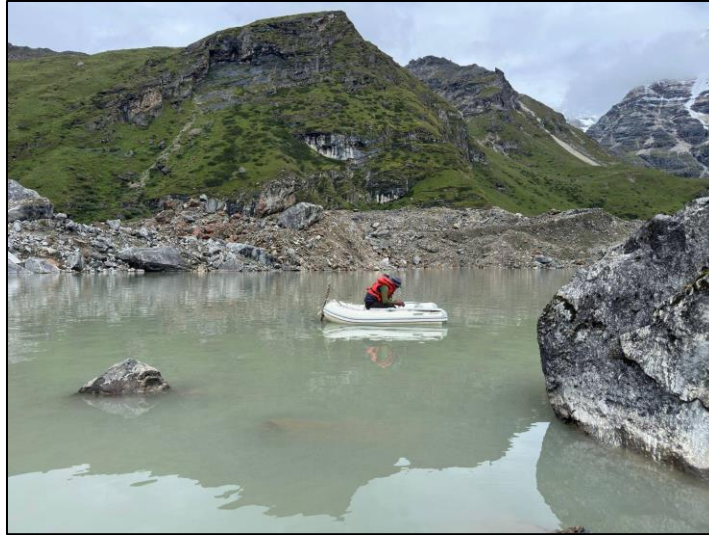
Lake volume is a key parameter in quantifying and assessing hazard from the lake and its potential impact on downstream settlements and infrastructure. A lake bathymetry survey was conducted using a rubber inflatable boat mounted with SONAR GPS-integrated sensors (FISH ELITE) to measure an estimated volume of the lake.

*Figure 3. Bathymetric survey of Jechu Drake Lake using a SONAR/GPS-integrated sensor mounted on an inflatable survey boat.*

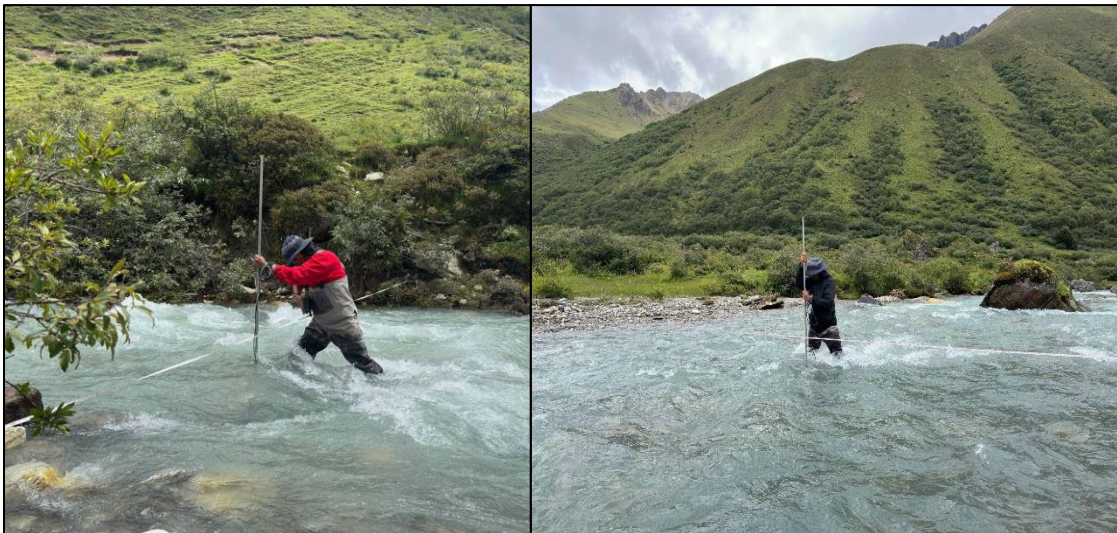
The discharge data indicate the rate of flow of rivers in the channel. Continuous time-series data can be used to investigate and detect rises and falls in flow in a river, which can be correlated with the occurrence of extreme weather events and GLOF events in a catchment or a basin. The discharge measurements were conducted using a current meter by the wading method at a suitable location.

*Figure 4. Discharge measurement by the current-meter wading method at (a) the lake outlet and (b) Jhomolhari base camp.*

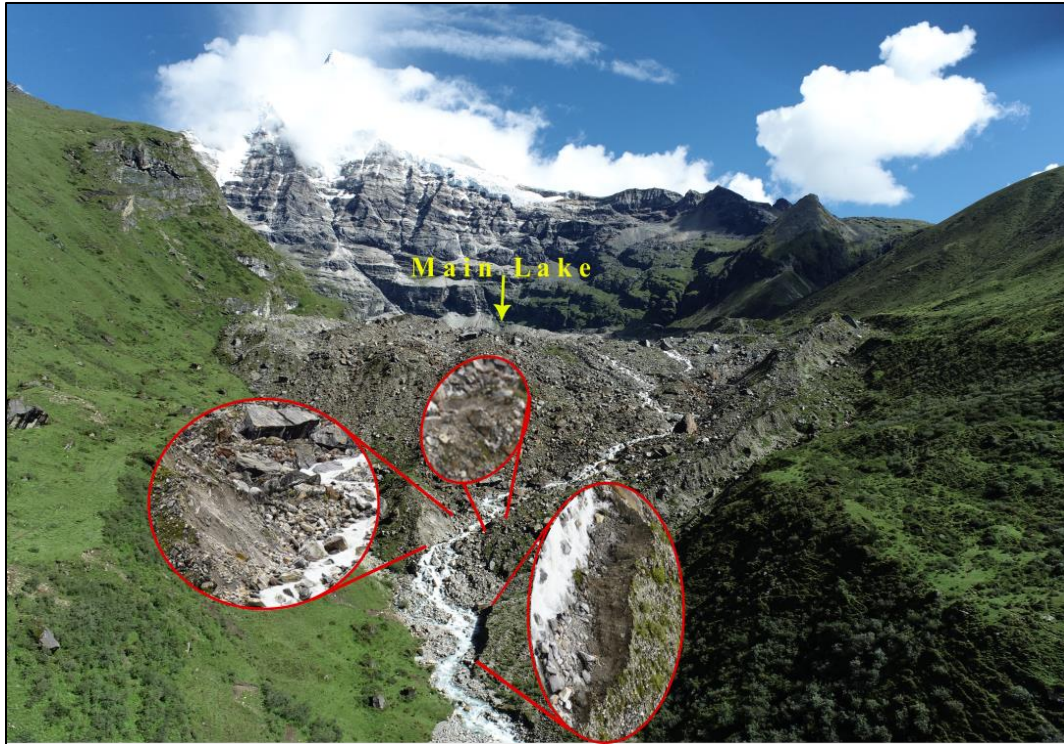
Field observations indicate that no significant erosion, incision, or enlargement of the lake outlet occurred during the event, indicating the main lake outlet remained comparatively stable. This also indicates that the recent event causing increased downstream discharge was therefore primarily a consequence of the additional inflow generated by the upper lake drainage. This event can be characterized as a secondary flood generated by the rapid transfer of water into the main Jechu Drake Lake, rather than a direct breach of the main lake.

Although the main lake outlet did not undergo significant erosion, multiple localized scour zones were observed at the foot of the damming moraine (Figure 8). These scour features indicate that the sudden increase in discharge generated sufficient hydraulic energy to erode and entrain unconsolidated moraine and/or valley-floor sediments. The resulting sediment entrainment caused a pronounced increase in suspended sediment concentration in the downstream flow. Consequently, the river changed from relatively clear water to a muddy or turbid appearance during the event.

*Figure 8. Localised scour zones observed at the foot of the main lake's damming moraine.*

- e. The scour zones identified at the foot of the main lake's moraine, while currently limited in extent, indicate that the moraine is being incrementally weakened under high-discharge conditions. This is a developing rather than a static condition and warrants continued monitoring rather than treatment as a one-time finding.

7. **Periodic reassessment and monitoring.** Given the dynamic and currently unresolved state of the glacier–moraine–lake system, including continued glacier thinning and active scouring at the main lake moraine, a follow-up field assessment (e.g., annually or after each monsoon season) is recommended, alongside routine maintenance of the automatic monitoring network referenced in Section 2.2.
