# **Report On Rapid Assessment of GLOF Event From Thorthomi Lake on 30<sup>th</sup> October 2023**

**National Centre for Hydrology and Meteorology  
2023**

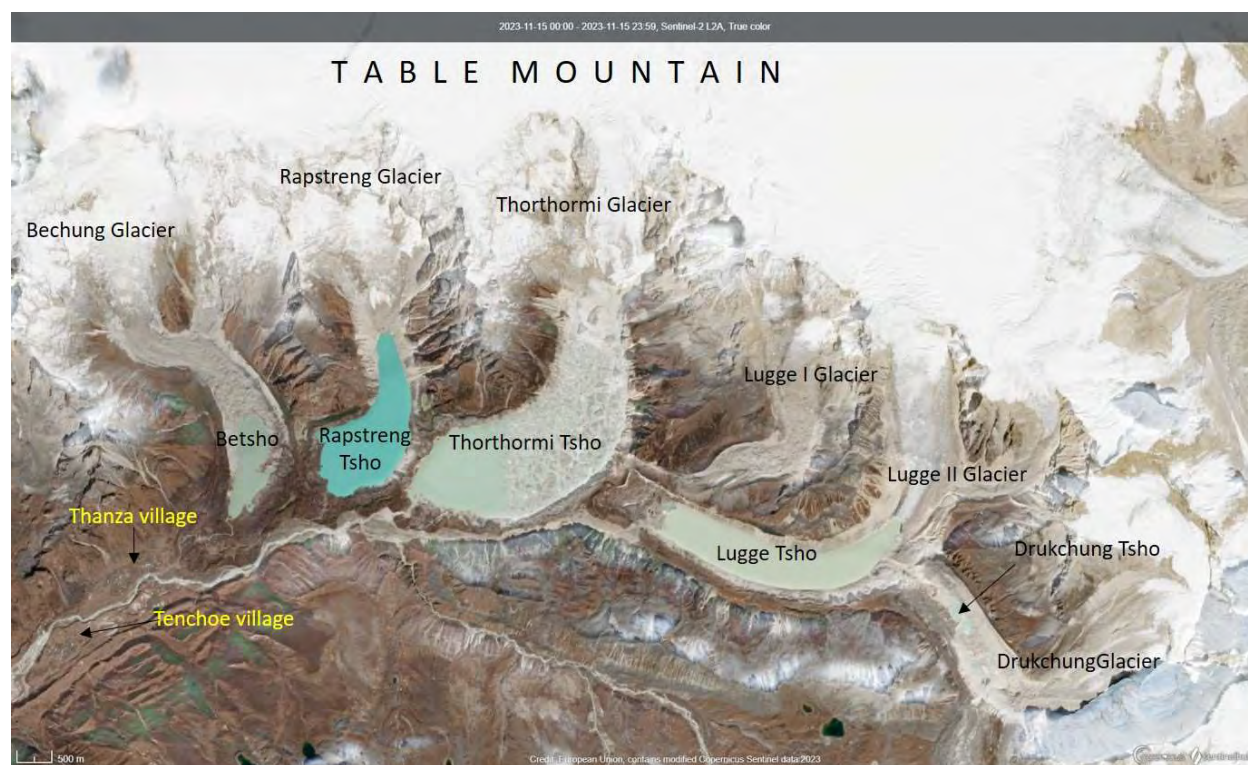
Figure 1: Image showing glaciers and glacial lakes along with the location of 2 most upstream village (Thanza & Tenchoe)

There are 6 main glaciers and 5 glacial lakes in Lunana (fig.1). Due to the close proximity of the glaciers and glacial lakes in terms of location to each other and also different behavioral characteristics of the glaciers and glacial lakes the area is commonly called Lunana complex. Four of the glacial lakes (Druk Chung, Lugge, Thorthormi and Rapstreng tshos) are categorized as potentially dangerous glacial lakes. Considering high level of Glacial Lake Outburst Flood (GLOF) hazard from these lakes, risk lowering work through artificial lowering of lake water level was carried out on two of these lakes in Lunana area (Rapstreng and Thorthormi) from 1996-1998 and 2009 – 2012 respectively. In addition, GLOF Early Warning System (GLOF EWS) were also installed in Puna Tsang Chu, Mangde Chu and Chamkhar river basins.

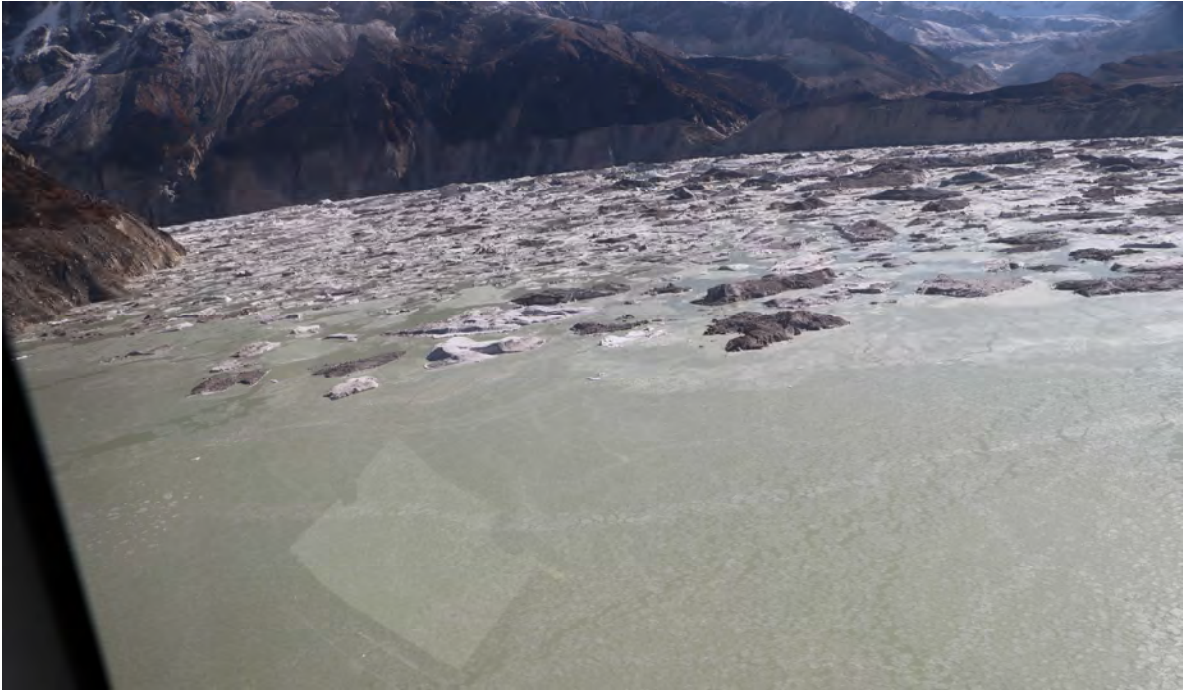
**Photo 1: Disintegrated Thorthormi glacier (view to the upstream)**

glacier body which existed in the upper part of Thorthormi glacier got disintegrated into ice blocks and found floating (Photo 1). The lower half of Thorthormi glacier which used to be covered with ice blocks and ice cliffs with supra glacial ponds in-between has turn into complete water mass (Photo 2) unlike in the past years. Floating disintegrated ice masses/ ice blocks were found to be concentrated the upper part of Thorthormi lake.

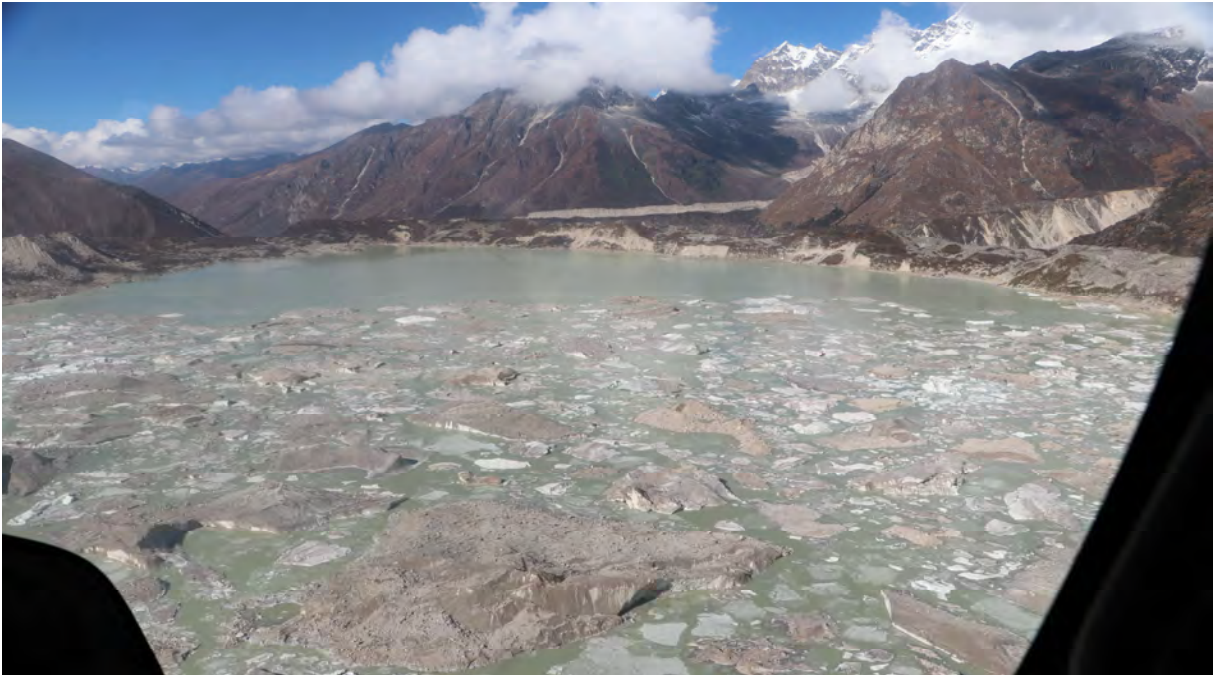
**Photo 2: Lower part of Thorthormi tsho (view towards downstream/outlet)**

- a. Almost whole of the ablation region of Thorthormi glacier has turn into water body. Upper half of the lake has ice blocks floating on water and lower half of the lake appear to be completely water body (Photo 2,5 and 11).

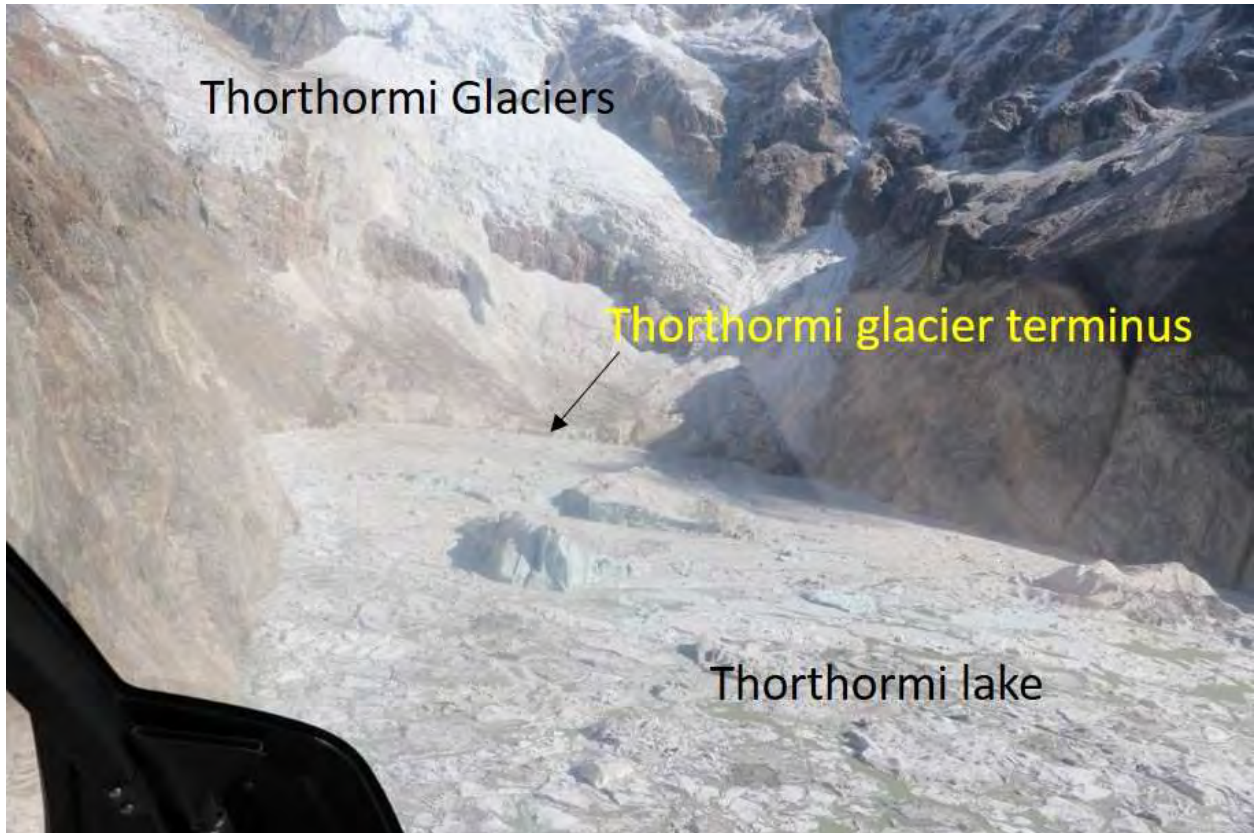
**Photo 3: Extreme upper part of Thorthormi Tsho**

At the extreme upper part of Thorthormi glacier it was observed that Thorthormi lake now has reached almost to the bed rock similar to Rapstreng Tsho. The terminus of Thorthormi glacier has shifted right at the edge of steep rock wall which lie at the base of Table mountain. It was also observed that the terminus of Thorthormi glacier which is clearly visible is in direct contact with the lake (Photo 3).

- b. The edge of the lake boundary has almost reached the steep bed rock of the table mountain where terminus part of Thorthormi glacier occupies only a small portion clearly visible in photo 3 and 12). Due to such morphological condition of the lake (close proximity of the lake boundary to steep bed rock) the probability of mass movement (avalanche/icefall/rock fall) from the accumulation impacting the lake directly is higher which may result in similar events in the future.

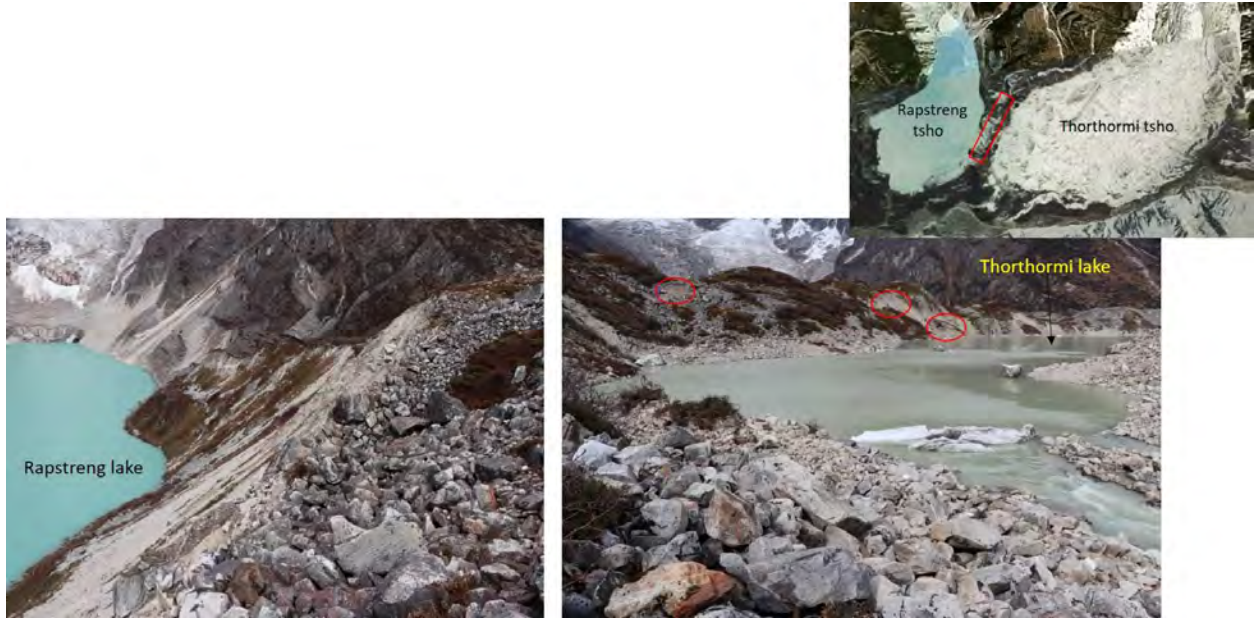
**Photo 4: Moraine barrier between Rapstreng tsho and Thorthormi tsho**

Fresh scars of mass movement (landslides) were noticed on the slope facing Thorthormi lake as indicated in red circles (Photo 4). Except for erosional marks which might have taken place during last summer, no signs of major fresh mass movements were observed on the slope facing Rapstreng tsho. In addition, the team also scanned the top of the moraine barrier ridge for any new signs of crack development and any unusual activities from the recent incident. No major mass movement both on Rapstreng and Thorthormi side were found except for few minor slides that were observed on the slope facing Thorthormi tsho. There were also no major cracks seen on the top of the moraine barrier ridge.

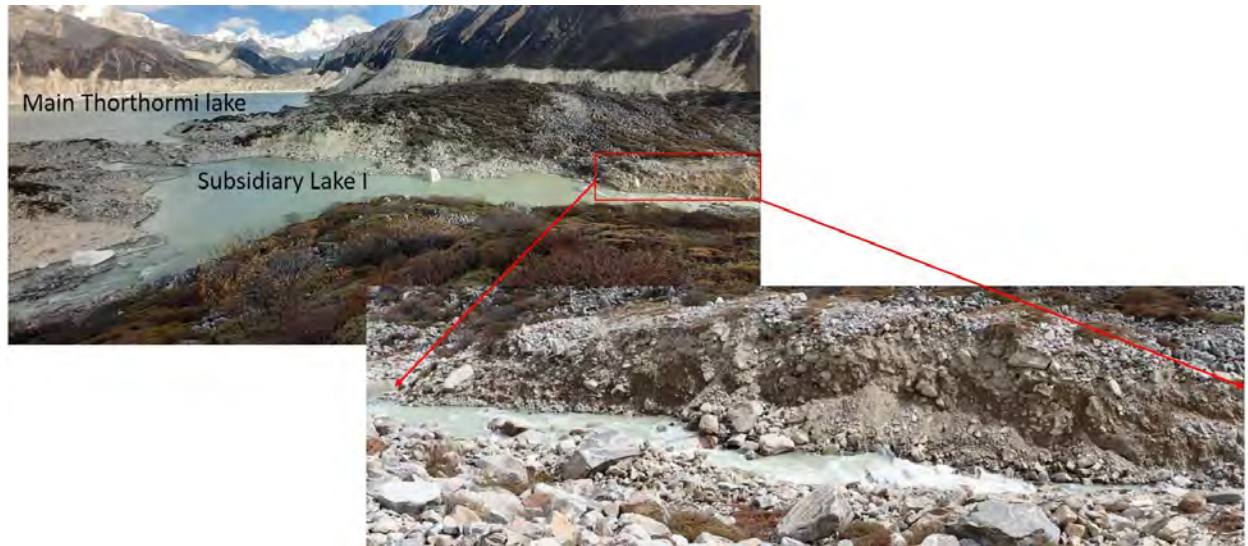
Due to the high-water flow in the channel during the recent incident lot of side erosion and also scouring of channel bed was observed (Photo 6). A scouring of around 40 cm channel bed was observed.

Photo 6: Erosion and scouring in the channel between subsidiary lake I and subsidiary lake II

- d. No signs of major impact from the recent event was observed on the moraine barrier between Thorthormi and Rapstreng tsho.
- e. Lot of erosion and scouring has taken place in the channels downstream of subsidiary lake I (Photo 6).

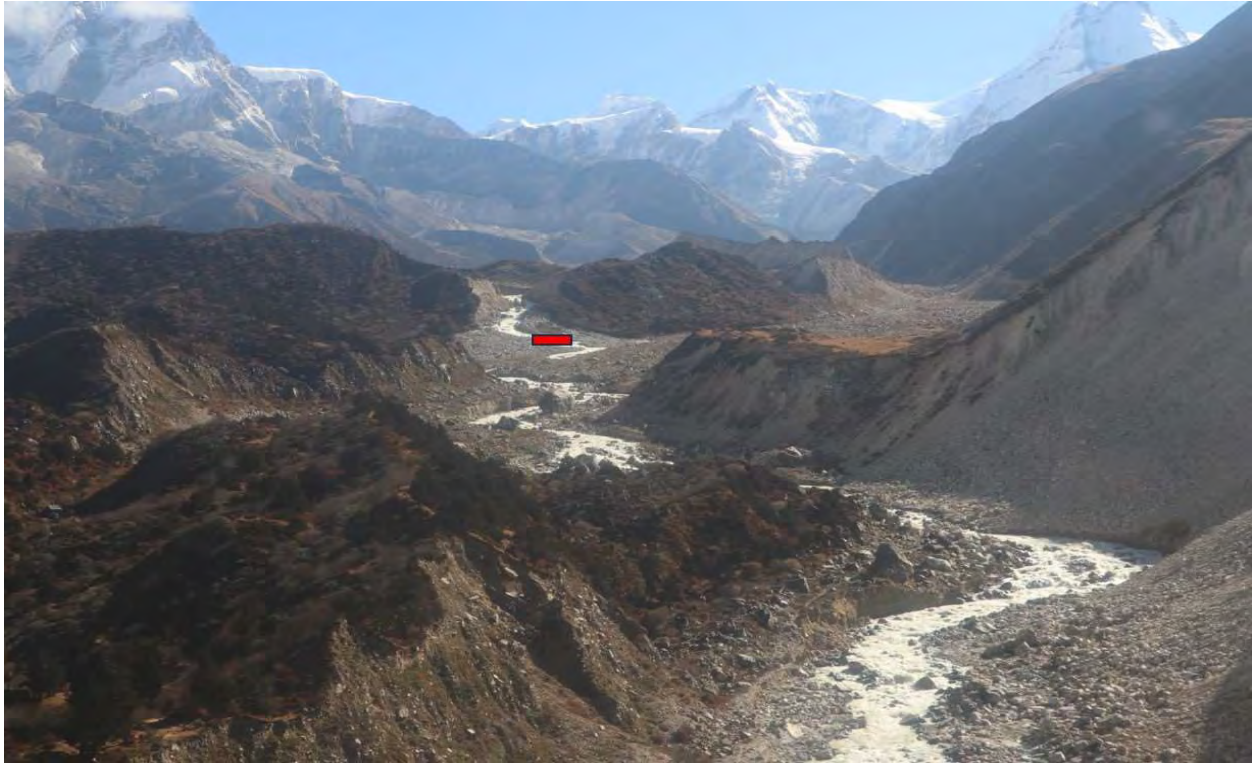
**Photo 9: Location of foot bridge on Thorthormi outlet**

The foot bridge over the stream which flows out from the Thorthormi lake was completely washed off (Photo 9). This bridge serves as an important means of communication for the locals of Thanza village especially to take their yaks to their winter grazing area near Lugge tsho. The bridge is also important for the staffs of NCHM posted in Lunana to conduct regular lake monitoring on Lugge tsho.

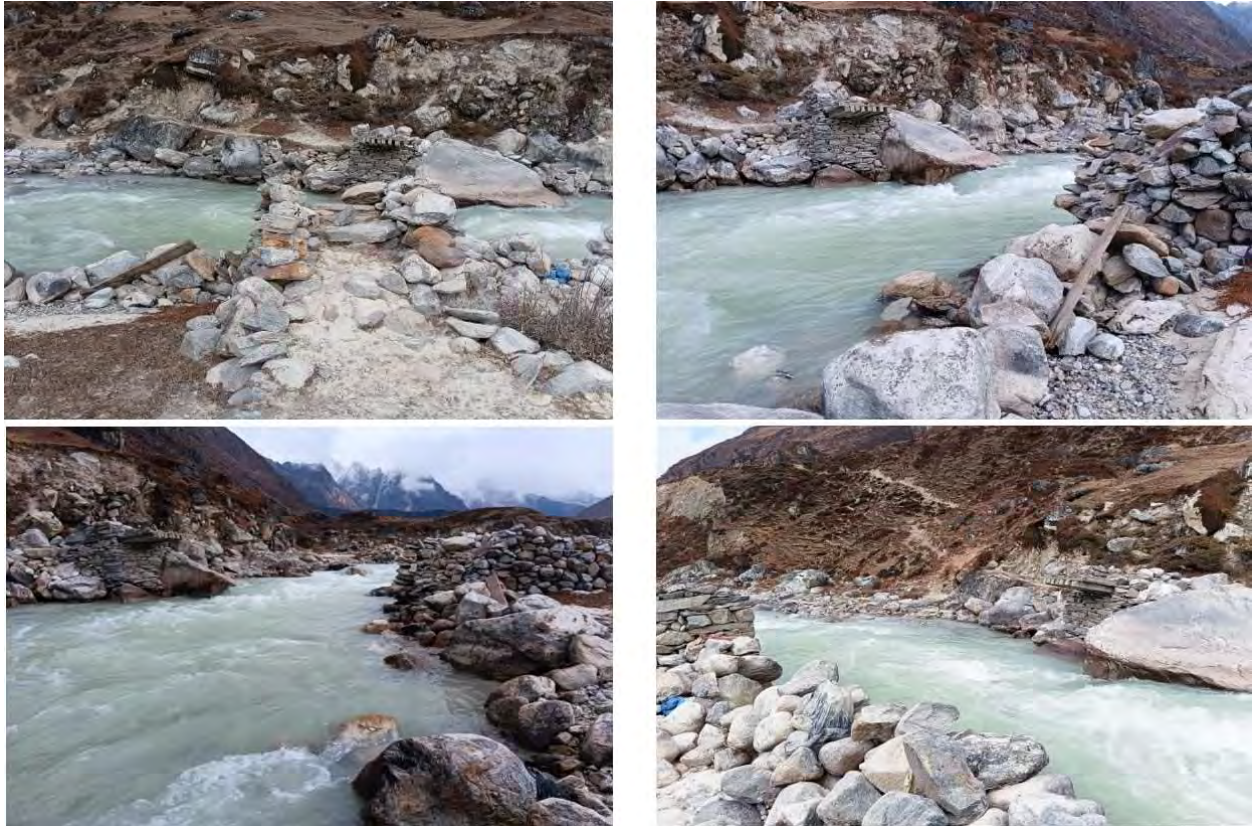
This bridge is located in downstream of the lakes between the village of Tenchoe and Dota. Based on the information from the local people, it was also badly damaged during the recent incident (Photo 10).

**Photo 10: Damaged bridge between Tenchoe and Dota village**

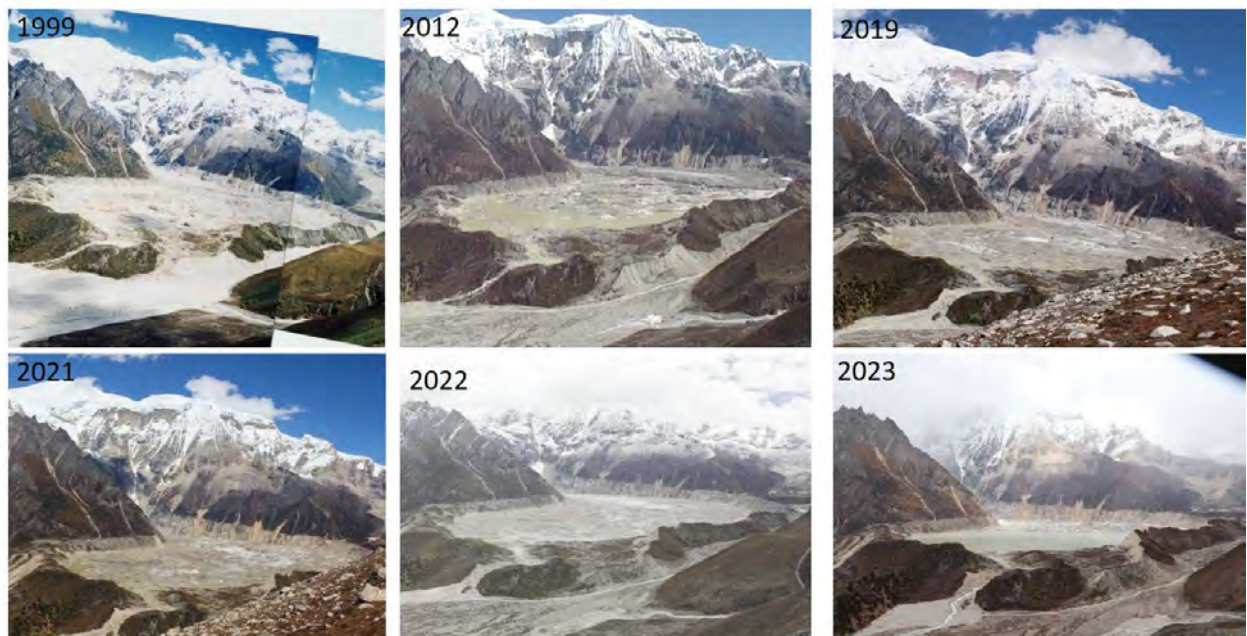
**Photo 11: Time series changes on the surface of Thorthormi glacier from 1999 to 2023.**

Time series changes that are visible on the surface of Thorthormi glacier from 1999 till 2023 is shown in photo 11. Recent changes that have taken place in the extreme part of Thorthormi glacier are shown in photo 12. Current condition of the main Thorthormi lake outlet along with subsidiary lake I are shown in photo. Based on the assessment conducted by the rapid assessment team after the recent incident, important points are highlighted in the following section:

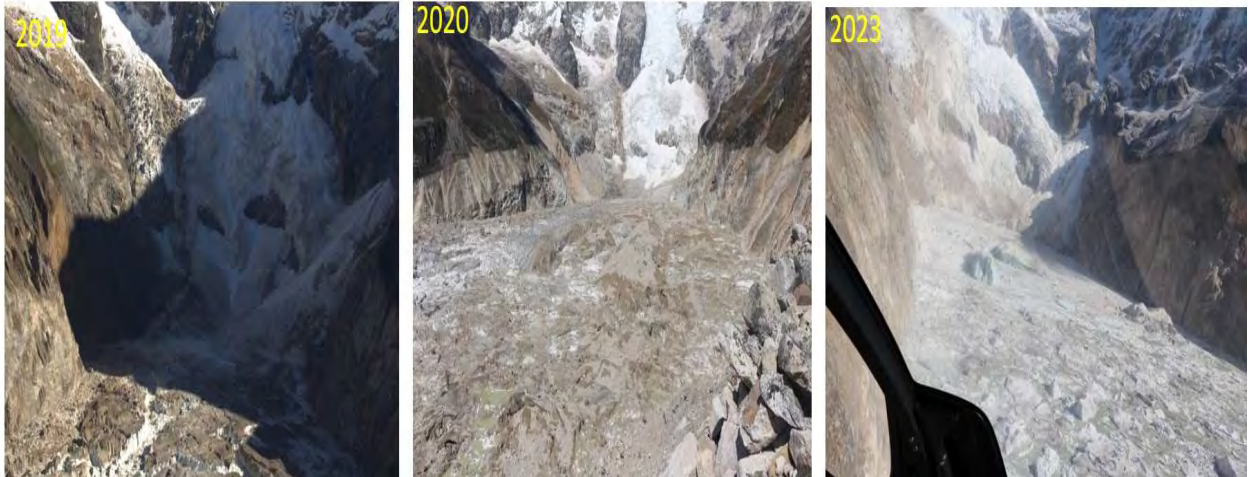
**Photo 12: Recent changes at the extreme upper part of Thorthormi glacier**

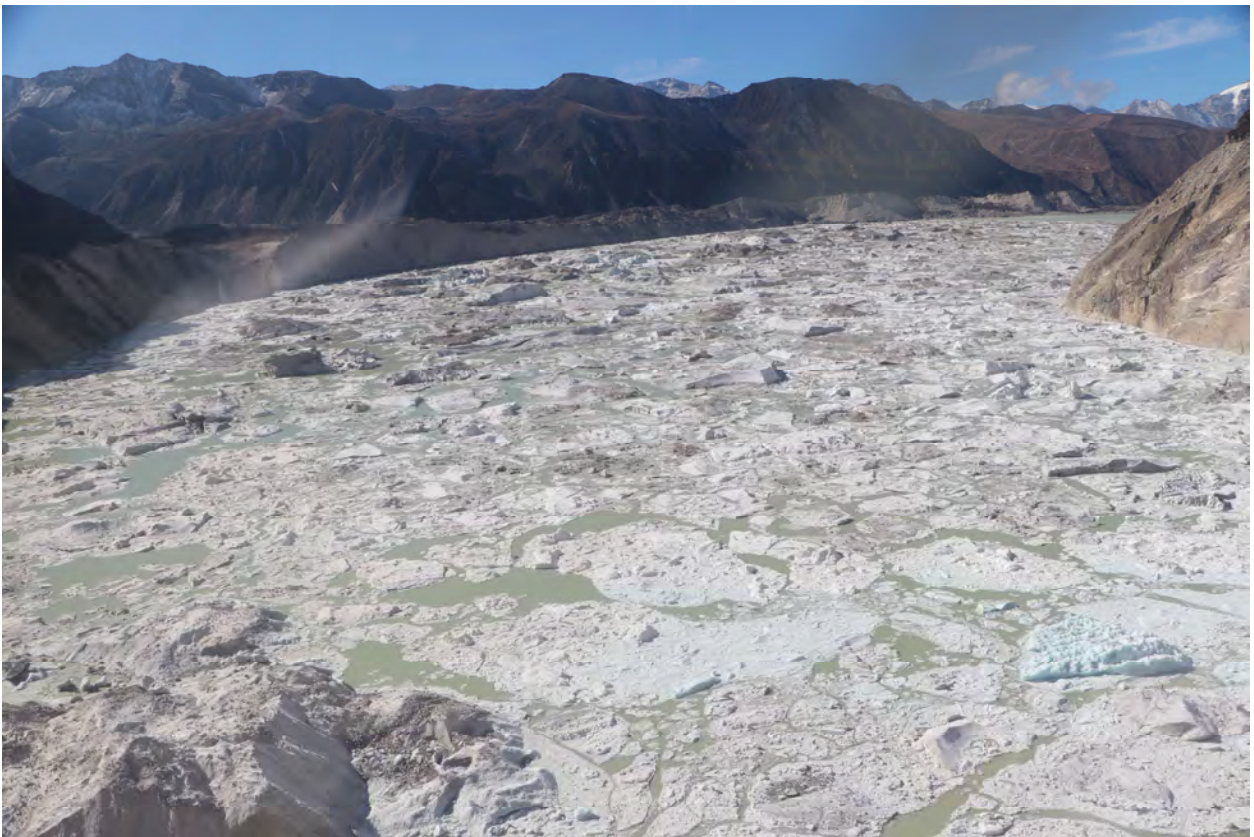
**Photo 13: Surface of Thorthormi glacier**
