# Reassessment of Potentially Dangerous Glacial Lakes in Bhutan

**NATIONAL CENTER FOR HYDROLOGY AND METEOROLOGY  
ROYAL GOVERNMENT OF BHUTAN**

**2019**

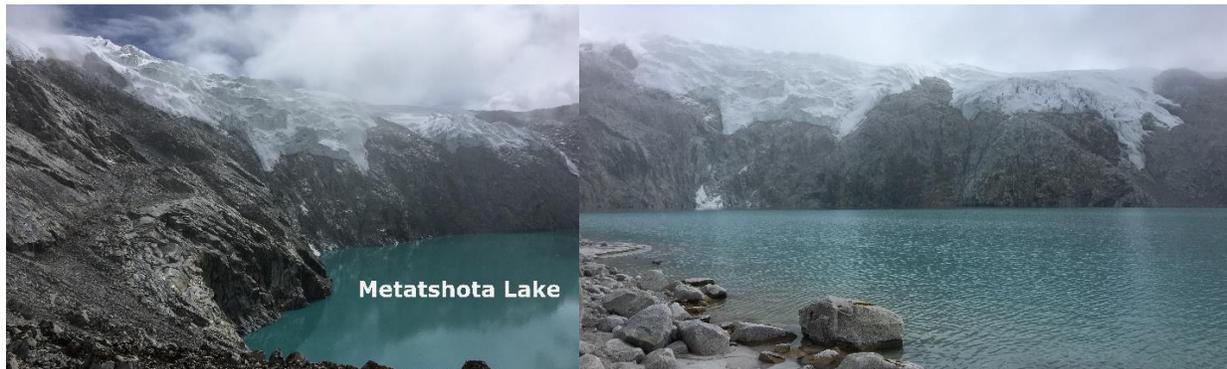
- It has the large surface area
- It has large amount of water stored
- Large area of hanging glacier which wastes the mass in the form of ice fall into the lake (Fig.3.18)

**Figure 3.18:** *Metatshota lake with hanging glacier above (Mo\_gr 5)*

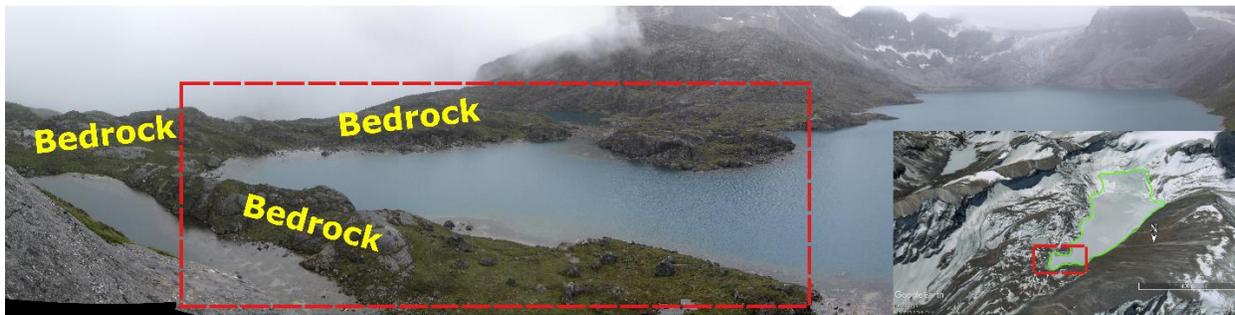
**Figure 3.25:** Panoramic view of Cham\_gl 198 (Phudung Tsho) lying completely in a bedrock topography. Dotted red box show the location of the lake outlet
