**ASSESSMENT REPORT OF SAMTELLING CHHU  
FOR FLOOD HAZARD AND ASSOCIATED RISKS**

**NATIONAL CENTRE FOR HYDROLOGY AND METEOROLOGY  
ROYAL GOVERNMENT OF BHUTAN  
THIMPHU: BHUTAN  
SEPTEMBER 2024**

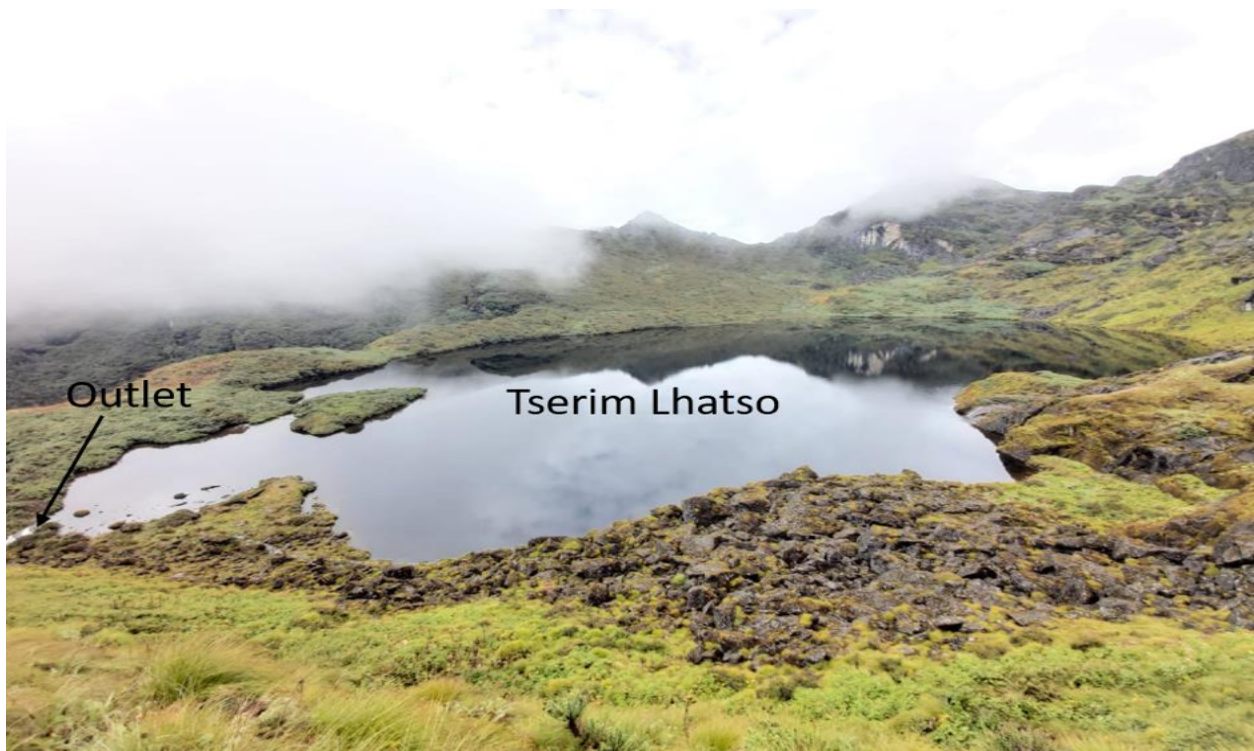
**Photo 2: View of Tserim Latso (Genyen Latso)**

Tserim Lhatsho was formed in a cirque-like landform towards the base of Yangse La (4480 masl) which now is surrounded by solid bed rocks belonging to Thimphu group mainly consisting of quartzite, schist interbedded with gneiss and occasionally some mafic rocks towards the base of the valley. (Photo 2 and Photo 3). The details of the rock attitude is shown in Figure 2.

Normally fresh water mountain lakes exist as water bodies with shallow depth unlike other glacial lakes. The surface area varies from lake to lake which is mainly determined by the shape and extent of the area in which the lakes were formed. Tserim Latso and Dheudrip Latso are typical fresh water mountain lakes (Photo 2 and Photo 4).

As shown in Photo 2 and Photo 3, Tserim Latso is located in a landform resembling a cirque near to the base of Yangse La. There are no glaciers or lakes above Tserim Latso feeding the lake. The lake is completely surrounded by solid high grade metamorphic bed rocks mainly consisting of granitic gneiss and schist at the top (near the outlet) which is underlined by quartzite and a thin band of mafic rock towards the valley bottom. The dip amount of the rocks ranges from 12 degree to 37 degree with dip direction towards NW (into the slope) and striking NE. The dip direction towards NW coincides with the direction of rocks dipping into the slope which is a good indicator of stable slope. As such no major fracture or shear zones are observed on the rock face surrounding the lake. There were also no major seepages observed downstream of the natural outlet of the lake. All these features indicate that Tserim Latso is quite stable and it is very unlikely that the damming materials surrounding the lake will fail and breach resulting in an instantaneous flooding situation.

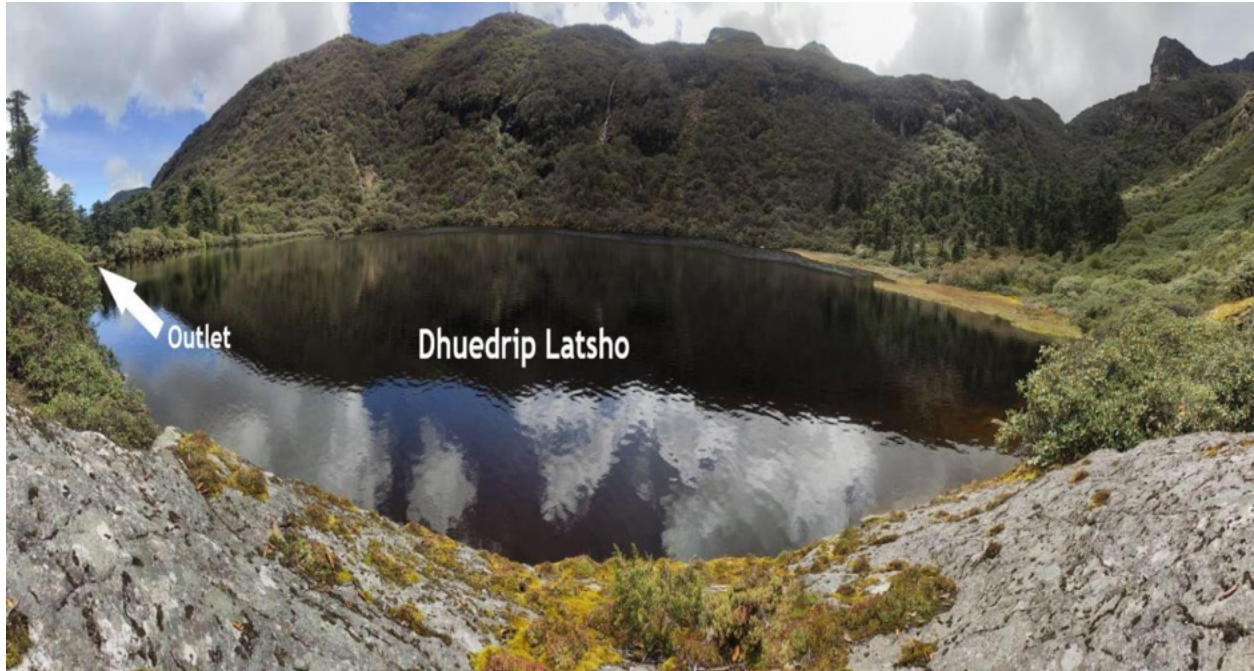
*Photo 4: View of Dhuedrip Lhatsho*

Dhuedrip Latso or Didrip Tso is the major lake lying in the headwaters of the main western branch of Samteling Chu. The lake is located at a distance of one day trek from Tserim Lhatsho crossing Yangse La (4480 masl). The lake is formed within a cirque landform at a tree line elevation of 3928 m.a.s.l. (Photo 4). Except at the outlet area, the lake is surrounded by solid rock mainly of Thimphu group; quartzite and gneiss. Since it is formed in a cirque the lake is dammed by frontal moraine in the outlet area where the natural outlet exists at present. The lake measures 38744.4 m<sup>2</sup> (0.039 km<sup>2</sup>) in surface area.

Dheudrip Latso is a cirque lake indicating that the lake was formed through collection of water in a cirque which was created through glacial activity in the past. Due to the past glacial activity there is a presence of frontal moraine which is damming the lake and on which the present natural outlet exists. Except for the outlet area, all other sides surrounding the lake are observed to have presence of insitu rock. Although the outlet of the lake lies on the frontal moraine, the downslope from the crest of the terminal moraine was found to be thickly vegetated with trees and bushes. Huge boulders of granitic gneiss and quartzite were also seen on the outer slope of the moraine which are covered with thick lichens and mosses. No major mass movements and seepages were observed on the moraine damming the lake. Presence of thick vegetation and under growth, absence of mass movement and seepage are all indicative of highly stable moraine dam. Similar to Tserim Latso no glaciers and lakes were observed above Dheudrip Latso feeding the lake.

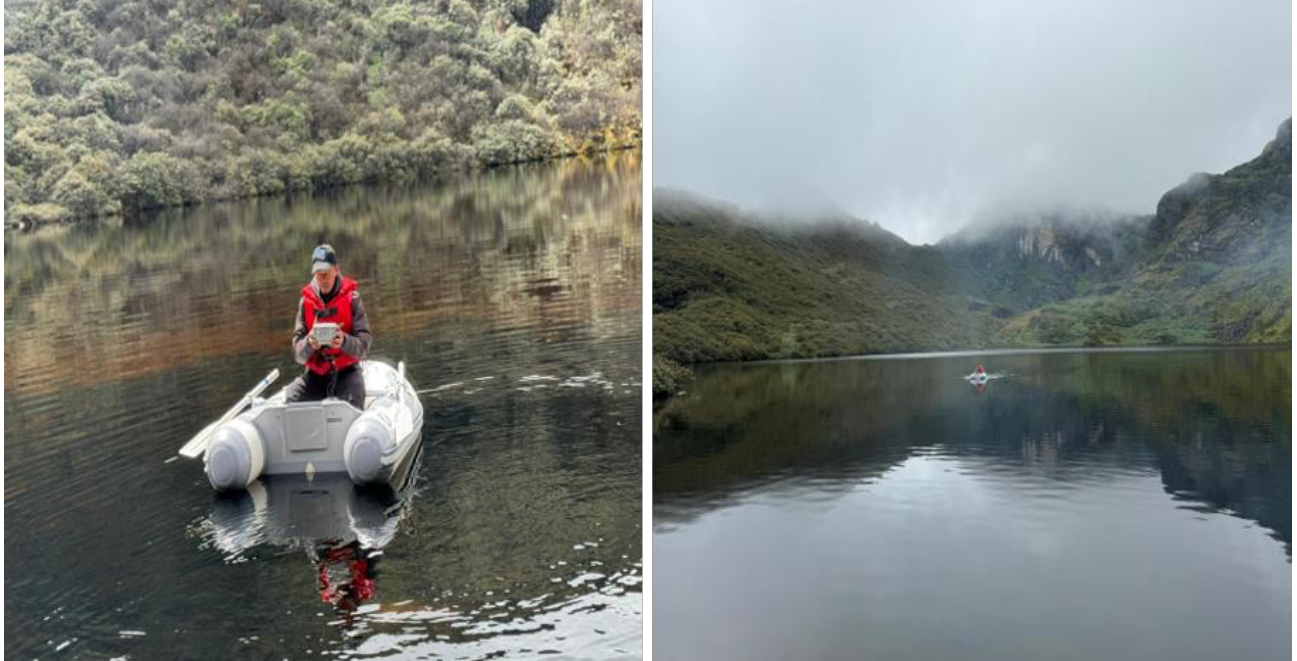
**Photo 6: Bathymetry Survey on Tserim Latso and Dheudrip Latso**

Bottom topography of the lake and volume of water stored in the lake plays an important role in assessing the flood hazard and its impact downstream from any type of lake. Bathymetry survey was conducted on both *Tserim Latso* and *Dhuedrip Latso* using a rubber inflatable boat mounted with SONAR GPS integrated sensors (FISH ELITE) as shown in Photo 6.
