Testing Natural Siphon Technology for GLOF Hazard Reduction: Lessons from Thorthormi Glacial Lake

**NATIONAL CENTRE FOR HYDROLOGY AND
METEOROLOGY**

2025

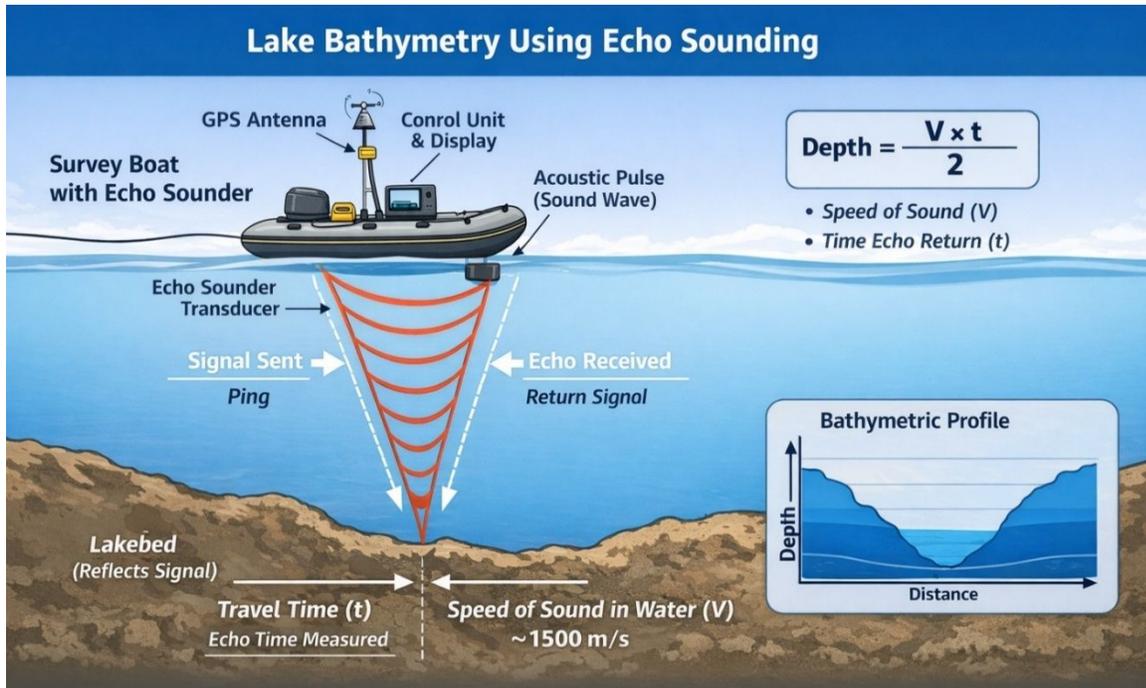
Figure 1: Schematic diagram of lake bathymetry survey

Lake bathymetry survey refers to the systematic measurement and mapping of underwater lakebed topography to determine water depth, lake volume, and basin morphology. Echo sounding is the most widely used technique for bathymetric surveys. It is based on the **transmission and reception of acoustic (sound) waves** through water. An echo sounder mounted on a boat or remotely operated platform emits a short sound pulse vertically downward into the water column. This pulse travels through the water at a known speed (depending on temperature, density, and

salinity). When the sound wave strikes the lakebed, it is reflected back to the transducer as an echo and the lake depth is recorded. The schematic diagram (Fig..) shows the basic concept of how the bathymetry survey is being conducted.

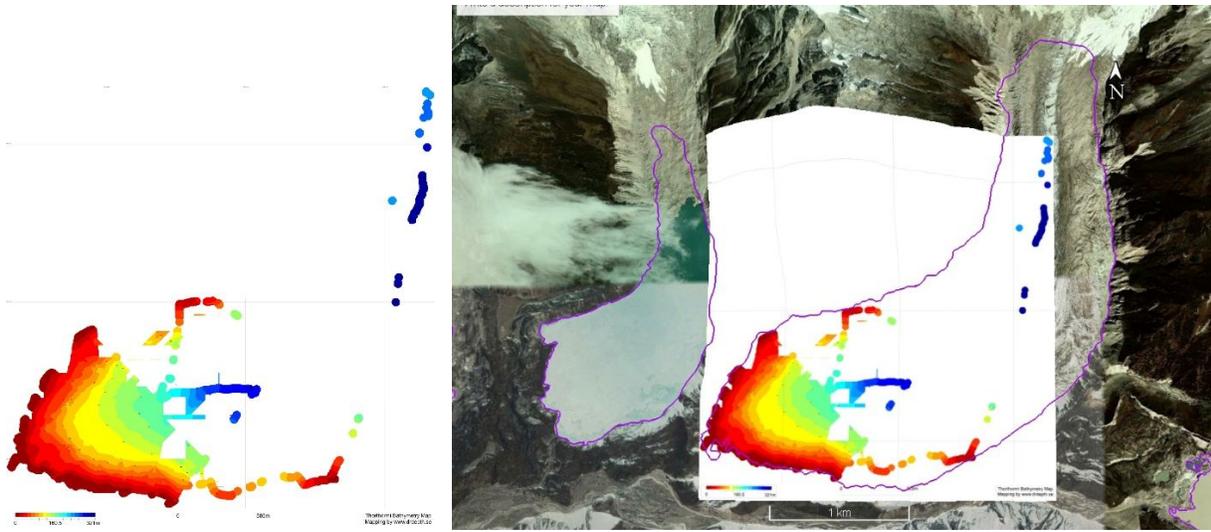
Figure 2: Portion of Lake Bathymetry map of Thorthormi (left) and the same map overlaid on Google Earth image showing the shoreline (purple line) of the lake

The echo sounder (sonar FishElite) integrated with a Geographical Positioning System (GPS) was mounted on an inflatable rubber boat and survey was conducted by navigating the boat on the glacial lake surface. The continuous lake depth data measurements were georeferenced and recorded on control unit. Several consecutive days of survey attempts were made to conduct a complete bathymetry survey. However, high concentrations of suspended sediments (silt) in the lake water, combined with the lake's large depth range, hindered the instrument's performance and prevented full-depth profiling. As a result, only partial bathymetric mapping was achieved, with a **maximum recorded depth of 326 m** as shown in Figure 2.

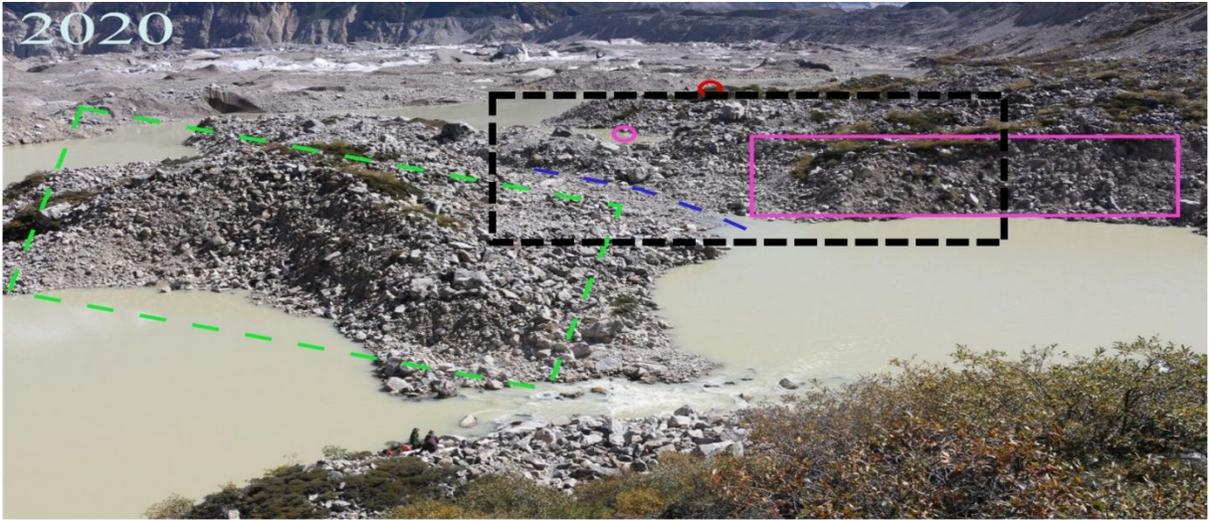
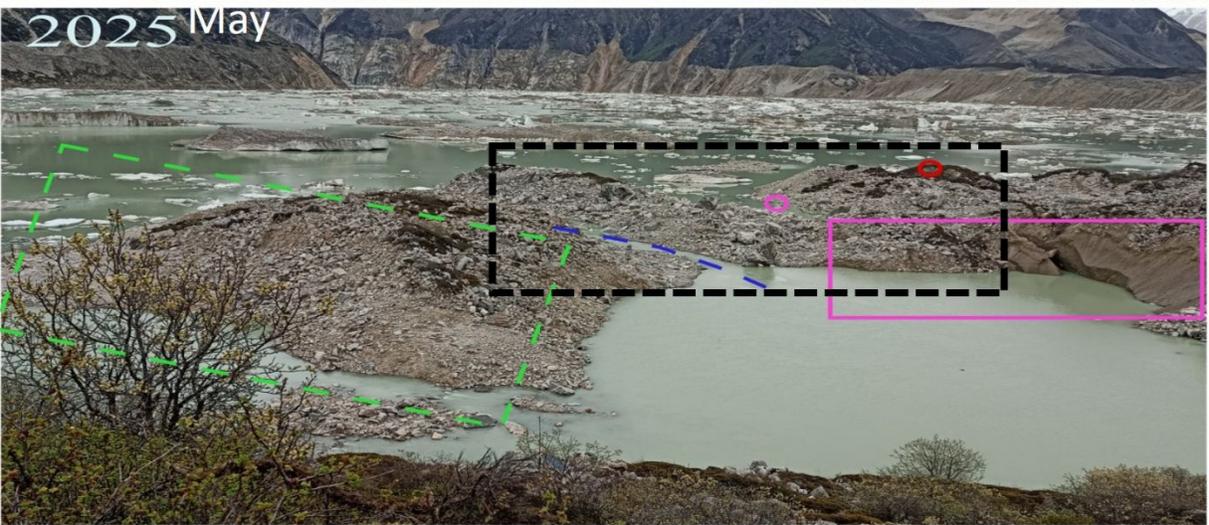
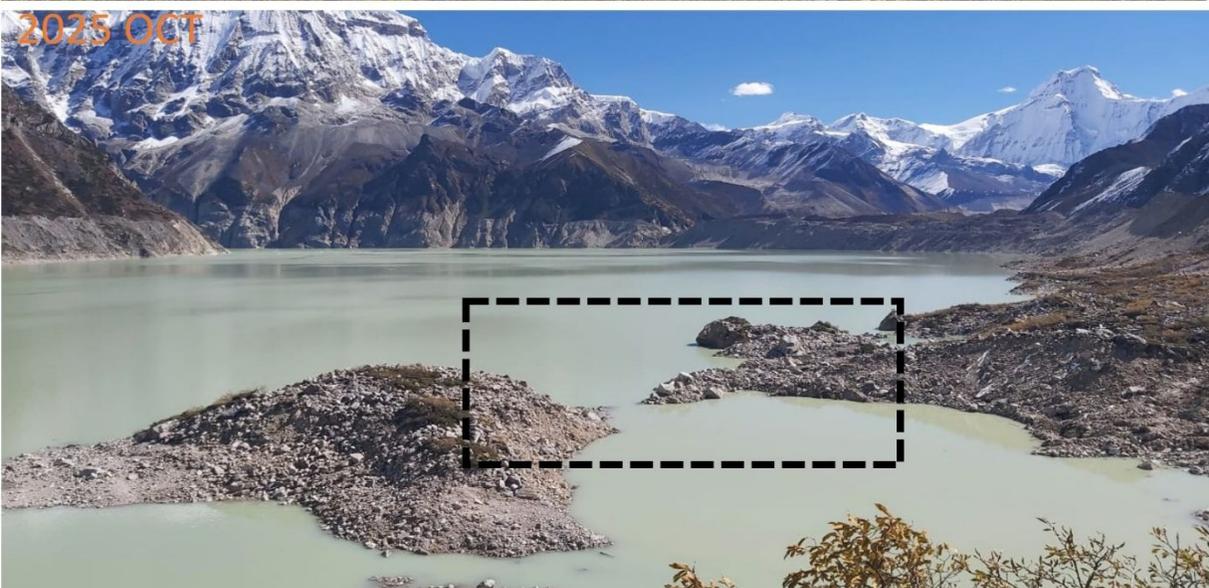
Photo 2: Photos showing are between main lake and subsidiary lake I

Thorthormi main lake is separated from the Subsidiary Lake I by moraine which are underlain by ice. This area was observed to be very active since the underlain ice are melting rapidly exposing fresh ice cliffs regularly. As a result, the main lake is expanding downstream towards subsidiary lake I and the Subsidiary Lake is expanding upstream towards the main lake. It is highly probable that the main lake will join with the subsidiary lake I very soon. Infact it was observed that the lakes have initiated merging on the surface (Photo 2)

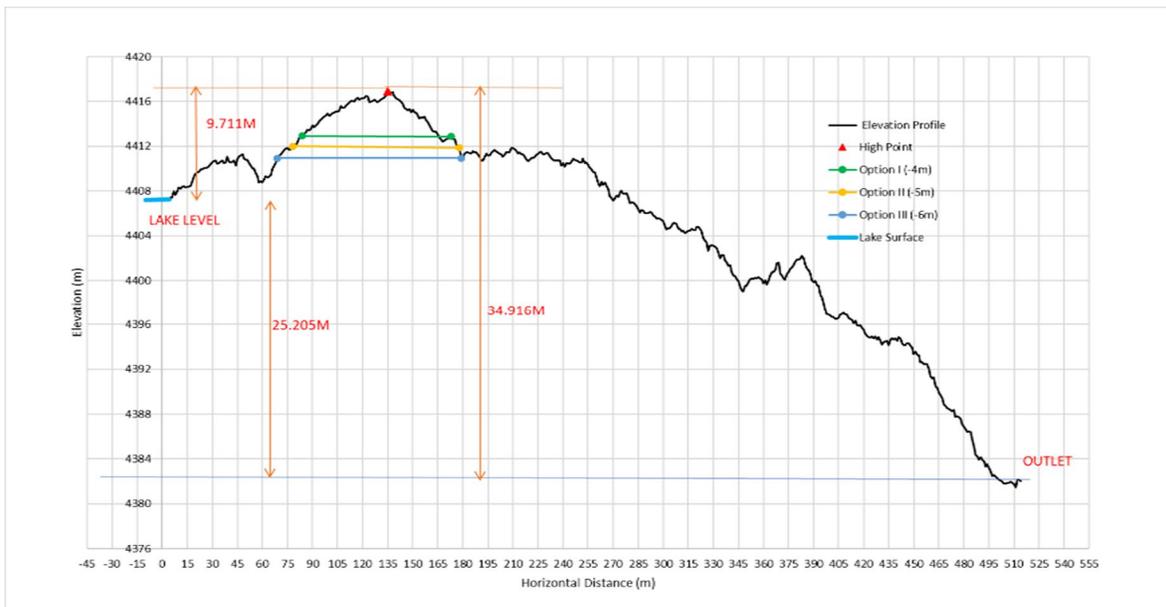
Figure 3: The profile of the site

The system operates on the fundamental hydraulic principle of a natural siphon, where a fluid flows from a higher-elevation reservoir to a lower-elevation outlet through a continuous, primed conduit, driven solely by the gravitational potential energy difference. For successful operation, the entire conduit must first be filled with water ("**primed**") to initiate flow, after which the weight of the water column in the descending leg creates a partial vacuum that draws water over the crest of the moraine dam ("**Apex**") from the lake, establishing a continuous, gravity-driven discharge as long as the outlet remains below the lake's surface level. The key **design criteria** were calculated based on site surveys and hydraulic formulas. A HDPE Pipe **diameter** of 5 inches (125 mm) was selected for the test siphon based on the portability by air lifting (helicopter) to work site and workability. The total **conduit length** was around 750 meters (125 M * 6 m) to safely route from a stable intake point, over the moraine crest, to a secure outflow point below the dam toe at the out-flow channel. The **required priming head initially** (the vertical distance the lake surface must be above the siphon's crest during priming) was 9.711 meters as per the field survey (Fig.3 & Fig.4)

With 9.711 meters of height difference, 125 mm of HDPE pipe a theoretical maximum flow rate (Q_{max}) was estimated at around 14.14 ltrs/sec) using standard pipe flow equations accounting for the measured static head and assumed friction coefficients. However, it clearly indicates that additional frictional losses, intake variables, pipe bends, air leakages and height difference could easily reduce the energy to overcome the pipe friction. As the objective was focused on proving feasibility and operational procedures and maximize water removal for risk mitigation, we went ahead with the pilot testing.

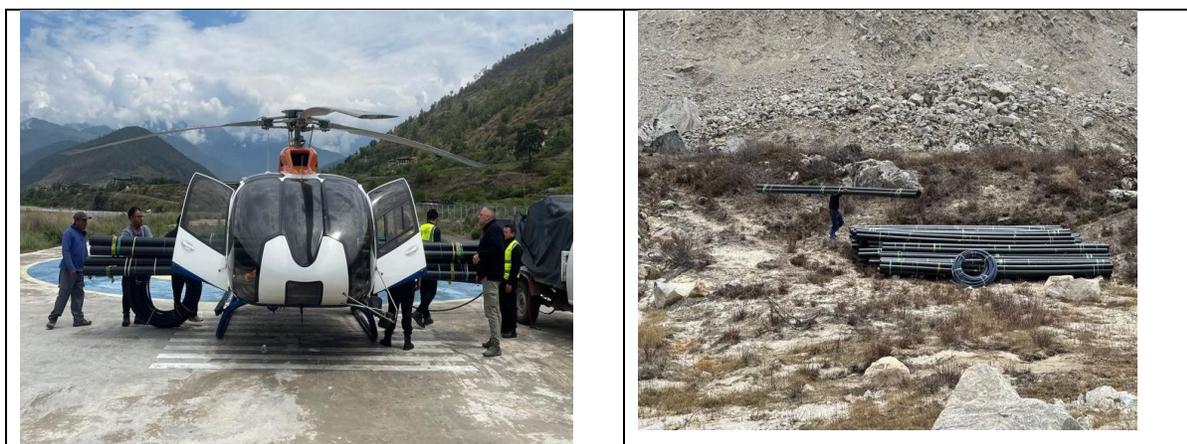
The major components of the test siphon such as HDPE Pipe, Butt welding, Flexi Joints, coupling, were transported using helicopter **slings-loads (Photo 3)** in May 2025. These transported materials were further transported manually from the drop area to the specific Project site. The remaining materials such as cement, tools and plant, protective gears, rations for the project team, valves fuel and others were transported in **August 2025** using ponies.

Photo 3: The Airlifting of the materials for the project.

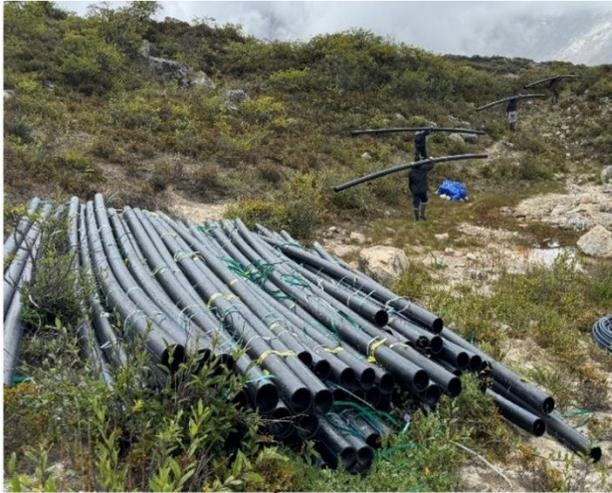
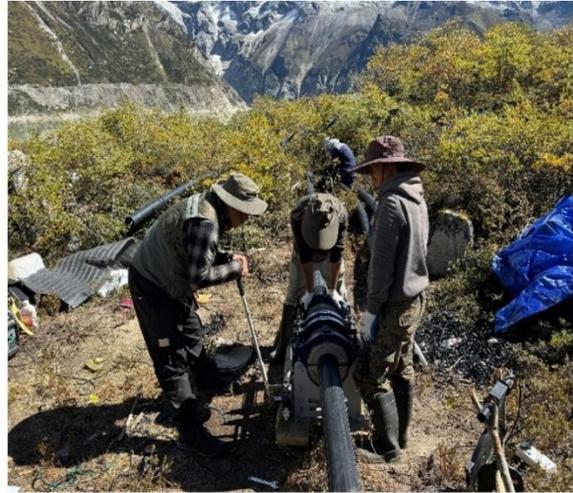
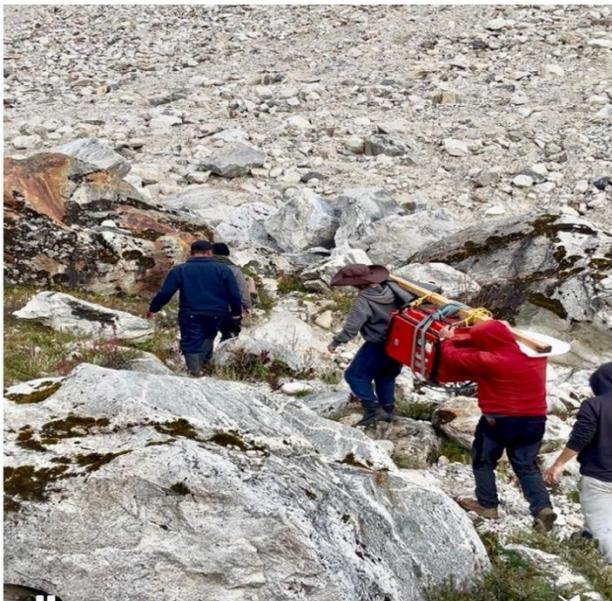
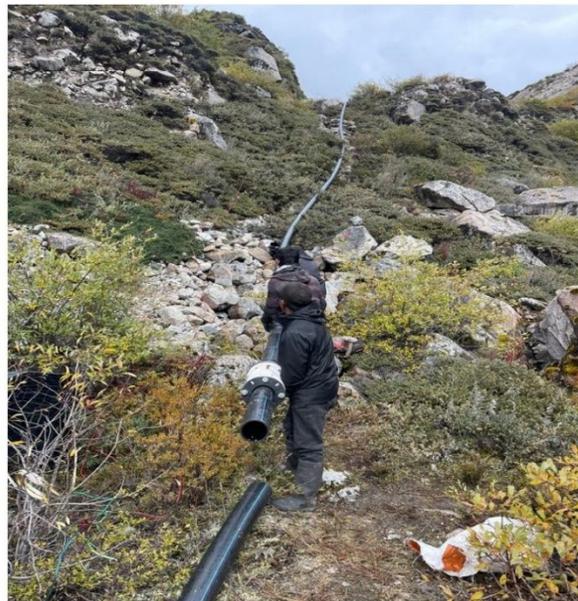
Photo 5: Laying and joining of pipes at the site using butt welding machine

The laying and jointing of the HDPE pipes constituted a major logistical and technical effort, conducted entirely on the rugged moraine profile. First, all pipe sections were manually unrolled and laid out along the predetermined route from the lake intake to the downstream outlet. The joining process utilized the **butt-welding** technique, where pipe ends are heated with a hot plate and fused under pressure. This work was executed in sections, welding multiple pipe lengths together on stable ground before maneuvering the now-longer, more cumbersome assemblies into their final position along the pre-determined profile. The primary challenge during this phase was **insufficient and unreliable power generation**. The project's 3 KW portable generator **failed**

to work at site upon deployment, necessitating a hiring of a 65-kilogram generator from the Lunana community school, located 3 hours from the site. Transporting this heavy unit to the project site required a team of over ten people, significantly delaying operations. Even with a functional generator, the extreme ambient low temperature at the high-altitude site presented a critical welding hurdle: the heating plate lost its required temperature (approx. 210°C for HDPE) rapidly between cycles, preventing a proper melt zone from forming. This required repeatedly overheating the plate, carefully insulating the work area with tarps, shades and executing welds in quick succession, greatly increasing the time, complexity, and risk of producing sub-optimal, weak joints.

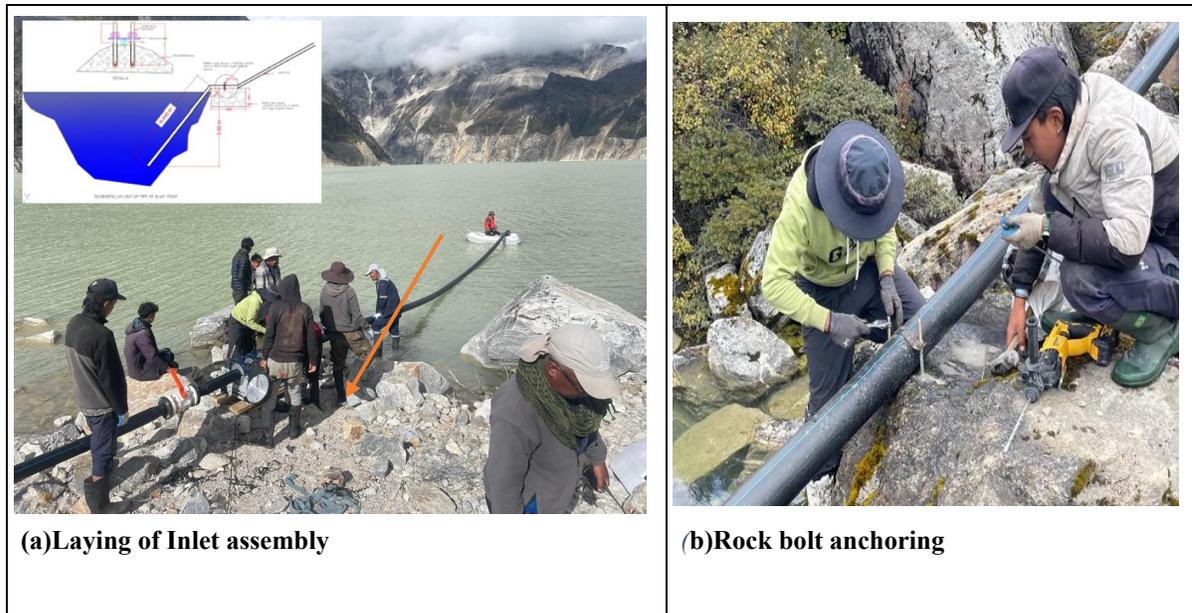
Photo 6: laying and securing of siphon section at the inlet part (lake)

The deployment of the intake system was a critical and high-risk operation, requiring secure placement at a sufficient depth to ensure a stable water column and minimize vortex-induced air entrainment¹. The assembly was prepared on shore. It consisted of the primary **125 mm HDPE intake pipe, fitted with a permanently welded ball valve** at its terminus for controlled priming, emergency flow cessation managing the water column during startup. The prepared intake was manually launched from a shoreline and floated into position using an inflatable rubber boat (Photo 6a). Using a combination of sonar and weighted line measurements, the assembly was positioned **at a distance from the shore sufficient to achieve a final submerged depth of approximately 4.5 meters below the lake surface**, placing it well below the active wave zone and potential surface ice layer.

The intake pipe was secured against a large, stable **boulder on the moraine dam face (Photo 6b)**. Using a portable rock drill, **anchor bolts** were installed directly into the boulder and then fastened around the pipe and bolted to this anchor point, preventing lateral or vertical movement. To further resist the significant hydrodynamic thrust force from the siphon flow, a Random Rubble Masonry **(RRM) thrust block** was constructed *in-situ* around the pipe's base where it contacted the boulder and moraine substrate. This RRM block effectively transferred the operational loads from the pipe into the stable ground, completing a secure, multi-point anchoring system designed to withstand dynamic lake conditions.

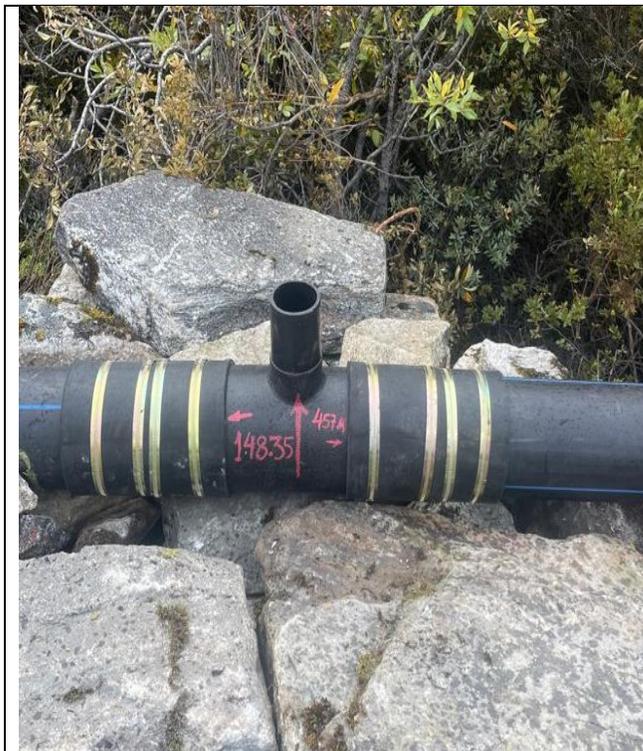
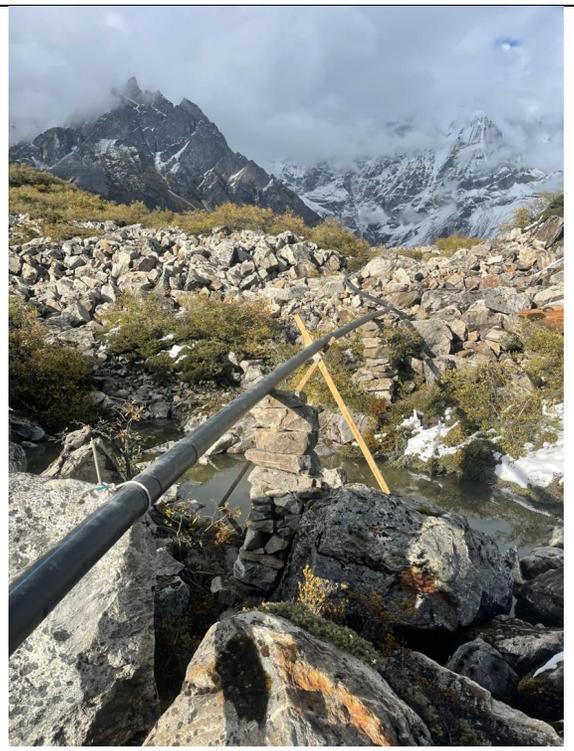
Photo 7: T section joint at the apex and pipe profile along depression

The routing and securing of the HDPE conduit over the irregular moraine dam carried out on the terrain-dependent operation. The total conduit was segmented from the apex as **148.35-meter** section on the **rising limb** (from the lake intake to the Apex) and a **457-meter** section on the **falling limb** (from the Apex to the downstream outlet). A T-section was joint at the apex for priming the system (Photo 7a). The sections wherever possible were anchored to prevent slippage and reduce vibration during the operation using rock bolt anchoring system. Primary anchoring for both segments was achieved using rock anchor bolts drilled into stable boulders, with stainless steel straps securing the pipe. To maintain a hydraulically smooth profile essential for priming and air management, significant site work was undertaken. At unavoidable positive kinks, particularly on the falling limb, Random Rubble Masonry (RRM) thrust blocks (Photo 7b) were constructed to fix gentle curves. In more severe constrictions, selective excavation of boulders and soil was performed to create a shallow trench, straightening the pipe's path. This process ensured the conduit maintained a continuous, optimized gradient from intake to outlet, minimizing friction losses and points of potential air accumulation.

(a) T section at the apex

(b) pipe laying over depression using thrust blocks

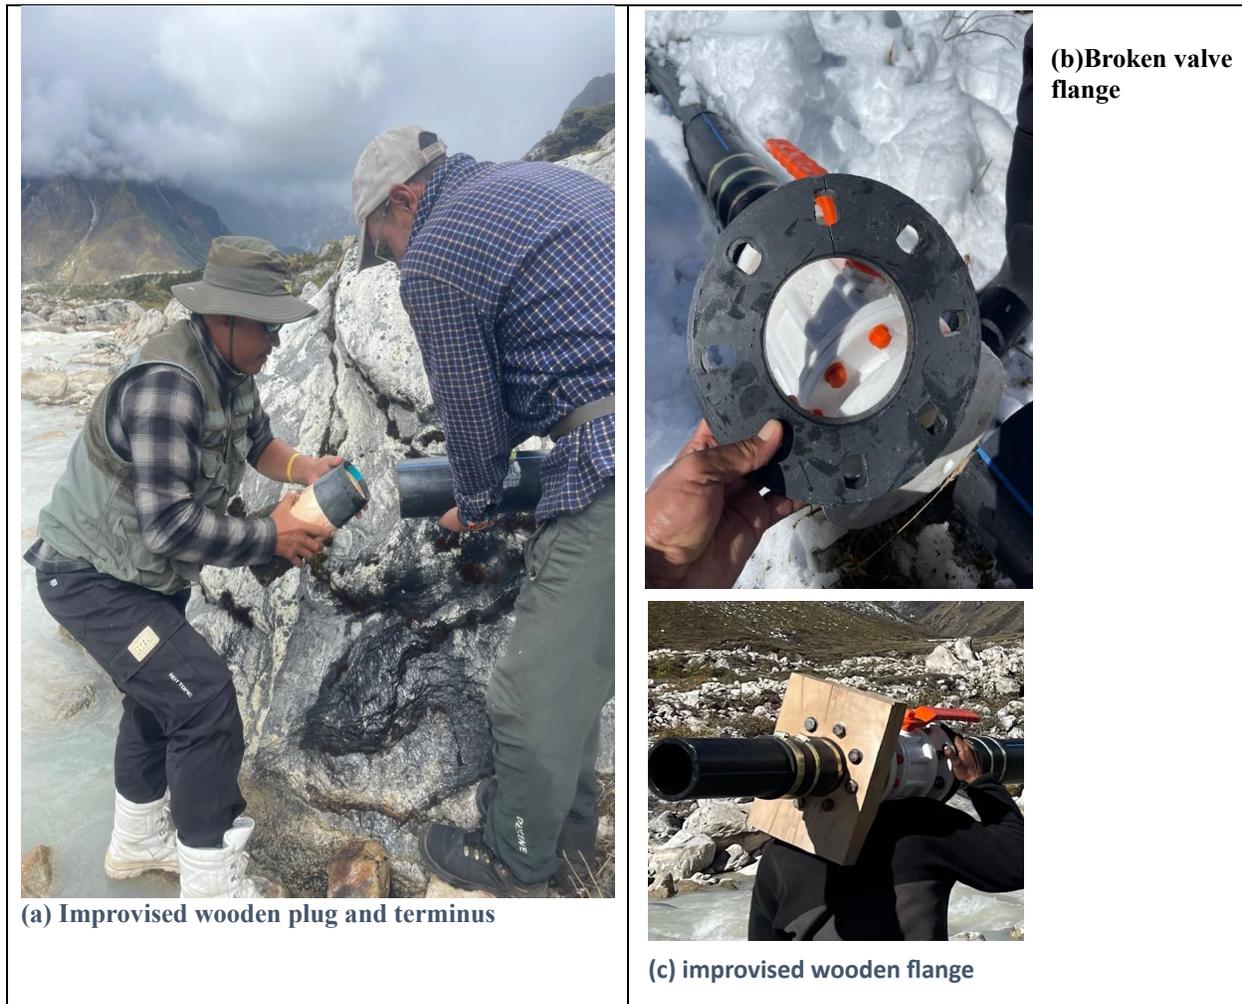
Photo 8: Terminal block of the siphon

The outlet pipe terminus was securely anchored to a large, stable boulder using rock anchor bolts and stainless-steel straps to withstand the thrust of the discharging water column at the toe of the moraine joining the natural flow channel. Initially, a standard 100 mm ball valve was installed to allow for controlled opening and closing of the siphon. However, during the first priming attempt, the excessive hydrostatic pressure caused a shearing the valve's PVC flange (Photo 8b). As an immediate improvisation, the team attempted to seal the outlet using a hand-tightened wooden plug wrapped with rubber bands (Photo 8a), but this proved incapable of achieving a watertight seal against the high pressure, resulting in significant leaks that prevented the system from holding prime. Following this, a local repair was undertaken: the broken flange was mended using an improvised wooden collar, fabricated on-site to reinforce the connection. Once the valve housing was restored, the 100 mm ball valve was reinstalled (photo 8c). This repaired configuration

successfully allowed for the controlled manual operation of the outlet, enabling priming of the conduit and initiating the siphon flow.

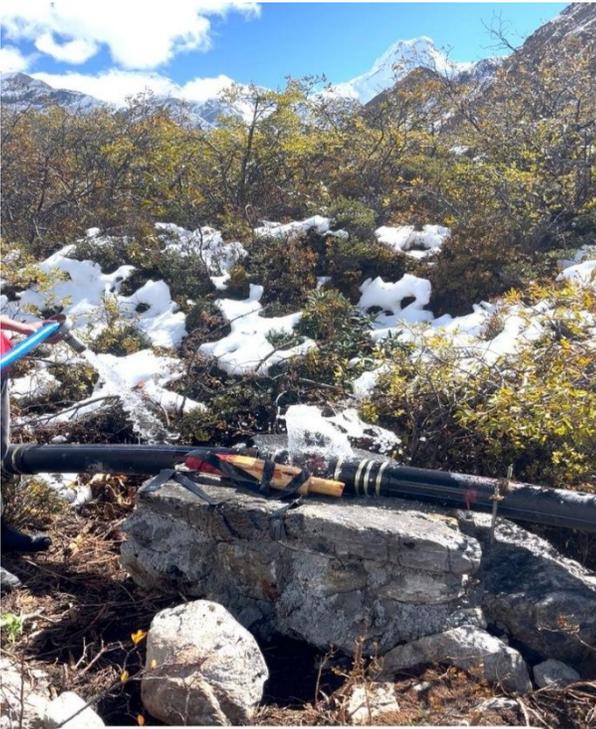
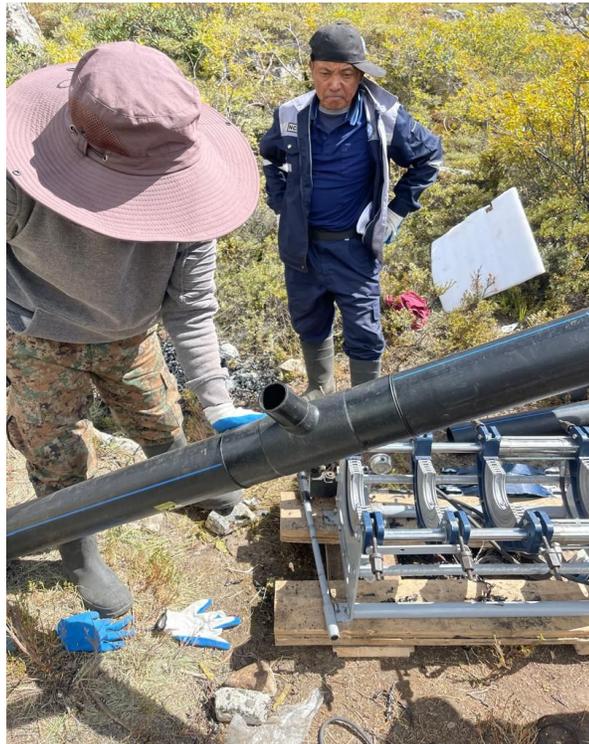
Photo 9: Priming components on RRM thrust block

To facilitate the process of filling the siphon conduit with water, a priming component was installed at the system's hydraulic apex—the highest point of the conduit located on the moraine dam crest. This component consisted of a **125mm x 125mm x 40mm HDPE reducer** (a fabricated section reducing from the main pipe diameter to a 40mm port), which was integrated into the pipeline via butt welding (Photo 9b). This port provided a secure connection point for the hose from the portable water pump, allowing water to be injected directly into the top of the system and to displace air both from the rising and falling limbs. To ensure absolute stability at this vital and high-stress location, the entire apex assembly, including the reducer and adjacent pipe sections, was fully secured by encasing it within a (RRM) thrust block (Photo 9a). This block was constructed *in-situ* around the pipe, bonding it to the underlying stable moraine material, thereby preventing any movement, vibration, or stress on the welded joints during the priming process and subsequent operation.

(a) apex secured on RRM thrust Block

(b) assembly of priming component -reducer

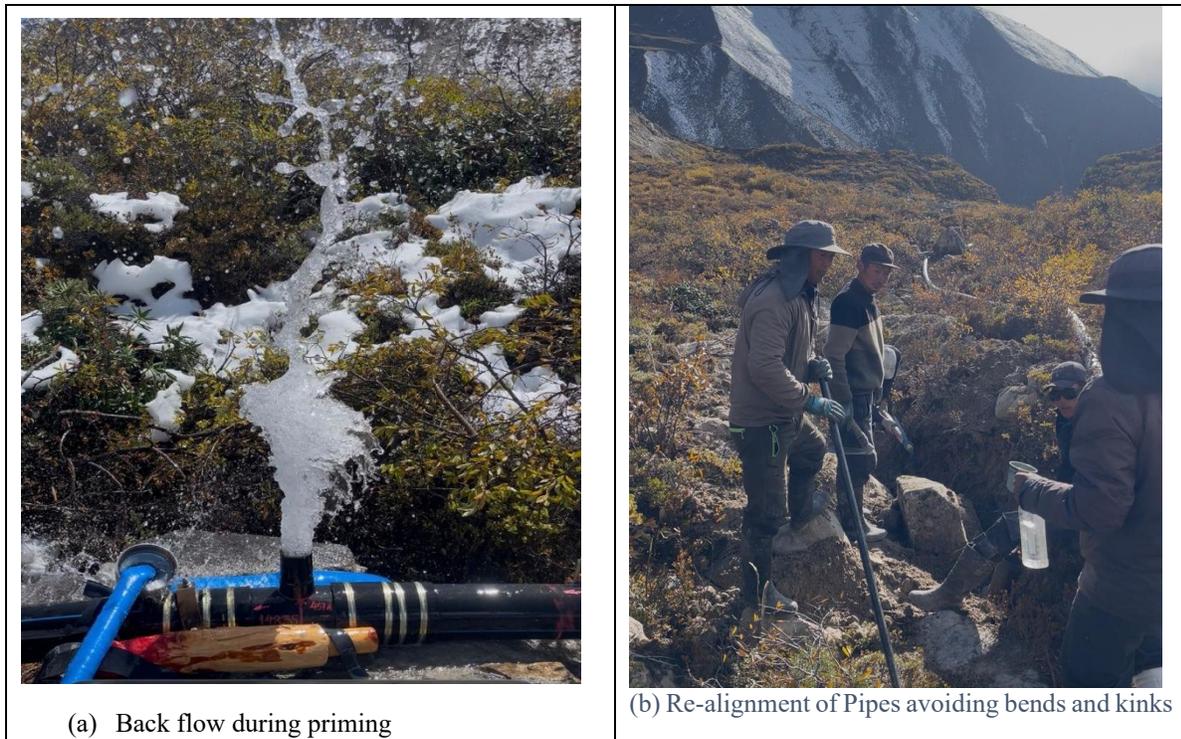
Photo 10: Back flow during priming and realignment of pipes.

Upon completion of installation, the first priming attempt was initiated by sealing both the lake intake (via its ball valve) and the downstream outlet (via the repaired 100mm ball valve), and connecting the water pump to the apex port. Using the portable gasoline pump connected to the 40mm port at the apex, water was injected to displace air from the conduit. Theoretically, with a sealed system, injected water should displace air, forcing it air out through priming intake as no dedicated air-release valve were installed. However, the process immediately revealed significant problem as excessive **return flow** was observed (Photo10a) at the Apex thereby increasing the time for priming by **2 to 3 hours**. This might have occurred because air became trapped at high points in the conduit—particularly along the 457-meter falling limb. The **air pockets trapped at high points** along the conduit, which acted as blockages resulting in prolonged pumping, high fuel consumption, and an inability to establish a continuous, air-free water column necessary to initiate the siphon effect. This necessitated a troubleshooting and adaptation particularly realigning the pipes on the falling limb to avoid high ground kinks and bends (Photo 10b).

3. The backflow during priming highlighted the need for proper laying of pipes avoiding kinks and bends and integration of air **vent valves** at the apex.

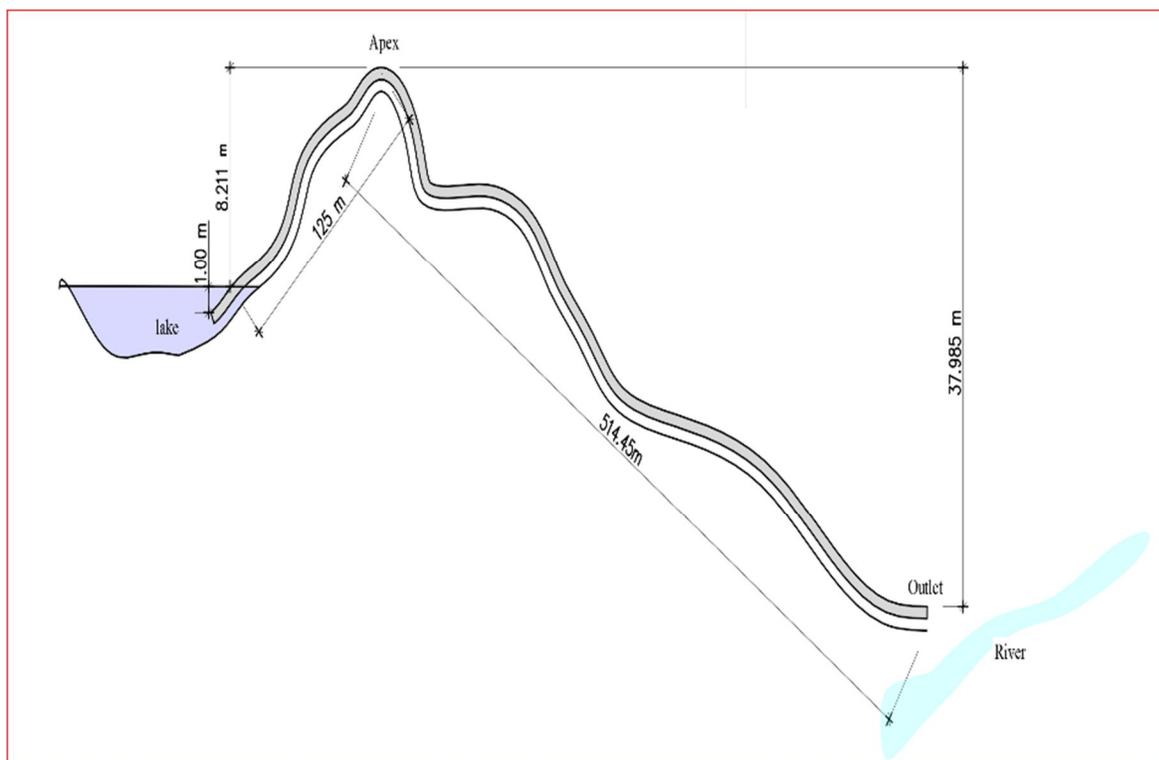
Figure 5: The Re-designed profile as constructed with lowered Apex by 1.55 m

1. The outlet pipe was extended by 30 meters to increase the effective static head;
2. The apex (crest) was physically lowered by 1.55 meters by re-routing the pipe over a lower point and surface boulder removal on the moraine to decrease the lift required (Fig. 5)
3. The intake pipe on the rising limb was shortened by 12 meters to reduce friction.
4. The intake point was raised from a depth of 4.5 meters to just 1 meter below the lake surface to minimize the initial suction lift needed.
5. The outlet valve was replaced with a larger 150 mm diameter unit to eliminate a major downstream flow restriction (Photo 11).

Despite these substantial alterations, which collectively represented a major recalibration of the system's theoretical hydraulic profile, operational testing showed no measurable improvement. The siphon still failed to establish continuous flow, stalling at the apex as before.

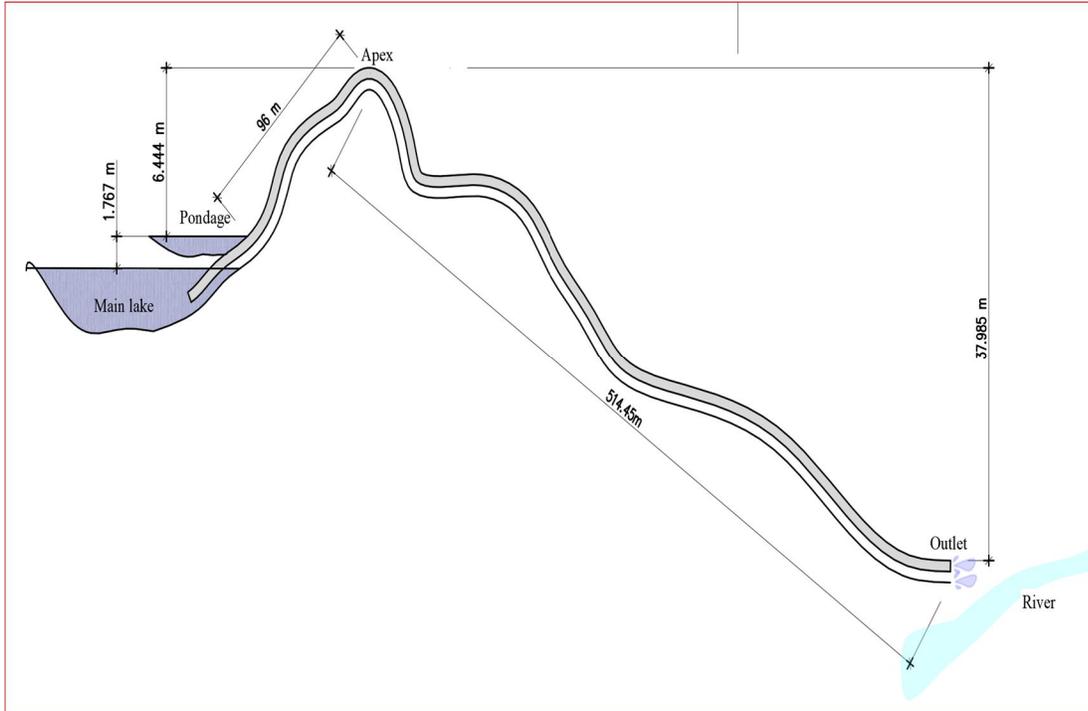
Figure 6: Test on pondage located 1.7 m above lake surface

As a diagnostic final resort, the intake was relocated from the main lake to a small, isolated **pondage** (a shallow, contained water body) located approximately **1.767 meters above the original lake surface level**, as verified with dumpy level surveying (Fig.6 & Photo 12). This test was conducted to determine if the system's consistent failure was due to the key theoretical constraint: the maximum possible siphon height (h_{max}) at altitude around 4300 m was 9.771 m. By raising the intake by 1.767 m and lowering the apex by 1.55 m, the effective static head driving the siphon was reduced to approximately **6.444 meters** (calculated as: $9.771 \text{ m} - 1.767 \text{ m} + 1.55 \text{ m}$), thereby testing the system's sensitivity to a significantly lower (h_{max}).

Results from this configuration showed a slight but notable behavioral improvement. During priming and startup, the water column successfully rose to approximately **three-quarters (¾)** of the length of the rising limb, a marked increase compared to previous tests. This indicated that with a reduced total lift, the system could more effectively begin the process of drawing water over the crest.

However, the siphon still failed to establish continuous, self-sustaining flow. The water column consistently stalled at the apex, unable to complete the transfer over the crest. Following each stall, the water in the rising limb gradually drained back into the elevated pondage, emptying the conduit as in all prior tests.

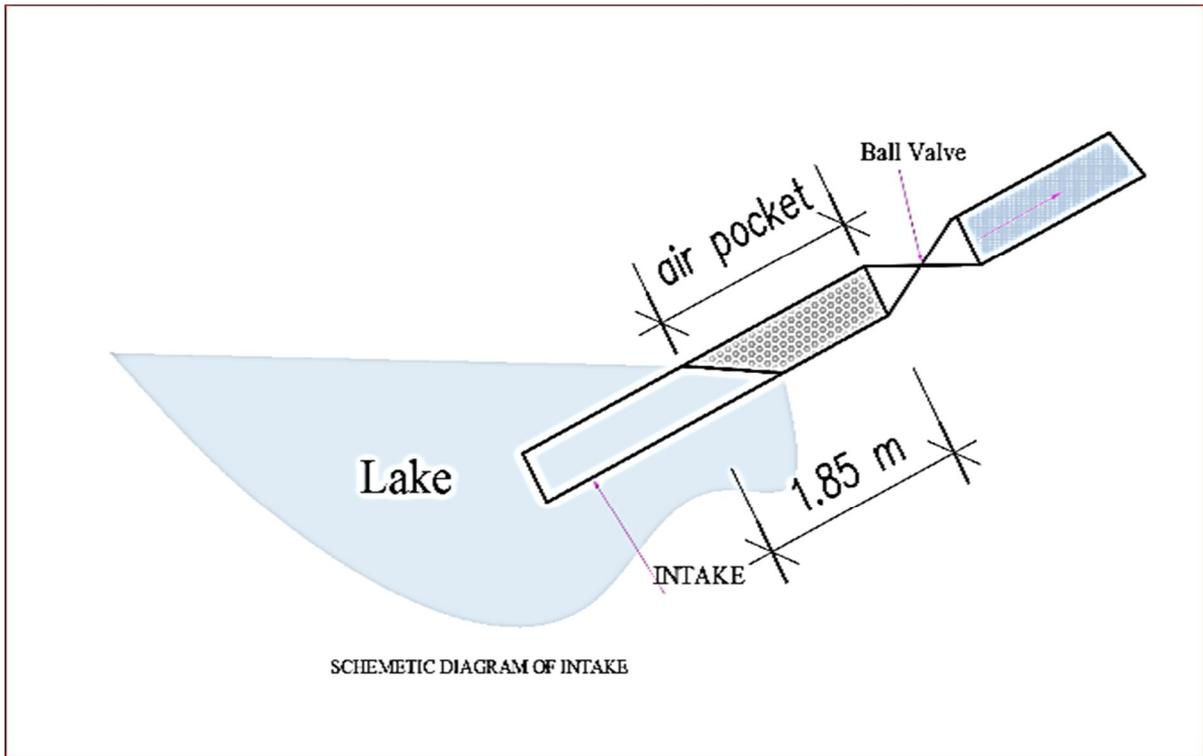
Figure 7: illustration of trapped air pocket between lake water level and sealed ball valve at the inlet section of the siphon

- I. The vertical separation between glacier lake and the siphon crest (Apex) refer table 2.
- II. Trapped air pocket between submerged pipe inlet and the sealed ball valve and Water Level (Fig.7)
- III. Frictional Loss due to internal bead, or **fusion ring**, at each butt-weld joint (Photo 13).
- IV. A section measuring approximately 80 m on the **falling limb with a near-zero slope** (Fig.8)

4. To replace the ball valve with a **submersible non-return (check) valve** directly at intake assembly to eliminate: a) The trapped air pocket that formed between the lake surface and

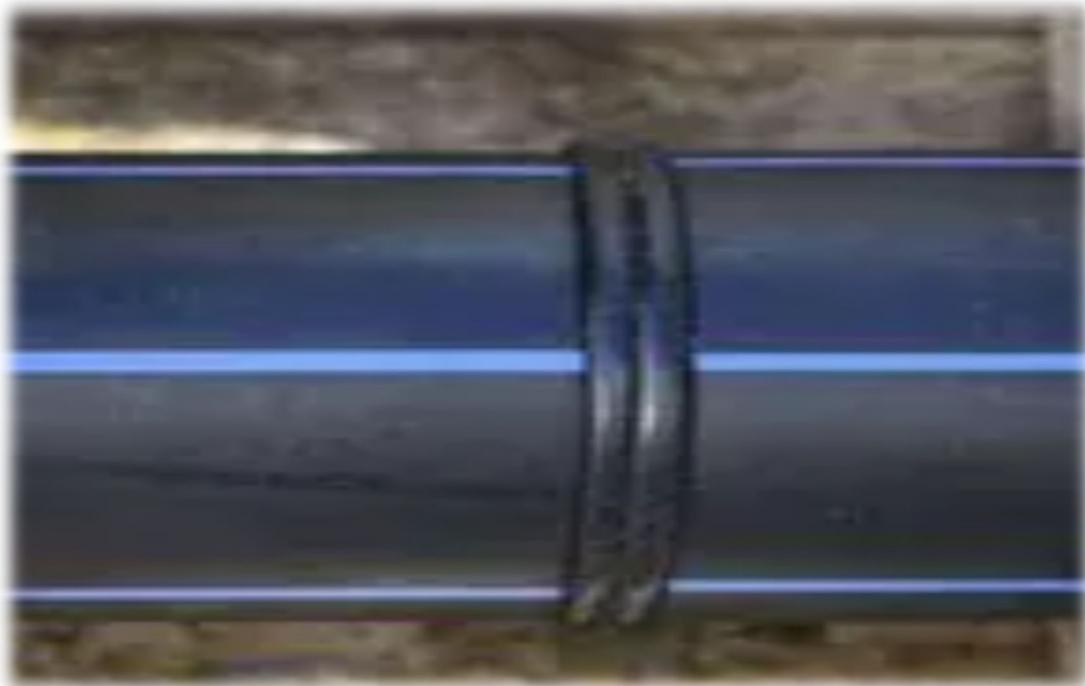
Photo 13: Fusion ring at each butt weld joint of the siphon pipes

5. One of the contributors to the system's hydraulic inefficiency was the increased frictional loss introduced by the internal bead, or **fusion ring**, at each butt-weld joint. During the field welding process, the heated ends of the HDPE pipe are pressed together, forming a raised internal ridge where the material fuses. While this creates a strong mechanical joint, it also introduces a localized reduction in the effective internal diameter of the pipe. For a siphon system operating with a marginal driving head, the cumulative effect of these periodic restrictions along a 550-meter conduit with numerous welds is substantial.

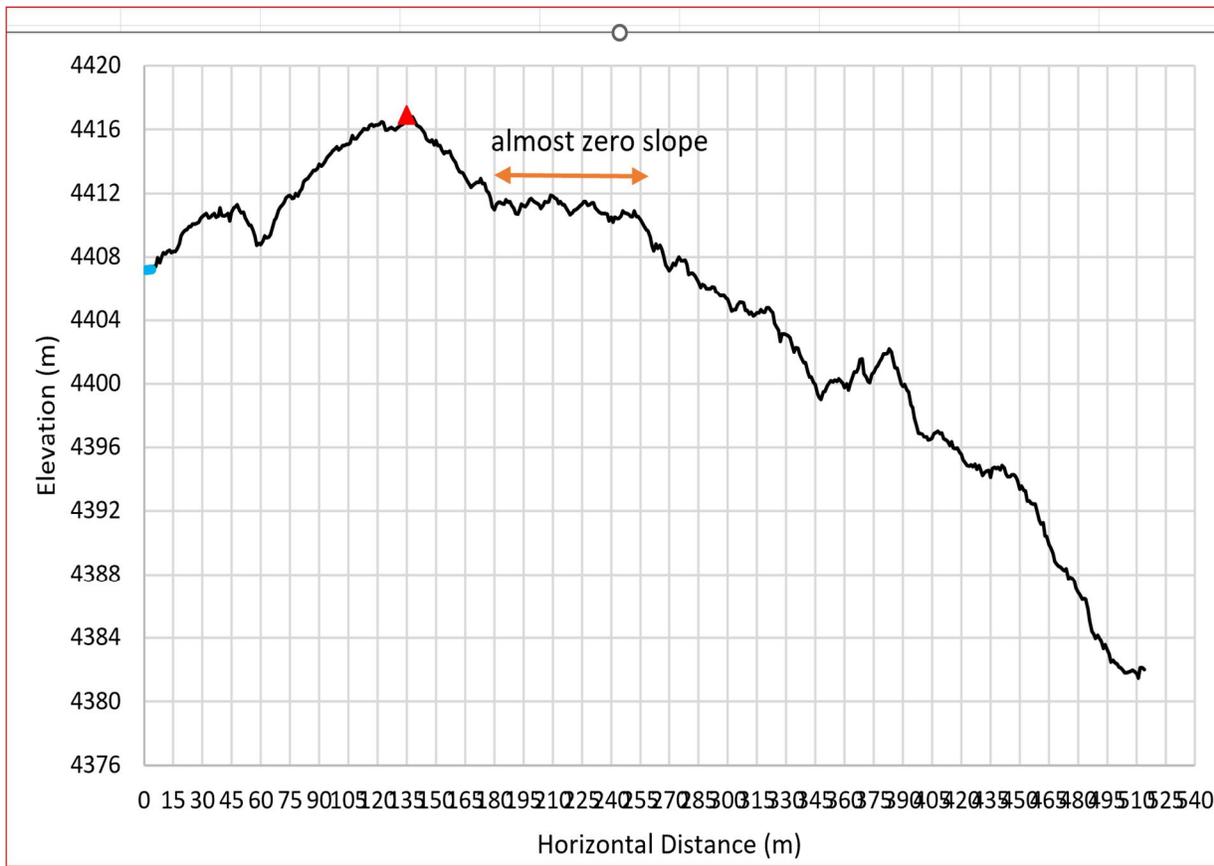
Figure 8: Siphon profile on falling limb showing section with near zero slope

6. The topographic survey and as-built profile, section measuring approximately 80 m on the **falling limb showed a near-zero slope**. During operation, water velocity in this flat section might be reduced due to friction, losing water momentum. We assumed that this is probably acting as bottle-neck causing the net siphon effect to diminish. **There was no option to re-rout this profile section.**
