Report on the Rapid Assessment of Thorthormi Lake and the Restoration of Automatic Water Level Sensors for the GLOF Early Warning System

NATIONAL CENTER FOR HYDROLOGY AND METEOROLOGY ROYAL GOVERNMENT OF BHUTAN

2019

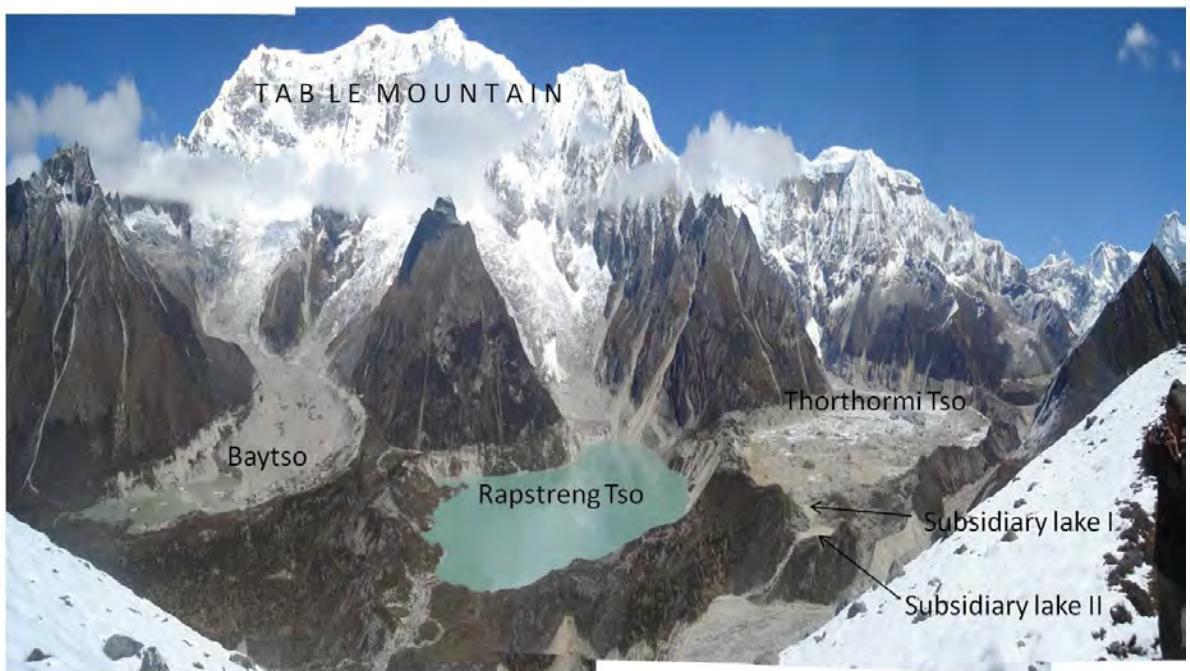
Photo 1: Location of Thorthormi lake

Thorthormi glacier/Thorthormi lake lies at the base of the famous Table Mountain (Photo 1). It lies to the left of Rapstreng tso and to the upstream lies Lugge Tso which outburst in 1994. To the far right (downstream) lies Baychung glacier which is associated with Baytso.

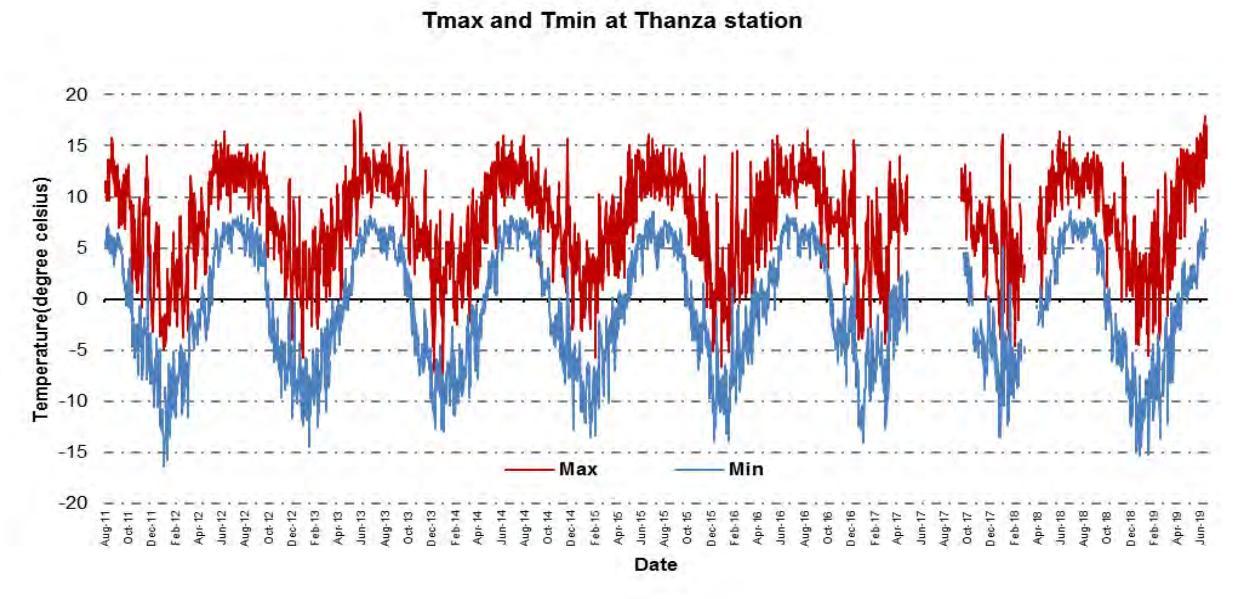
Figure 1 : Daily Tmax and Tmin from Thanza station

The months of April, May and June 2019 had recorded the highest maximum temperature over Thanza (Figure 3) compared to the past 8 years (after the installation of GLOF EWS). The maximum daily temperature reached 17°C in June 2019 (Figure 1).

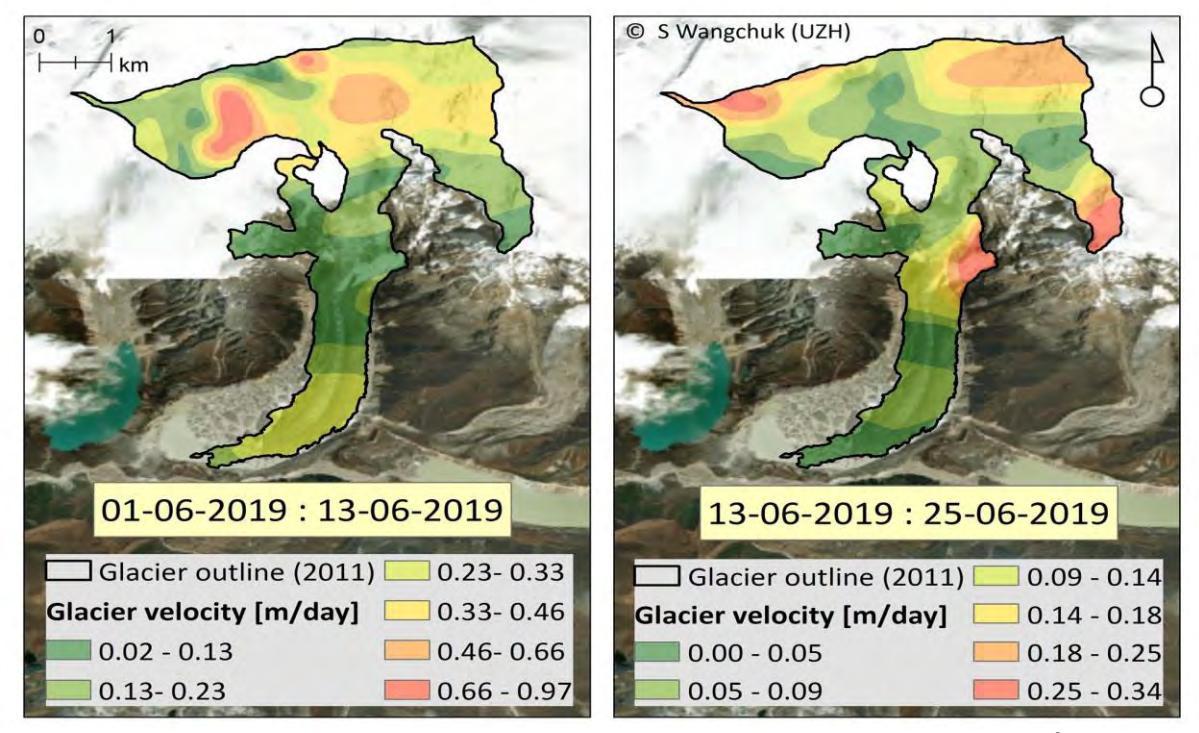
Figure 8 : Comparison of displacement on Thorthormi glacier between 1st June, 13th June and 25th June 2019 (Courtesy: Sonam Wangchuk, University of Zurich, Switzerland).

Figure 5, 6 and 7 shows movement on Thorthormi glacier before breaching occurred (before 20th June 2019). It is evident from these images that there was active displacement measuring between as low as 0.34 to as high as 1.2 meters per day on Thorthormi glacier in the early part of June 2019. However, after 20th June 2019, such displacement on Thorthormi glacier subsided (right image of figure 8). The velocity measurement in the late 1990s on Thorthormi glacier showed 90 m per year in the upper region and 40 m in the lower region (Joint Japan – Bhutan research report, 2003) which roughly translates into 0.25 m per day and 0.11 m per day which is lower than the movement observed in the month of June 2019.

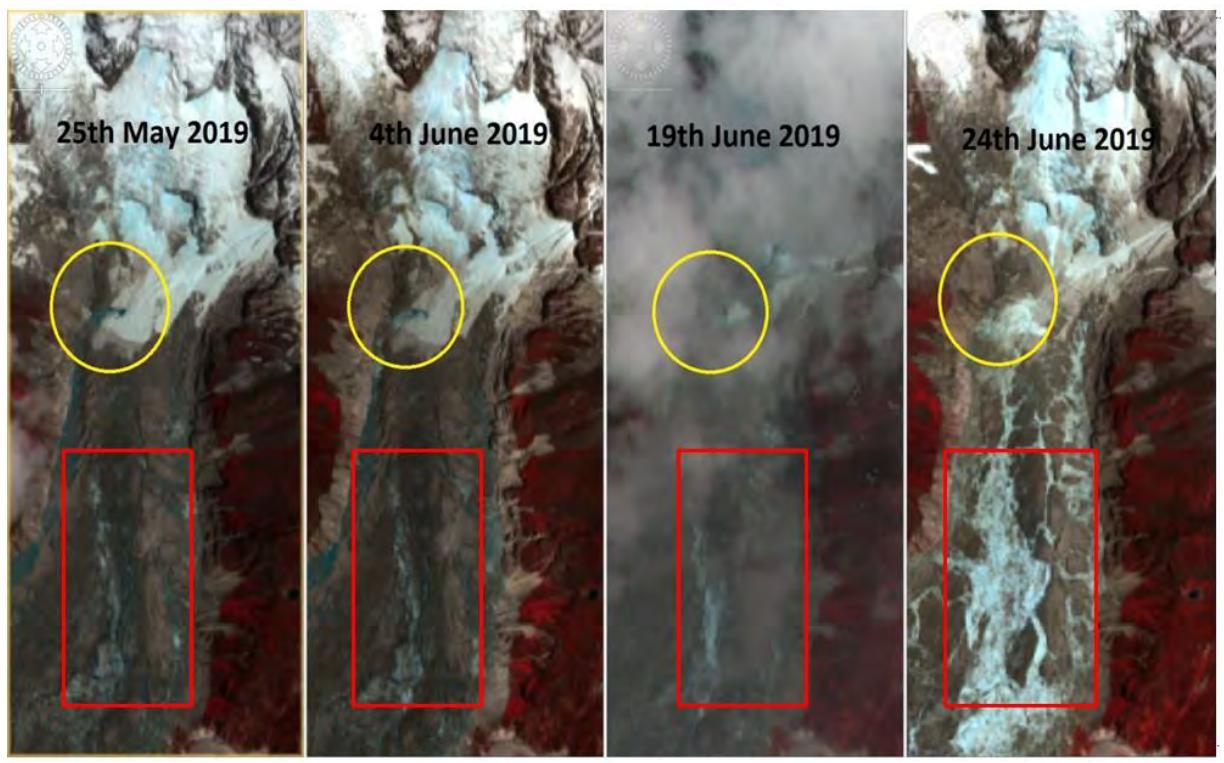
Figure 9 : Time series Sentinel 2 image the status of Thorthormi glacier.

Figure 9 and 10 shows time series Sentinel 1 and Sentinel 2 images of 25th May, 4th June, 19th June and 24th June 2019. The bright white part on the Thorthormi glacier (figure 9 & 10) which is visible on the last image of 24th June 2019 is not present on the previous images. This bright part is the exposed fresh glacier ice of Thorthormi glacier which is a result of breaking and disintegration of the glacier due to movement taking place within the glacier. As a result of all these disturbances taking place on Thorthormi glacier, the small pond (yellow circle) in the upstream part of the glacier disappeared (Figure 9). Evidence of the increased melting is also visible in the disintegrated area (red circle part in figure 10).

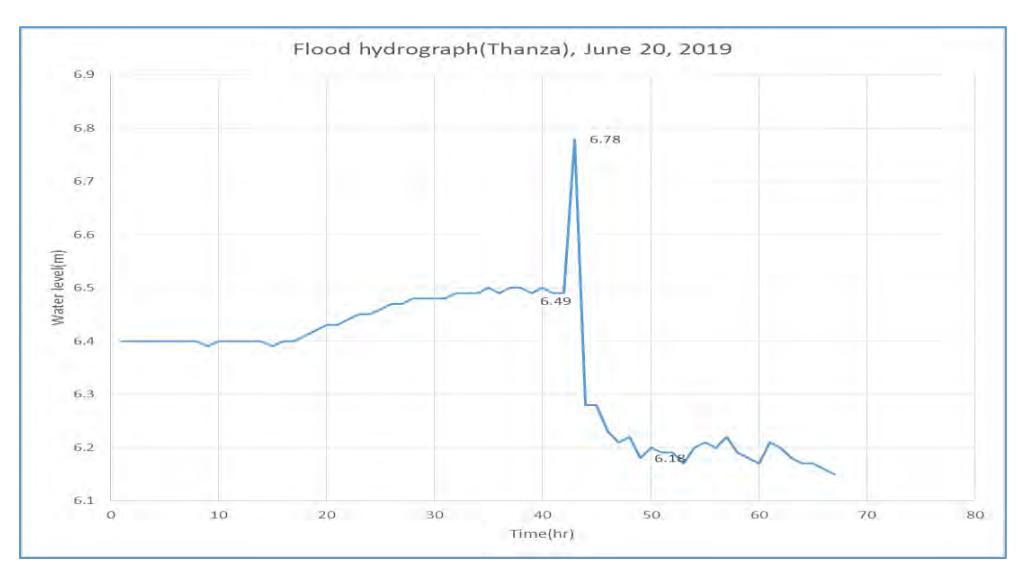
Figure 3: Detection of the rise and fall of water level at Thanza Station

The rise of water level was also detected by GLOF EWS monitoring station at Thanza, that is located approximately 4.60 KM along the river channel downstream of Thorthomi lake.

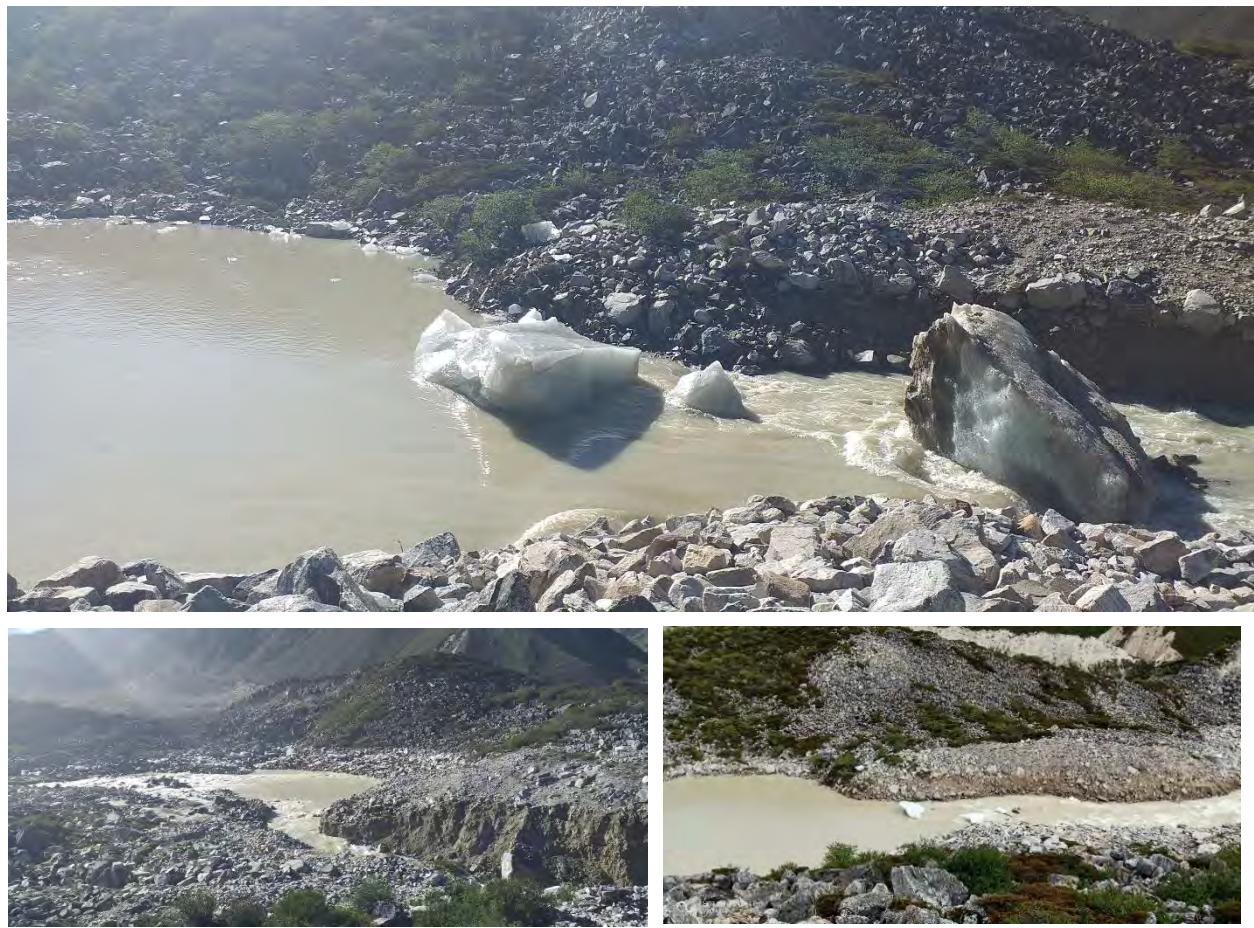
Figure 9: First photos of the site update in

The field staff stationed at Thanza were deputed for field verification soon after detection. Despite harsh weather condition, the two-site staff immediately initiated the action. One stayed at Thanza AWLS reporting the situation while the other continued to the Thorthormi Lake. It was reported at 12:08 AM, 21st June that the subsidiary lake II of the main Thorthomi lake had fully drained out. Since it was dark, no site photo could be sent to CRs but at the very early hours of the day when it became visible, site information through photos was shared. They informed the Head Quarter about the Thorthormi AWLS which was rendered functionless was due to water being fully drained out exposing the sensors. Similar problem at Thanza AWLS was also reported.
