**Post-Flash Flood Assessment Report:  
Tsaticihu Flash Flood Incident of 19 July 2026 at Lhadrong,  
Lhuntse Dzongkhag**

**Submitted by  
National Centre for Hydrology and Meteorology  
Dorjilung Hydropower Project Authority  
24 July 2026**

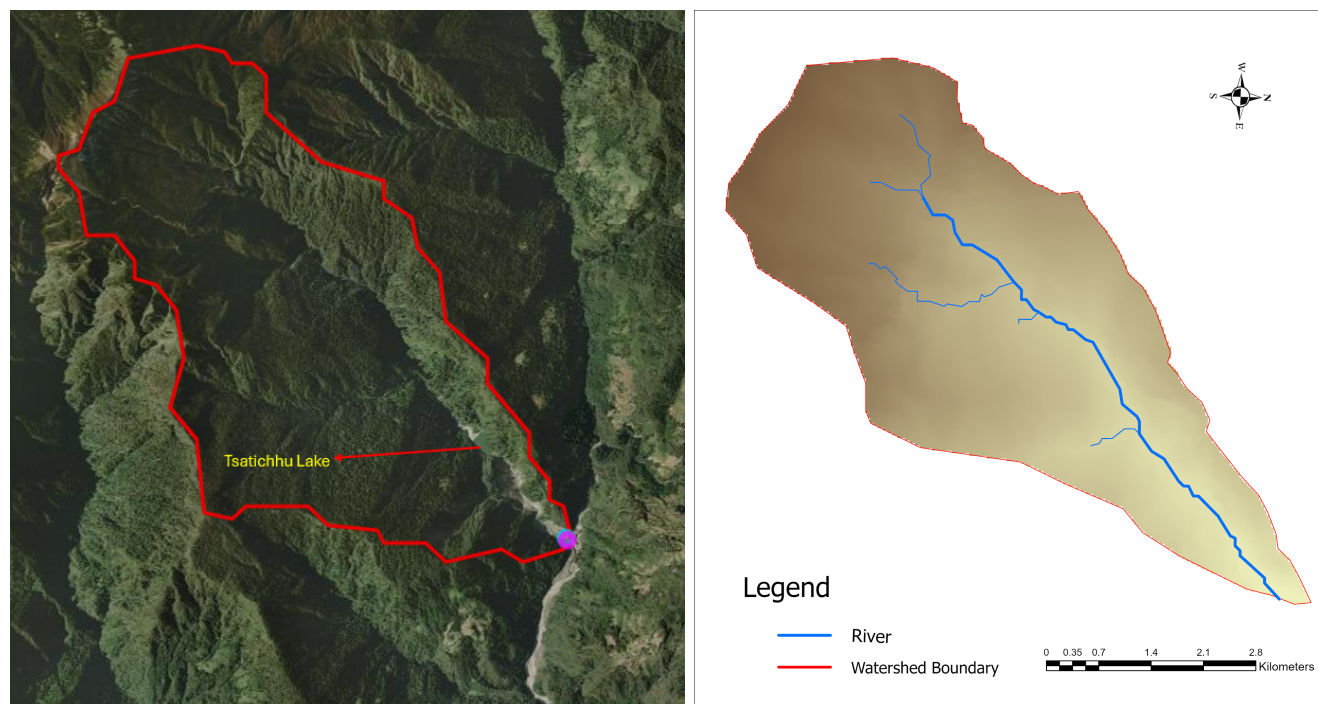
Figure 2: Watershed Map of Tsatichhu

The catchment area is characterized by extremely steep terrain, fractured bedrock, and highly landslide- prone slopes, making it intrinsically susceptible to slope failures and temporary channel blockages during intense summer monsoon events.
